FLIGHT COMMENT

JANUARY · FEBRUARY · 1967

DIRECTORATE OF FLIGHT SAFETY

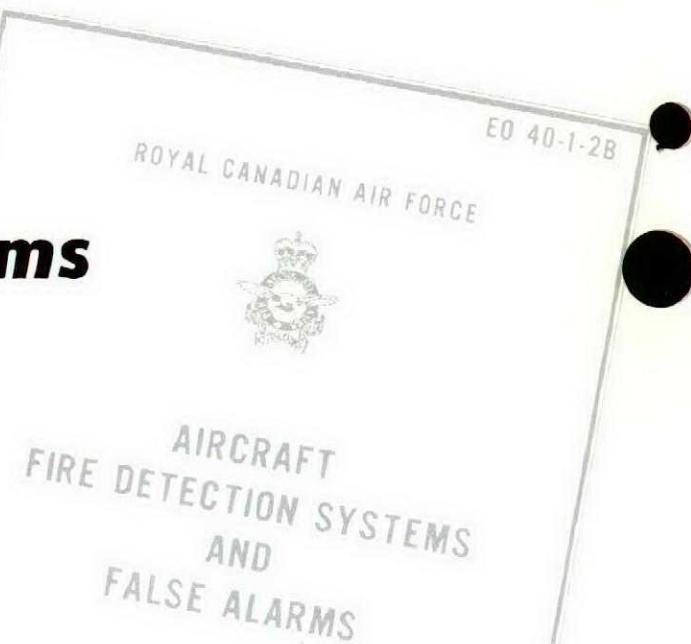
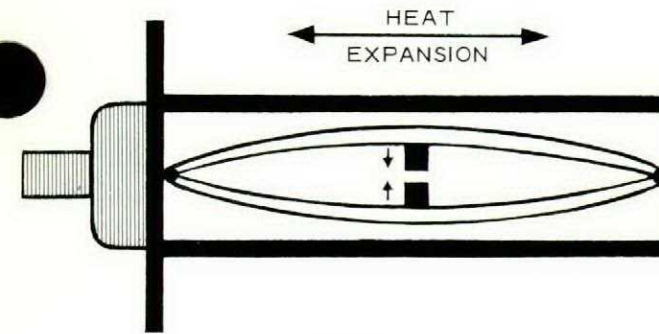
Fig 1

This system is quite simple. It consists of a number of switches connected in parallel, so that the actuation of any one of them completes the circuit of the warning device. The heart of the system is the thermoswitch which is a cartridge-like shell of stainless steel inside which are two contact-carrying struts mounted under compression (Fig 1). A rise in temperature causes the shell to expand and extend, reducing strut compression.

The contacts touch when the temperature calibration point is reached. Some systems employ a different type of thermoswitch in which a contact on a bi-metallic element completes a circuit at a certain temperature setting.

Thermoswitch fire detector systems have given good service in some aircraft such as the CF104, but have been troublesome in others. The dual-loop/two-wire system using a circuit-breaker relay does not generate a false alarm due to grounding; however, the single-wire system will false-alarm on grounding, and should not be called up on new engine fire detection installations. This system is capable of point detection but has a drawback of routing electrical connections and wiring into high-temperature areas. Further, the switch units, although rugged, can be jarred out of calibration.

Thermoswitches cannot be repaired or reset in the field but can be easily tested to confirm adjustment to a proper setting. In a potential fire zone, the high temperatures, the severe humidity, and vibration, subjects the wires and terminals to chafing, oxidizing and loosening, which degrade system reliability. The thermoswitches and mounting components which deteriorate with age should be replaced. All tradesmen working in the area must be careful to avoid jarring the switch units.

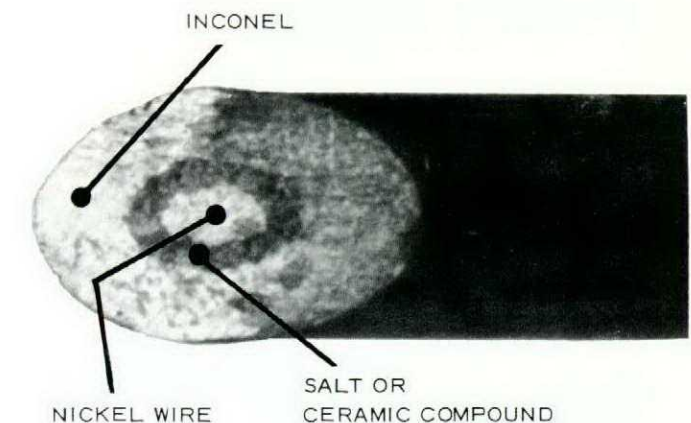
Fig 2

This is one of the later types to appear on the scene. While other detection systems perform point detection only, the fire detection cable can monitor for fire along its whole length. The cable is a flexible metal tubing enclosing a wire core insulated by a ceramic material (Fig 2). It can be any length, and several lengths can be coupled.

In a typical system, power from the aircraft is applied to the fire detection cable core through a bridge circuit. No current flows until a breakdown of resistance is induced somewhere along the cable by heat. The detector cable circuit is connected as a loop, so that a single break in the element leaves the system fully operative (provided the break has not left the cable outer shell in contact with the inner wire core) – at least, so the theory goes! Here again, a system test switch permits quick checks for open circuits. Fire detector cables lend themselves to easy routing but this feature multiplies the chance of malfunction.

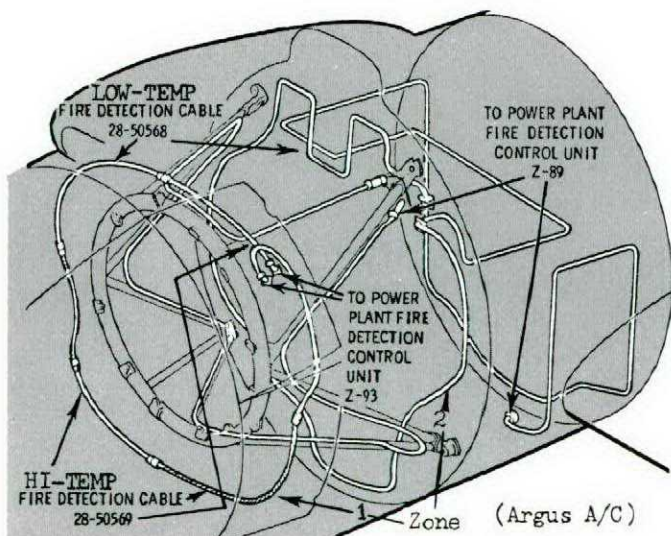
Typical continuous-wire installation (Argus)

(EO 40-95AB-2 describes one type of continuous wire system, and applicable aircraft -2, -4, -7 and -7A EOs detail specific installations and inspection requirements.)

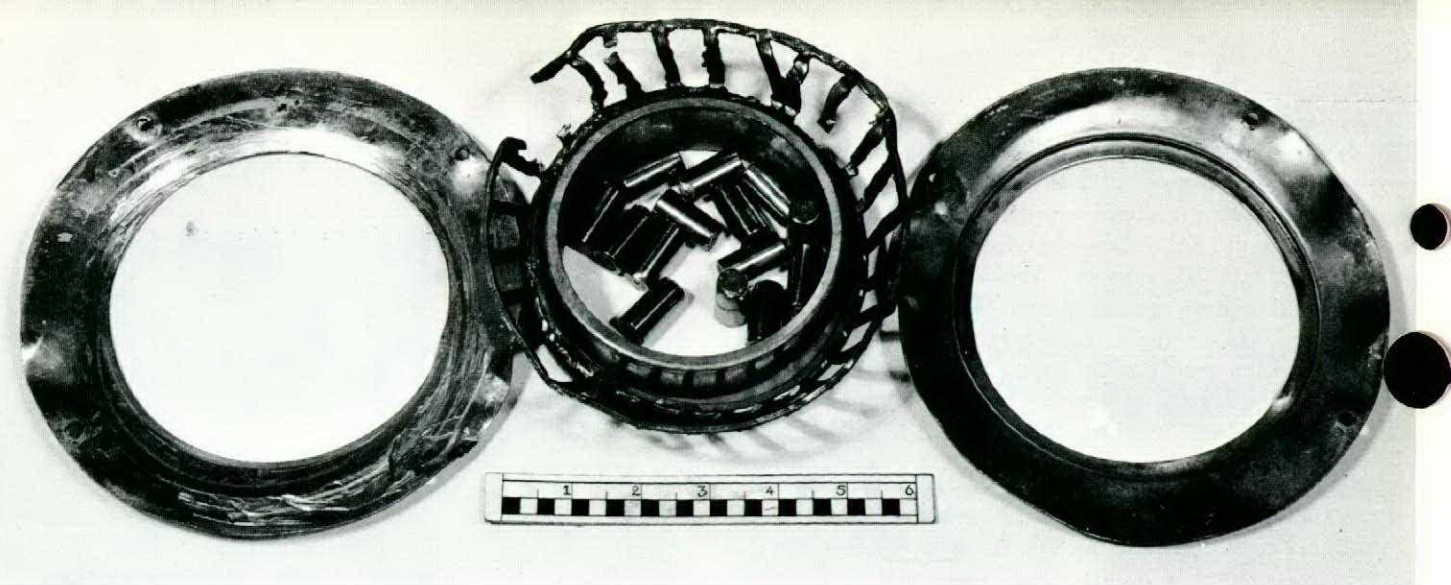
A little more attention...

They hadn't towed the Hercules very far from the hangar following the removal and reinstallation of a brake assembly when a loud scraping noise was heard from the vicinity of the port wheel. The damage to the bearing and brake assembly is shown in the photos.

Had the noise not occurred or the extensive damage been detected, the aircraft would have remained in a hazardous condition for taxiing, takeoff or landing.

Earlier, the brake assembly had been removed from the axle and returned to the tool crib. A spacer, which "usually stays on the axle when the brake unit is removed" this time, stuck to the brake assembly. Assuming the spacer unit to have remained on the axle another unit was installed with the resulting damage.

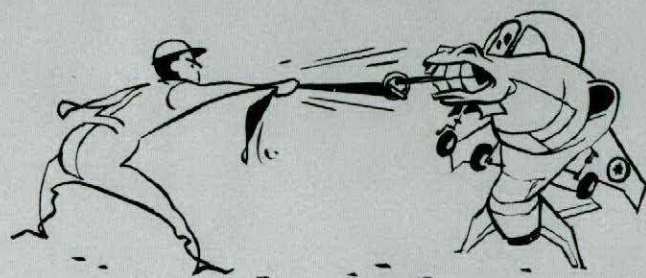
Flag Yankers!

An alert corporal at 1 Wing (Cpl FR Sova) UCRd the split rings which attach the T33 seat pins to the flags. These rings are no match for the brawny aircrew who regard these flags as pin handles. The rings could be beefed up, the corporal suggested, by lock-soldering the rings - and his advice has been taken.

Now, what of the aircrew with a penchant for over-stressing streamer components? Clearly, these pins are devices to prevent injury or death. They should be maintained in tip-top shape by careful inspection - and handling.

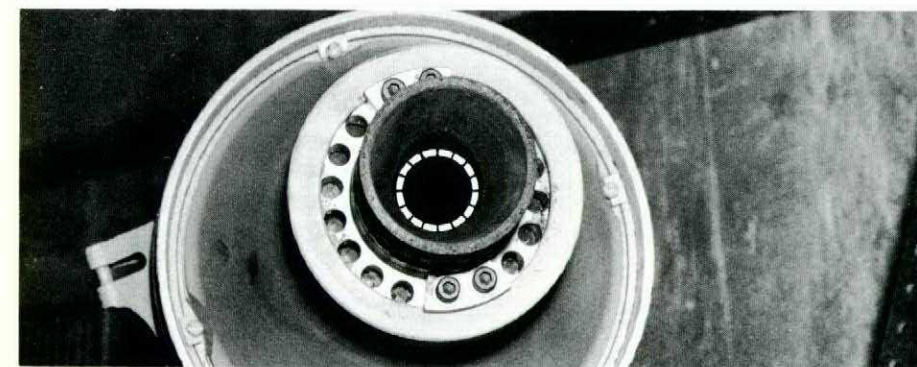
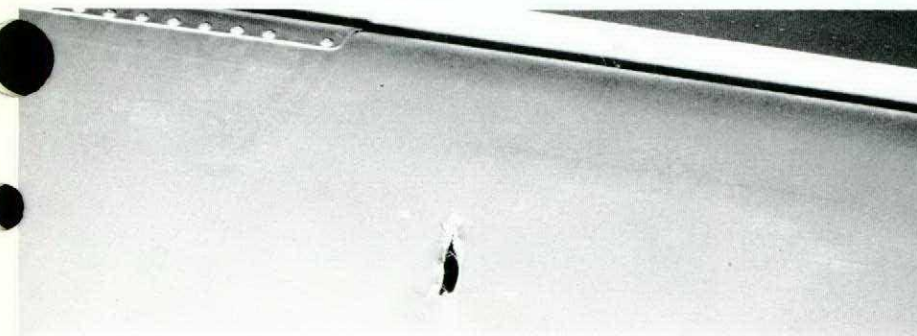
Nevertheless, in the one and a half years from January 64 to June 66 no fewer than 61 people were involved directly and several hundred others indirectly in towing accidents resulting in aircraft damage.

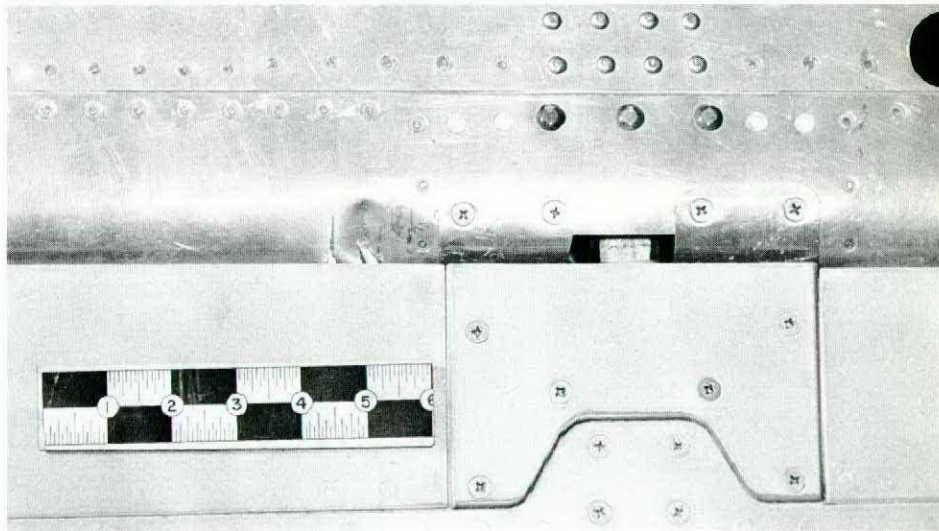
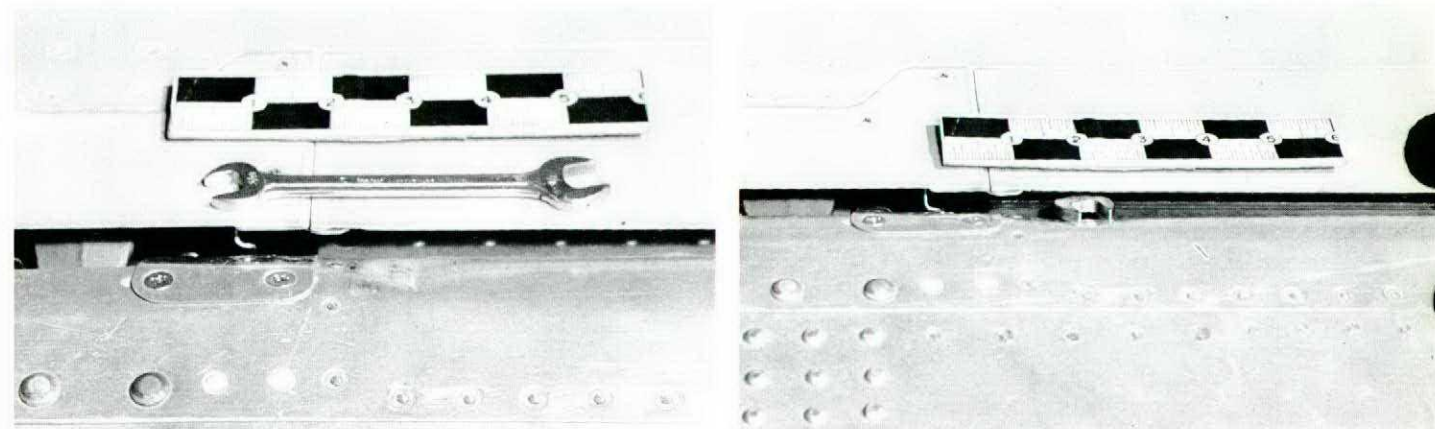
Table 2 - Total Cause Factors

analysis. Personnel figure in less than half of the total assigned causes. Noteworthy, is that briefing errors, ie, supervisory, are present in over half the cases in which towing personnel are a contributing cause.
