FLIGHT COMMENT

SEPTEMBER • OCTOBER • 1969

COL R. D. SCHULTZ
DIRECTOR OF FLIGHT SAFETY

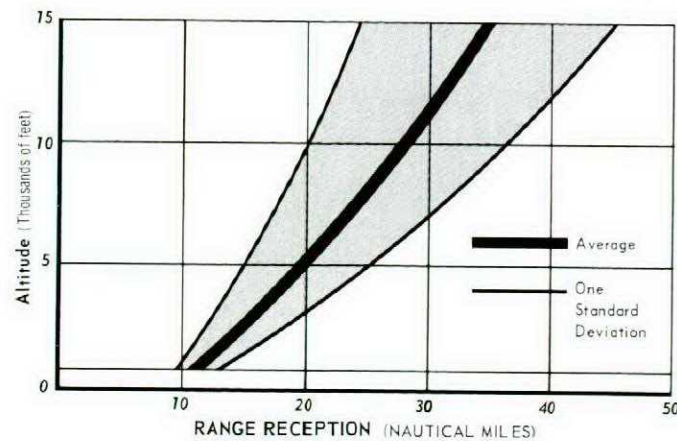
User trials of the URT503 were conducted in 1968 by VX10 Sqn to establish its operational suitability; the detection ranges determined for a beacon mounted in a dinghy are shown here: cont'd on next page

Detection ranges depend mainly on the sensitivity of the airborne receiver installation and the output power of the beacon. The spread in ranges shown in the graph is typical, and results from three aircraft types - the Albatross, Tracker and Sea King - being flown against five different URT503 beacons. The trials proved the beacon

to be satisfactory except for the cable/connector assembly, which was not rugged enough. A new, tough, waterproof cable and connector have been incorporated in later production models and will be retrofitted on all beacons with the original cable.

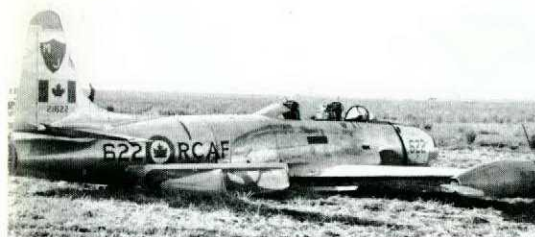
T33, OVER-ROTATED When the student taxied out for his first night trip, it was also his first front-seat trip in three weeks. With a full fuel load, his aircraft was approximately 1000 pounds heavier than he had been accustomed to flying.

On takeoff at 70 kts the student rotated the nose higher than normal; the aircraft became airborne at 110 kts in a very nose-high attitude. The instructor recognized they were in "a semi-stalled condition" but was reluctant to take over. However, after no reaction by the student he finally forced the stick forward.

The nosewheel appeared to strike the runway, the aircraft rebounded into the same nose-high attitude and veered off the runway. At this point the instructor told his student he was taking control. Deciding his only course was to keep airborne, he attempted to gain flying speed by lowering the nose. Behind the power curve, the aircraft hit heavily and bounced back into the air very nose-high.

Power and switches were then cut and the aircraft landed straight ahead. After a light initial touchdown, the aircraft swung left through 180° before coming to a halt. A strong smell of fuel prompted jettisoning the canopy. The instructor received a minor back injury and the student was uninjured. The aircraft was a write-off.

mark. The student stated he had attempted to maintain a nose-high attitude of 3/8" on the attitude indicator on the rotation. Investigators, although stating it is not to be relied on, found the reading should be close to 1/4" for the best attitude. (The 3/8" attitude corresponds with the climbout attitude with which the student was most familiar.)

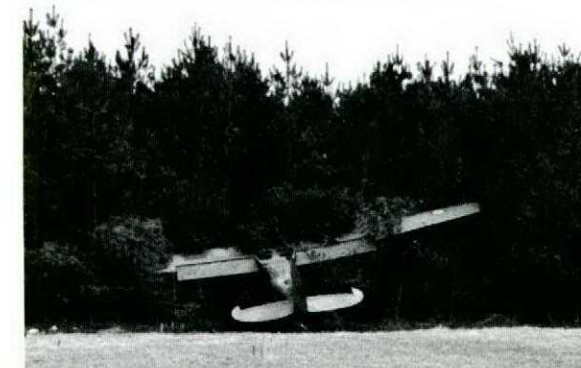
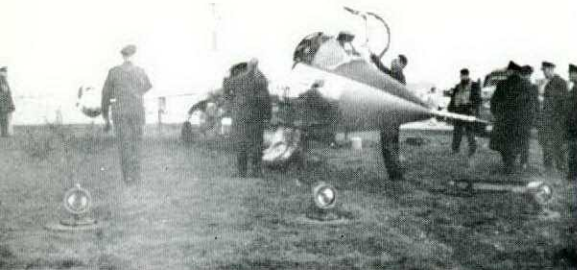
L19, FROST ON WINGS The pilot found frost patches on the upper wing surfaces when doing his pre-flight for a night training exercise but "considered this to be negligible". The aircraft was operating out of a short turf strip in a pasture bordered at each end with 20-foot trees. The L19 got airborne in about three quarters of the length of the strip, but no sooner was it airborne and in a climbing attitude "when the aircraft appeared to sink". After a quick check that takeoff flap was selected, the pilot decided he could not clear the trees. He closed the

The pilot who was uninjured stated the impact was slight as he was not thrown forward in the straps. However, the damage required replacing both wings, the engine, propeller, and engine cowling plus repairs to the firewall, windscreen and forward fuselage skin.

aircraft being airborne within the expected distance points to:

- ▶ frost on the wings or
- ▶ in the darkness the wall of trees could have unduly influenced the pilot's judgement of the aircraft performance.
