FLIGHT COMMENT

JANUARY • FEBRUARY

1972

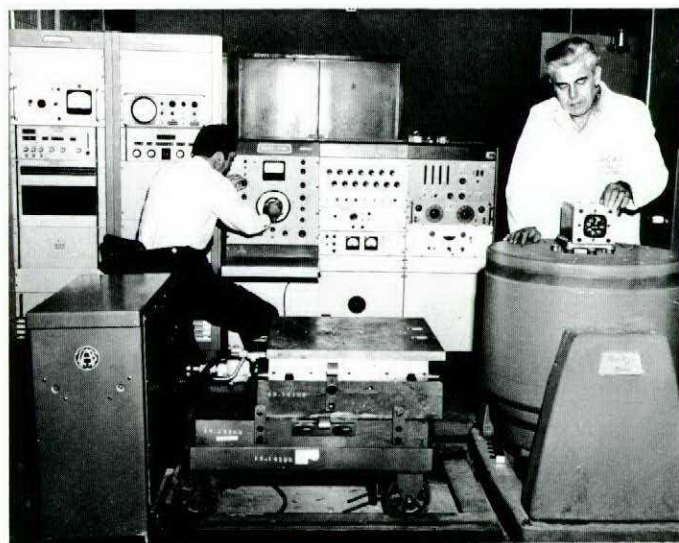
AVS and civilian technicians vibration testing an airborne instrument in the durability laboratory. Vibration testing was prime criteria in determining the fault in the bomb release (see article).

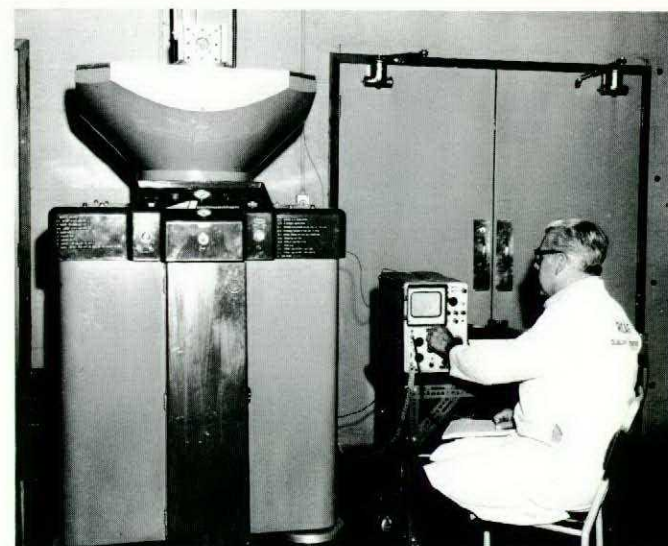
Specified-pulse shock machine investigating impact resistance of airborne instrument to withstand hard landings and excessive "g" forces.

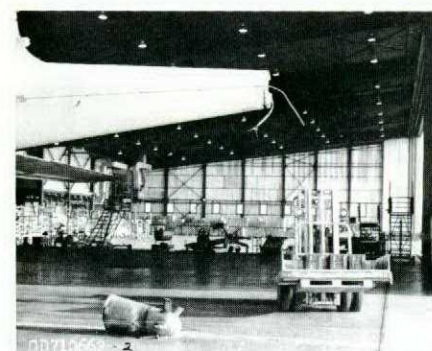
ARGUS, ATTACKED BY FORK LIFT
After a last minute change in primary aircraft, a new back-up had to be quickly readied for flight - prior to the evening shift coming on duty, if possible. After the loading was completed, the fork lift driver's assistant left to bring the aircraft's log entries up to date, leaving the driver to return the fork lift to a previously interrupted loading operation. As he moved away, the driver

failed to notice that the fork lift had not been lowered - until he knocked the MAD head off as he backed around the tail of the aircraft.

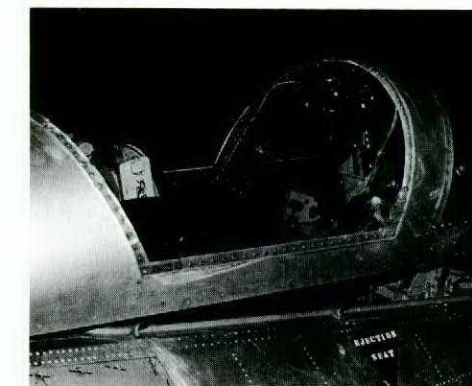
VOODOO, LOOSE PANEL
During a snap-up attack at 22000 feet, 350K, the navigator's canopy suddenly shattered. The pilot immediately reduced airspeed to 230K and began a descent. A short time later the aircraft returned to base and landed.

On the ground, investigators found that the utility hydraulic panel was missing. One part of it had struck the canopy and other pieces were ingested by the right engine, damaging a number of compressor blades.

Evidence showed that some of the "air-loc" fasteners on the panel had been left unlocked. This was missed by both aircrew and groundcrew on the various pre-flight checks.

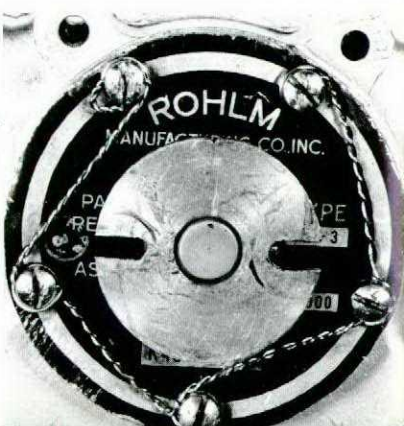
"Murphied" selector

DAKOTA, "MURPHIED" FUEL SELECTOR
The pilot was surprised to find both main fuel tanks almost full at the end of a flight, since these tanks had been selected "on" for most of the trip. His first reaction was to suspect the fuel gauges, however a dipstick check confirmed that the tanks were indeed full. Turning to the fuel selector, it was soon found that the selector had

been incorrectly assembled by the contractor. The driver plate was 180° out of place on a rotating cam shaft (see photos). A replacement selector was found to be similarly "murphied". This was a case of old "murphies" coming back to haunt

Correct installation: The punch mark on the cam shaft matches the position of the v-notch on the driver plate.

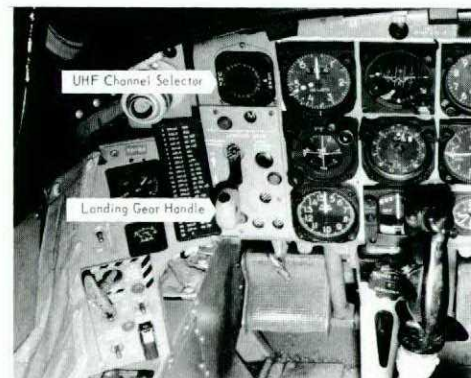
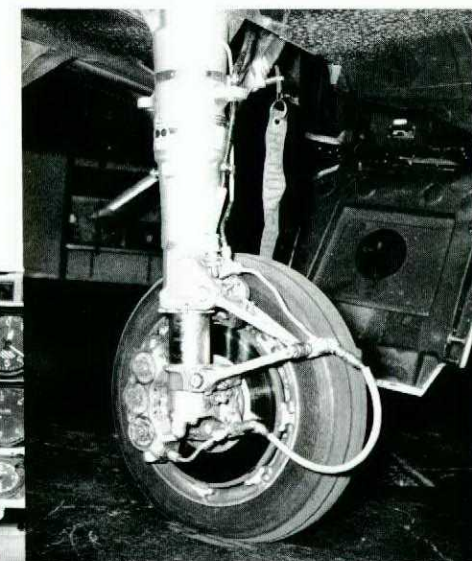
TUTOR, UNANNOUNCED "G"
Coming out of a vertical eight after practising their aerobatic sequences, the two staff pilots decided to call it a day and head back to base. While the pilot in the right seat was getting the bird heading in the right direction, the captain decided to call for landing instructions. However, when he reached for the UHF channel selector, he was surprised to feel the sudden pull of approximately 4 "g" - enough to pull his hand from the channel selector down onto the gear handle. The landing gear system functioned more or less as advertised - at 310 knots!

The captain immediately took control and reduced airspeed to below 175K. The right main gear indicated "unsafe" and had to be lowered by the emergency system, after which the captain landed the aircraft from a straight-in approach.

The post-flight investigation revealed that the fairing door on the right main gear had been torn away.
