FLIGHT COMMENT

MARCH • APRIL 1972

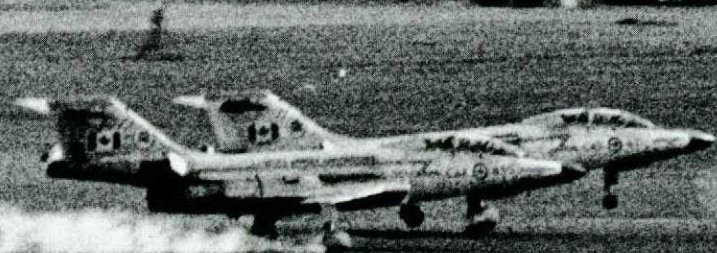
Photo #1

CF101 main wheel tire failure. The ribs of this tire were torn off during the first landing. The adhesion between the first reinforcing ply and tread material was found to be low, and was probably the cause of failure. In the latest procurement specifications the Canadian Forces have stipulated minimum values for adhesion between the various components.
