FLIGHT COMMENT

SEPTEMBER OCTOBER
1974

T33 Parachute Pack Failure

The Story of UCR No. 4208/A37

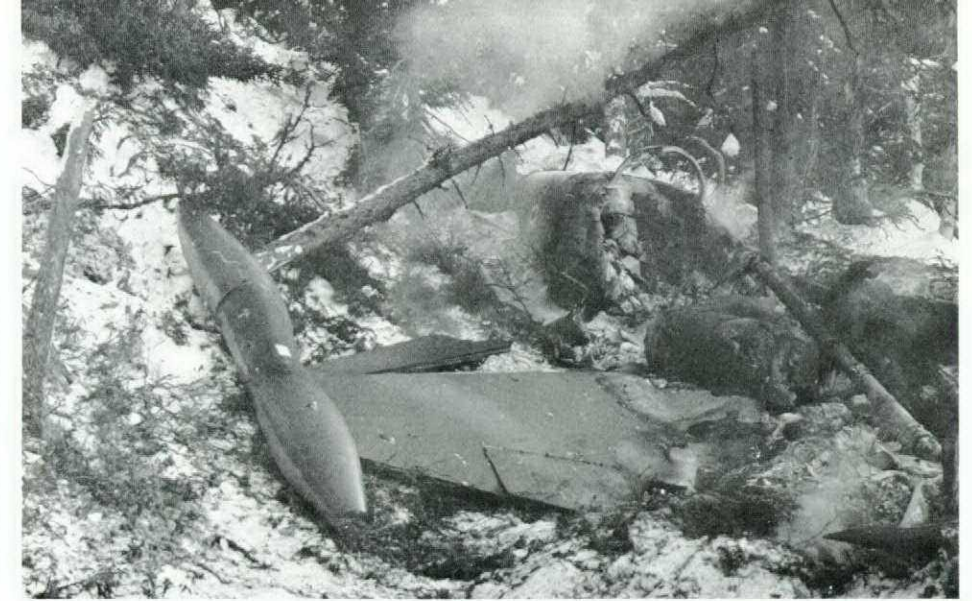
CF5A The pilot of a CF5A was authorized to carry out a general aircraft handling mission and after completing an aerobatic sequence he initiated a high pitch attitude stall. Entry was made at 15,000 ft MSL, 480 KIAS and the aircraft was rotated into a 70 degree pitch attitude with 4 "g" and 97 percent power. As the speed decreased the 70 degree climb angle was maintained with full nose up pitch trim and full aft stick. At approximately 25,000 ft MSL the nose of the aircraft began to fall to the horizon with airspeed 60 knots or less. Full aft stick and nose up pitch trim was maintained. With the nose approximately 65 degrees above the horizon the left wing began to drop. The pilot attempted to correct with partial right aileron and one third right rudder pedal deflection. The left wing continued to drop to 45 degrees of bank and yaw commenced to the left. The pilot neutralized the controls at this time with the pitch trim remaining at full nose up. With the nose now approximately 45 degrees above the horizon the yaw to the left accelerated and the left wing started coming back to level flight. Near completion of the first rotation with the nose attitude stabilized at 5 to 10 degrees above the horizon the pilot initiated spin recovery i.e., full left

aileron, full right rudder and as much aft stick as possible. The rotation continued and the aircraft stabilized into a non-oscillatory, steady and very smooth rotation to the left at 70 to 120 degrees per second. There was no evidence of negative "g" and the pilot was not subjected to any forward forces. He maintained continuous spin recovery control inputs for at least five rotations with no visible effect and finally ejected successfully at 8000 ft MSL. The aircraft impacted in nearly level flight with relatively low vertical velocity and zero forward airspeed. Both engines flamed out prior to impact.

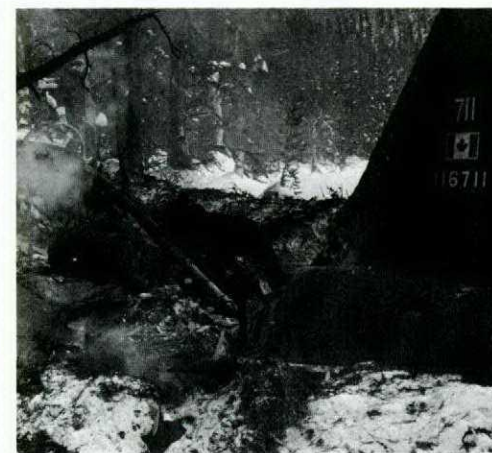
Investigation determined that the aircraft had entered a stabilized flat spin after the pilot used an improper stall recovery procedure. The accident is an expensive reminder that the CF5 is spin

resistant but not spin proof. CF5 AOIs have also been amended to provide further amplification and clarification of the slow speed handling and spin characteristics of this aircraft.
