FLIGHT COMMENT

THE FLIGHT SAFETY DIGEST OF THE CANADIAN ARMED FORCES

No 2 1979

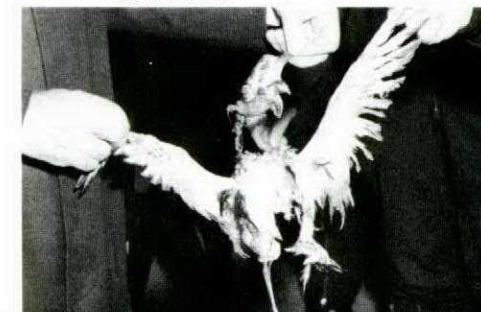
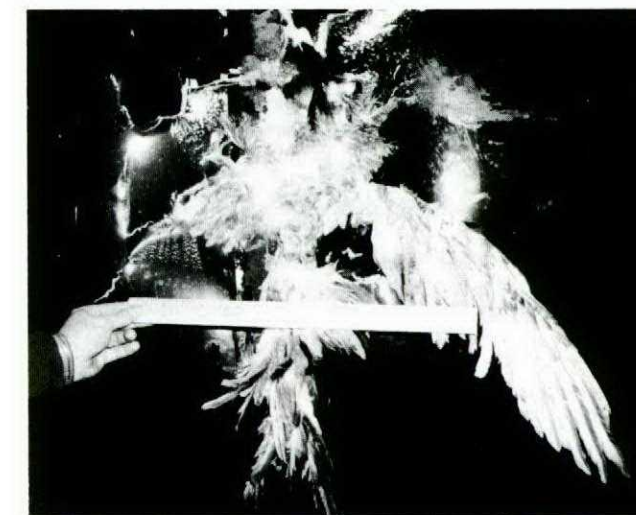
This bird struck an Argus. — Cet oiseau a heurté un Argus. This bird also struck an Argus. — Cet oiseau, lui aussi, a heurté un Argus.

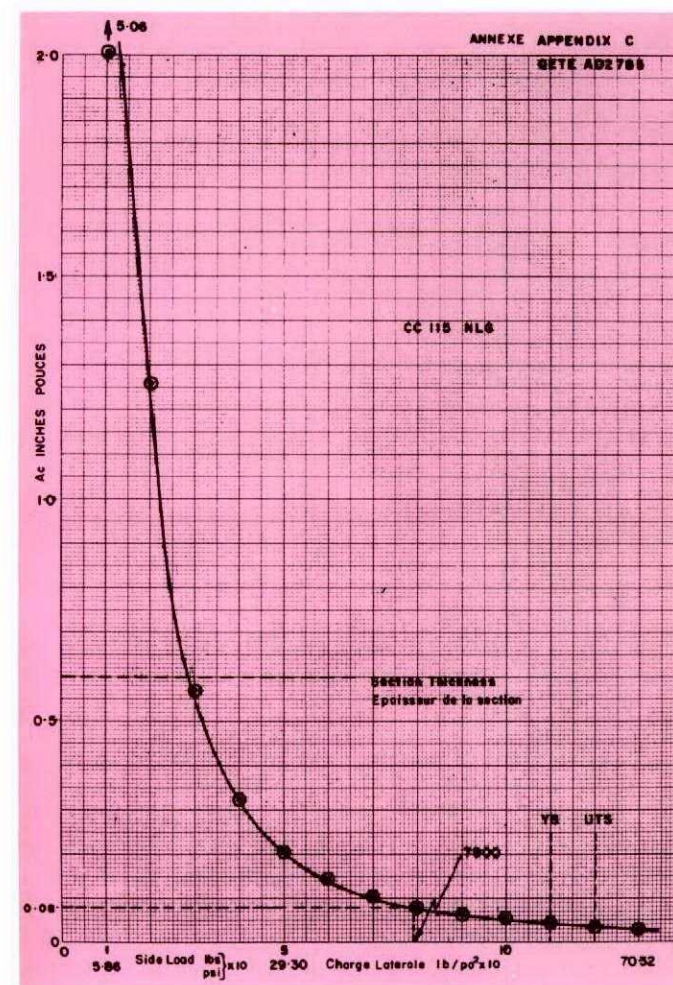
Previously conventional design theories had been used that account for stress, material strength and stress-concentration factors at geometrical discontinuities, however they do not account for inherent flaws and defects that all materials naturally contain. Component fracture resulting from extension of small crack like defects is a failure that depends upon localized phenomena. The crack tip region can be identified as the site of localized action that results in failure. Fracture toughness is a mechanical property that measures a materials resistance to fracture. This parameter characterises the intensity of the stress field in the material local to the crack tip when rapid crack extension occurs. Because the intensity of the stress field and hence the stresses at the crack tip are linearly proportional to the remotely applied stress/load and to the square root of half the crack length we can use this to estimate the stress required to produce failure of the NLG trunnion. Fundamental data on the 2014 T6 alloy were used to compare a side load versus critical crack length. The data on the graph were applicable over the range bounded by the section thickness and material field stress. The stress evaluation carried out by the Flight Safety Systems Engineering group and DAES showed that the load that was derived at failure was not an unusual load, Fig 9.

FIG 9. Graphical representation of data based upon theoretical and actual measured values used to evaluate basic design of aircraft component.

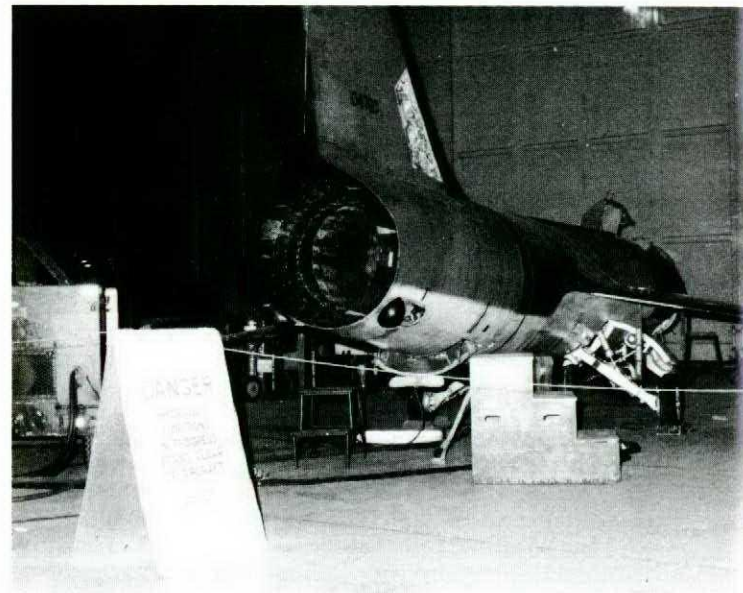
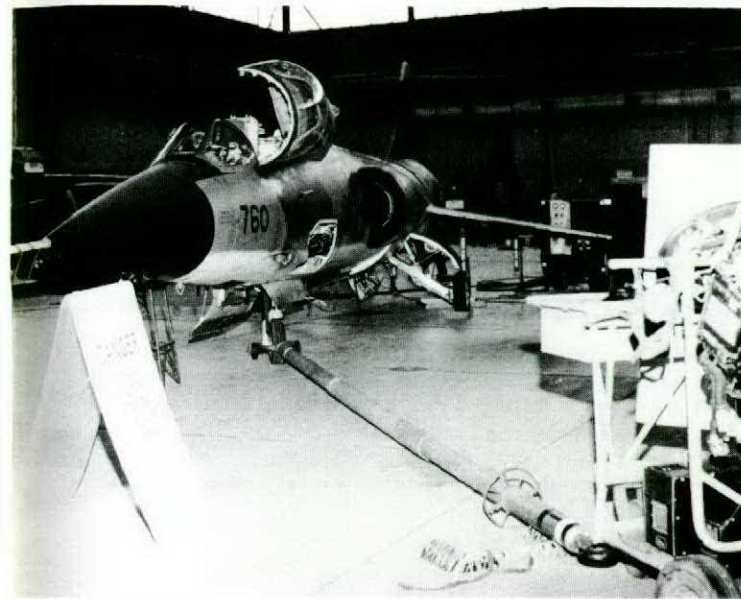
Accident mortel au sol

There have been nine other similar occurrences involving the CF-104 but fortunately none of the others proved fatal. As a result of the previous incidents, orders and procedures were changed, safety posters were produced, technician training programs were amended to stress the hazards of working in the wheel well area while power was being applied to the aircraft and aircraft with power being applied during maintenance functional checks were required to be roped off with appropriate warning signs. All actions were intended to safeguard against recurrence.

In spite of the safeguards, it would appear in this case that an experienced, highly competent technician for some unexplained reason elected to enter the recognized danger area for the purpose of completing his maintenance task without advising others of his intentions. Unfortunately this brief lapse in normal behavior proved fatal. The lesson is clear — Safety Orders have been developed for good reason and to remain effective must be religiously adhered to.

Le 21 décembre 1978, un mécanicien est resté coincé dans le logement du train principal droit d'un CF-104; il essayait de freiner le robinet du vide-vite du liquide hydraulique qui est situé dans le logement. Il a succombé à ses blessures cinq jours plus tard.

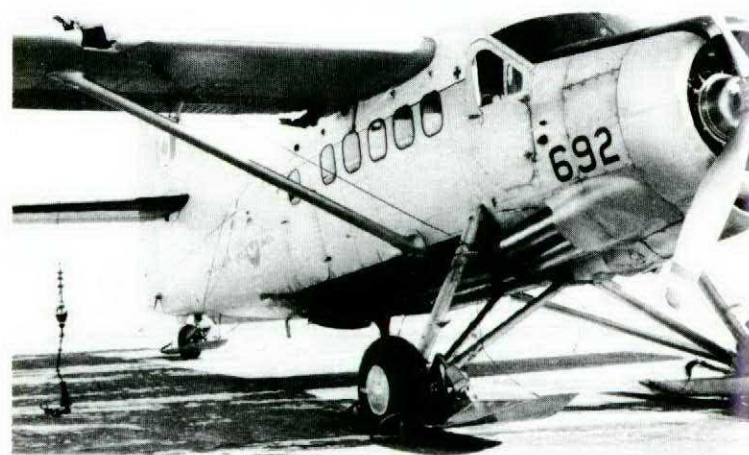
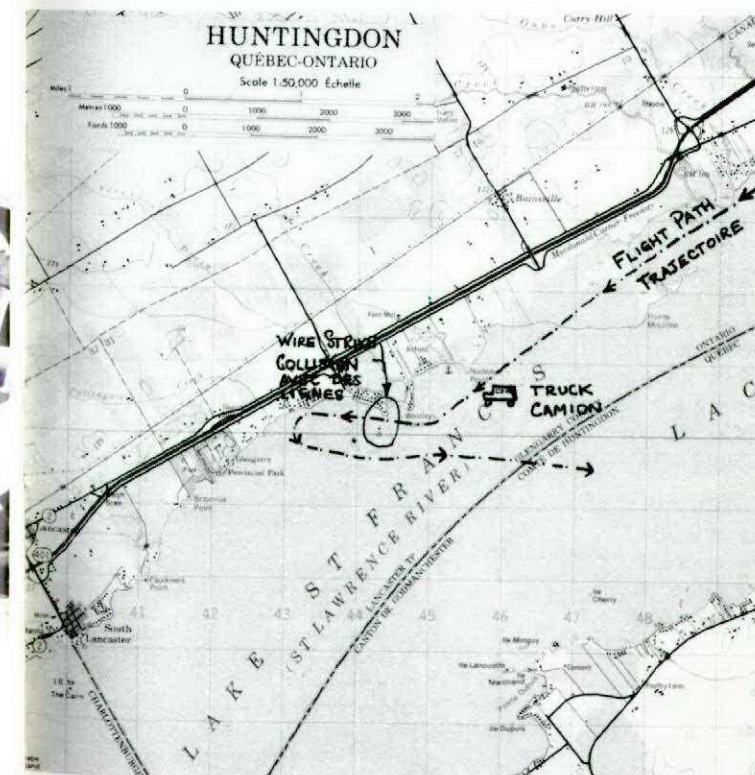
Accident d'Otter — ou un fil à la patte

Part way through his mission the pilot observed a vehicle which appeared to be in difficulty on the frozen surface of a large lake. A decision was made to descend to low level to determine whether the vehicle or its occupants required assistance. Despite having determined that assistance was not required, the pilot continued cruise flight at approximately 100 knots and 30-40 feet AGL for what must be considered an unnecessarily extended period of time. He then elected to pass between an inhabited island and the mainland where the wire strike occurred.

Clearly this case contains many of the factors common to most wire strikes. Yet, despite his flying at a very low level, the pilot at no time appeared to be concerned about the possibility that wires might be encountered. Furthermore, after having determined that a wire strike had occurred and that a length of hydro wire with insulators attached was flailing from the right wing, the pilot, following a control stability check, elected to fly his ski equipped Otter back to his original point of departure at St. Hubert.

Post accident investigation determined that "B" category damage had occurred to the aircraft and that mechanical failure was

L'enquête sur l'accident a révélé que l'avion avait subi des dégâts de catégorie B et qu'aucune panne mécanique n'était à l'origine de l'accident.

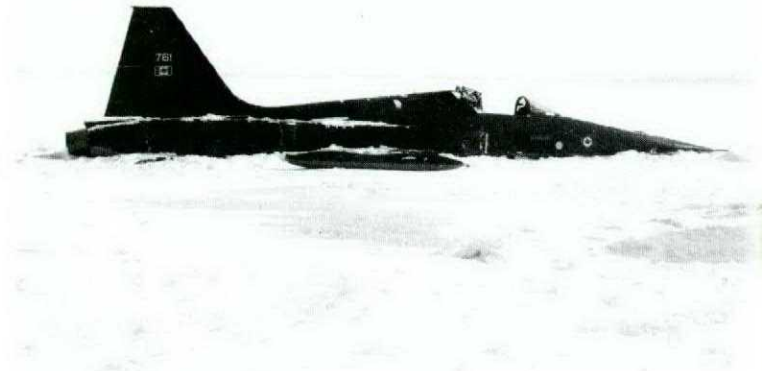
CF5 — levier du train d'atterrissage

A visual check by the second aircraft revealed that the main landing gear had been torn off, the right hand horizontal stabilizer was damaged. Although no flight-control problems were experienced, a controlled ejection was conducted from 8000', 20° nose up at 260 KTS indicated. The ejection was successful and the pilot was picked up within seconds uninjured.

It appears that the pilot, in his efforts to maintain visual contact with the attacking aircraft was using the glare shield for leverage to see in his rear hemisphere. The rapid reversal and application of "G" forced his hand down — inadvertently moving the undercarriage lever to the down position.

vibrations de la cellule et de forts grondements. Une inspection du poste de pilotage a révélé que le levier du train d'atterrissage était en position train sorti.

Un contrôle visuel effectué par le second appareil a montré que l'atterrisseur principal avait été arraché et que l'empennage horizontal droit avait été endommagé. Bien que le pilote n'ait éprouvé aucun problème avec les gouvernes, il a effectué une éjection contrôlée à 8000 pieds, dans un cabré de 20 degrés et à une vitesse indiquée de 260 kt. L'éjection s'est bien déroulée, et le pilote a été recueilli indemne quelques instants plus tard.

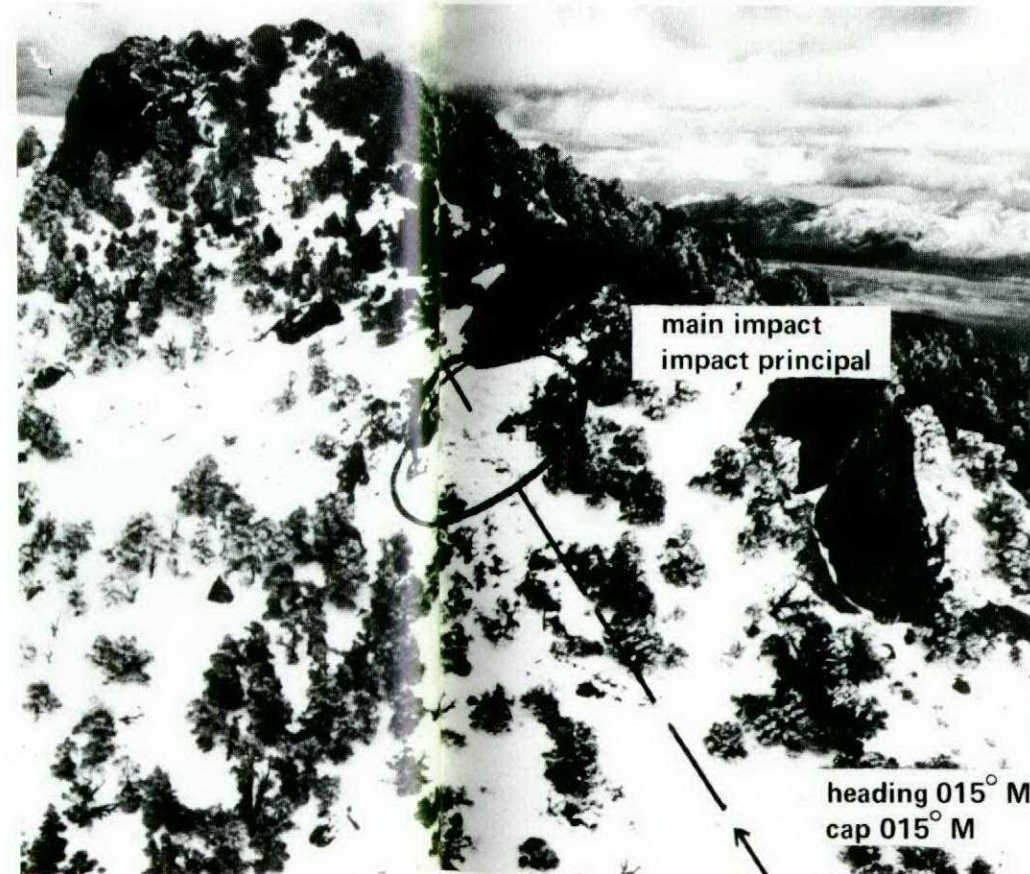
CF104

Approximately three minutes after leaving the target the leader approached a ridge line which was obscured in cloud. This forced him to fly a heading which was 90° from his planned egress track. The two aircraft had still not effected a rejoin and number two, being unsure of the lead aircraft's position and intentions, elected to climb on top of the weather and return to base. The lead aircraft continued at low level and high speed and penetrated a restricted area. His progress was being watched on radar and as he approached the restricted area he was called on GUARD and told to turn. Two more unanswered calls were made and radar contact was then lost inside the restricted area. The crash site was located seven miles from the point of lost radar contact, just outside of the restricted area.

The aircraft struck the side of a 8,200 foot mountain 400 feet below the peak. Prior to impact the aircraft was in a 20°-25° climb with wings level. The speed at impact was estimated to be in excess of 500 KTS. There was no attempt to eject. Other pilots flying at the time of the accident noted that the mountain tops in the area of the crash site were in cloud.

L'appareil a heurté le flanc d'une montagne de 8 200 pieds, à 400 pieds du sommet. Avant l'impact, l'appareil était en montée à 20 ou 25 degrés, et les ailes étaient à l'horizontale. La vitesse au moment de l'impact a été estimée supérieure à 500 kt. Il n'y a eu aucune tentative d'éjection. D'autres pilotes qui volaient au moment de l'accident ont constaté que le sommet des montagnes se trouvant dans la zone de l'écrasement étaient ennuagés.
