National
Défense

FLIGHT

COMMENT

4/1995

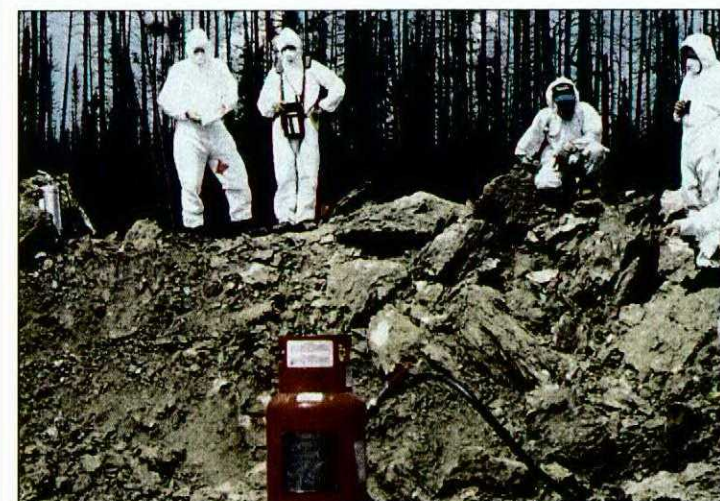
Carbon fibre protection gear - low density zone.

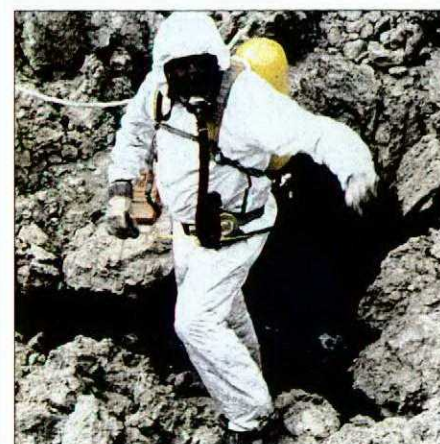
Protection gear - confined area.

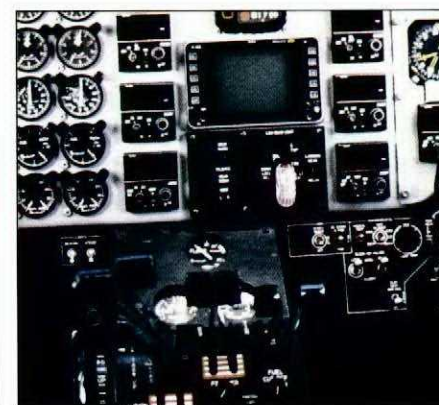
Cockpit controls of CC145903.

airspeed and full flap configuration to deactivate the weight-on-wheels switches, thus allowing the landing gear to begin the retraction cycle. The AC saw what had occurred and applied power in an attempt to overshoot. The airspeed was still too low for take-off and as the right propeller struck the runway the AC chose to abort. The aircraft settled onto the runway and skidded for approximately 800 feet. The crew carried out the emergency procedures and exited the aircraft unassisted.

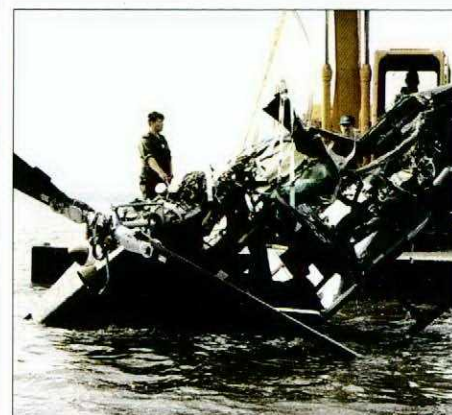
This flight represented the first attempt to perform a NVG landing on water. Direction as to the proper techniques and, more importantly, approval should have been sought from 10 TAG HQ prior to the flight. New flight manoeuvres require testing and validation by a qualified test establishment before they are performed by the line units.

Recovery of CH136213.
