SUMMER 2000

# Flight Comment

- 1.....Fuel Imbalance Cited in  
Learjet 35A Control Loss
  - 7.....Cockpit Voice Recorder Transcript,  
U.S. Air Force C-21A,  
April 17, 1995
-

The Canadian Forces  
Flight Safety Magazine

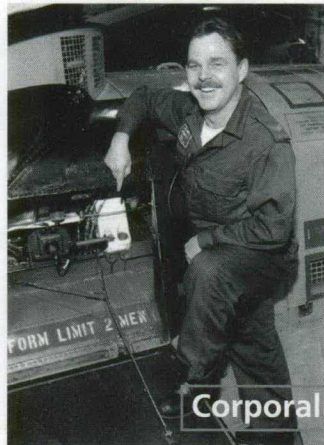
**Corporal Rob McMullin**

While conducting an after-flight check on a Sea King helicopter, Corporal McMullin noticed that the corrosion preventing hard coating had cracked around the two forward

bolts of the main gearbox mounts. He also noted that the washers under the head of the bolts could be turned freely. It appeared that the bolts were too long and had bottomed out in the airframe mount leaving a small gap between the bolt head, washer, and the airframe mount.

Corporal McMullin elected to investigate further. Positive identification of the proper bolt was difficult — all were stamped with an incomplete part number and then stored and issued in bulk quantities. Furthermore, the bolts on the helicopter remained completely coated with anti-corrosion compound. Despite the obstacles to his investigation, Corporal McMullin ascertained that the two forward bolts were intended for a different series of main gearbox. A fleet survey was carried out and confusing maintenance instructions were amended.

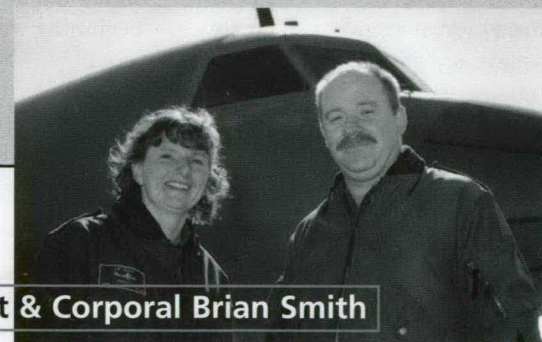
**Corporal Patsy Sweet & Corporal Brian Smith**

Corporal Smith and Corporal Sweet were tasked to replace the pilot's skylight window of an Aurora aircraft. While removing the unserviceable pane they detected a small amount of moisture on one area of the seal where it met the frame of the aircraft. The presence of moisture on an apparently undamaged seal is not addressed in technical orders. Although the situation could have been easily ignored they decided to remove the entire seal to inspect the underlying structure.

Corrosion was discovered in three separate areas between the seal and the structural frame of the aircraft. In one of the areas the corrosion had progressed to the point where the damage was beyond normal tolerances. A complete replacement of the affected ring segment was required.

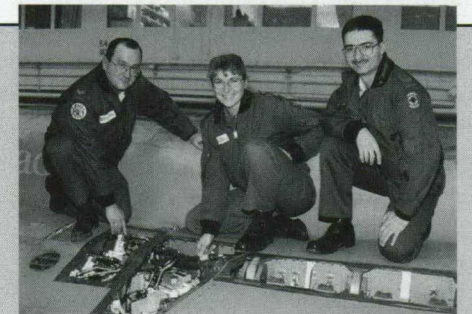
While preparing a Hornet aircraft for operations over Kosovo, Corporals Rattliff, Fehr, and Glanville thought they heard an unusual noise emanating from the area of the electronic warfare jamming system. Fault finding with the test set produced no results. Knowing that the aircraft was soon to be deployed they decided to investigate further.

An exhaustive examination revealed an unseated pin in a plug on the receiver portion of the electronic warfare jamming system. The fault is invisible to the pilot during flight operations and is undetectable by the test set. Had the condition remained undetected, both rear quadrants of the system would have been unable to receive, process, and adequately jam hostile threats.

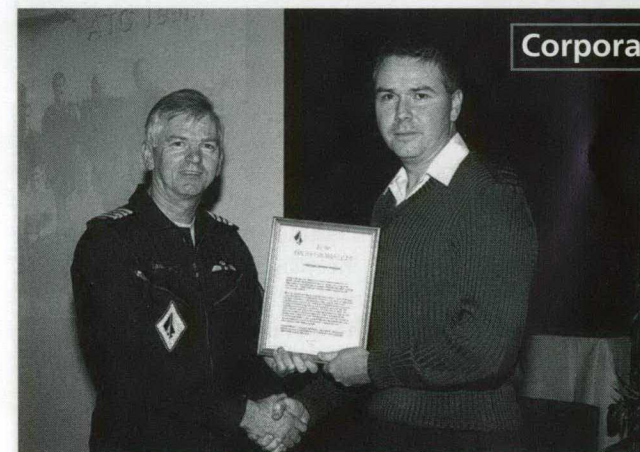
**Corporal Gerard Morgan**

Corporal Morgan was tasked to conduct a primary inspection of a Buffalo aircraft. During the inspection he noticed rub marks on the upper edge of the forward-facing surface of the left flap. After notifying his supervisor, Corporal Morgan initiated a detailed search for the source of the contact.

When the aileron was placed in the full down position, Corporal Morgan noted that the bolt in the attaching hardware of the push-rod appeared too long. Consultation with technical orders, and the three extra washers found under the nut, confirmed Corporal Morgan's suspicions. Further investigation showed that the right-hand push-rod was also installed with the incorrect hardware — one that was too short. The extra long bolt had come within millimetres of interfering with the exit opening; as well as coming dangerously close to snagging on the aileron cable. Further evidence indicated that the fault had existed for a considerable length of time. Corporal Morgan then developed a local special inspection and two more incorrect installations were discovered on other Buffalo aircraft.

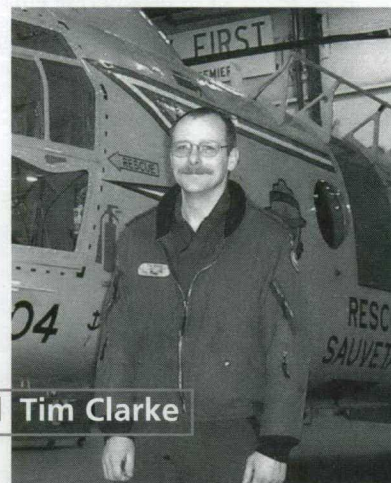
**Master Corporal Tim Clarke**

Further research by the rotor blade repair shop revealed that the blade had been over-pressurized by excessive water ingestion. The over-pressurization had resulted in blade warping and de-lamination. The deformity was virtually undetectable from ground level.

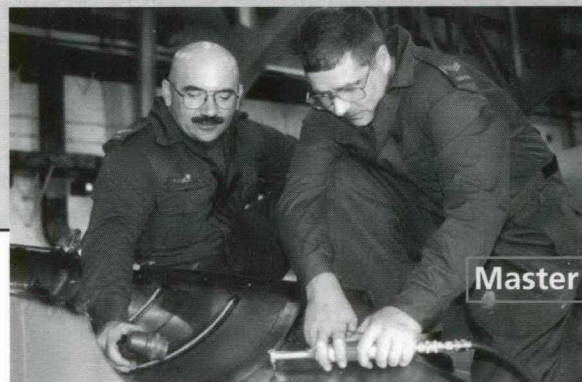
**Master Corporal Max Farrell  
& Corporal Mark Benham**

Master Corporal Farrell was tasked to carry out a special inspection on the nacelle upper-fire-shield of an Aurora aircraft. During the course of the inspection he noticed an irregular contour on the lower skin surface of the left-hand aileron. Investigation of the flight control surface revealed a four-millimetre crack.

Corporal Benham was tasked to carry out the repair to the aileron. When the damaged skin was removed severe intergranular corrosion was discovered. Knowing

that a large portion of the aileron skin is spot-welded, and that further corrosion could be indicated by weld separation, Corporal Benham decided to investigate further. He detected another inconsistency in the surface approximately two feet outboard of the original repair area. Examination of the area revealed corrosion that was deemed beyond unit repair capability.

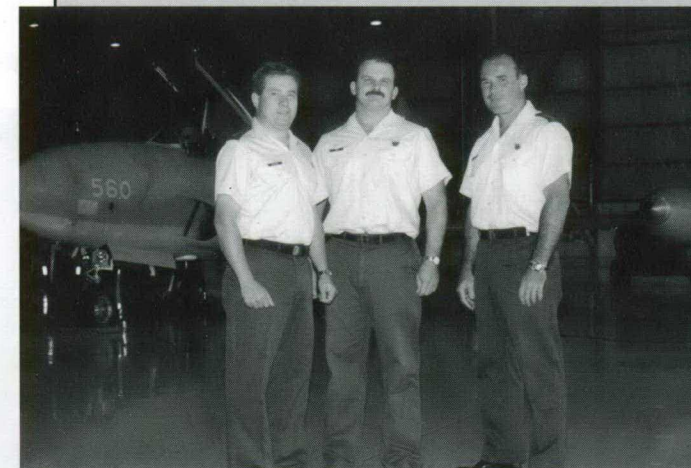
**Sergeant Randy White,  
Master Corporal Arnie Dauphinee  
& Master Corporal Art Amey**

Upon hearing of the problem, Sergeant White and Master Corporal Amey decided to scrutinize another Silver Star that was undergoing acceptance checks. Their examination revealed that the aircraft was in a similar condition to the previous one. An immediate fleet wide special inspection was quickly initiated. The subsequent investigation revealed that some aircraft had had incorrect fittings installed on the new narrow panel oxygen regulators. The use of these fittings had resulted in the oxygen line to the rear cockpit being improperly routed.

During maintenance of the Tow Target System wiring bundle on a Silver Star aircraft, Master Corporal Dauphinee noted that the flexible oxygen line leading to the rear regulator was rubbing against the rudder pedal walking-beam. The aircraft had undergone significant modifications thirty flying hours prior to Master Corporal Dauphinee's discovery. Although the line was undamaged it had scored a deep groove into the beam.
