CRASH COMMENT

JULY AUGUST SEPTEMBER 1950

ISSUED BY
ACCIDENT INVESTIGATION BRANCH
R.C.A.F. HEADQUARTERS OTTAWA ONT

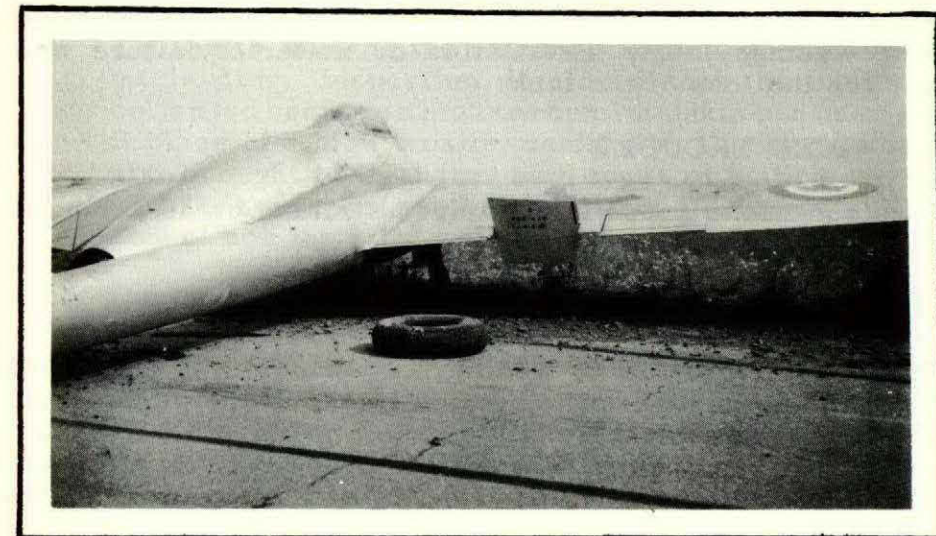
* No. 1 -- PILOT ERROR

Pilot error, especially during landing, was conspicuous in the Vampire statistical review for the quarter. The following are outstanding examples:-

- The pilot rounded out too soon and too low causing the starboard flap to collide with a fence post.
- The pilot made a low approach at low airspeed. During the round out the aircraft stalled and the starboard wing struck the runway. The wing had to be replaced.
- The pilot undershot and landed short. The aircraft struck the centre contact light just short of the button, resulting in damage to the port flap.

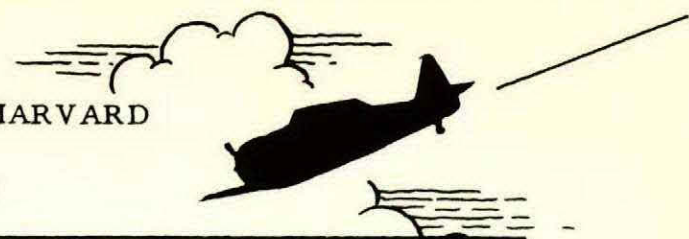
- Excessive wear on the canopy operating lever locking pin caused the pin to disengage during flight. As a result the canopy blew completely open and cracked in two places. The pilot was able to effect a safe landing.

- The canopy problem is still unsolved. This one disintegrated at 31,700 feet. The pilot returned to base successfully.

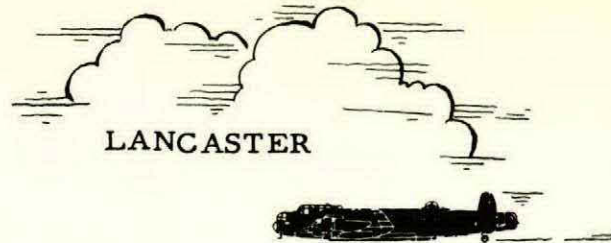
* No. 16 -- FUEL STARVATION

During approach to land, at an altitude of approximately 100 feet and one hundred yards from the end of the runway, the aircraft suddenly swung to port.
