CRASH COMMENT

FOURTH QUARTER 1951

ISSUED BY
ACCIDENT INVESTIGATION BRANCH
R.C.A.F. HEADQUARTERS OTTAWA ONT.

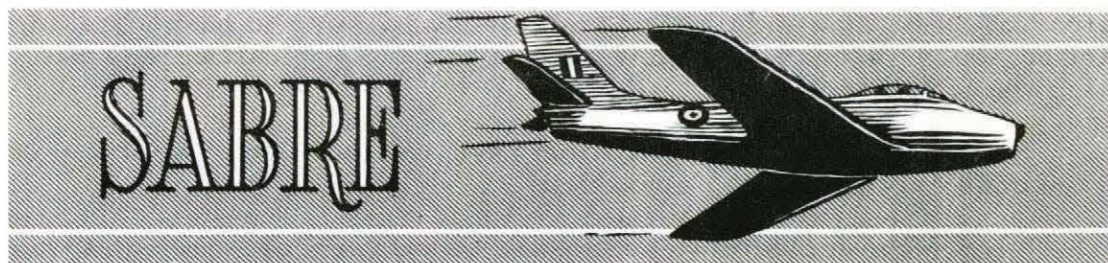
● NO. 4 -- INEXPERIENCE

After completion of a simulated landing at altitude the throttle was opened for an overshoot. Being inexperienced on type, the pilot allowed the airspeed to build up beyond the "maximum permissible for undercarriage down" before selecting "wheels-up". This resulted in damage to the nose wheel door and retracting linkage on the forward bulkhead.

The cause of this accident - inexperience on type.

We wonder if the pilot was adequately briefed on this point.

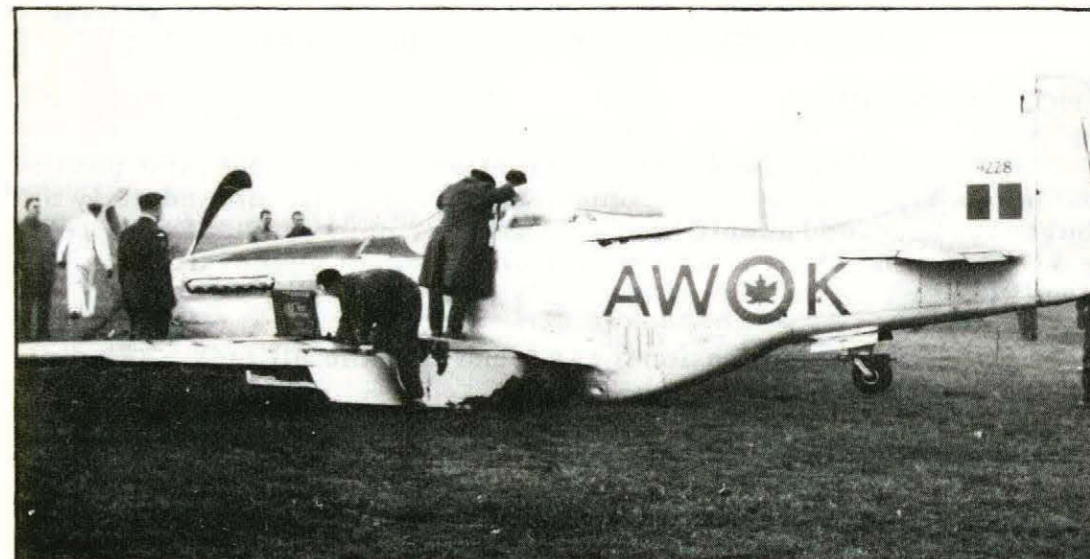
● NO. 5 -- A WHEELS-UP LANDING

The pilot reports he made a normal selection for lowering the undercarriage and did not know that the wheels had failed to go down. The tower warned the pilot of the position of his undercarriage too late to avoid a wheels-up landing. Retraction tests carried out on the aircraft showed that although the undercarriage warning horn was unserviceable, the undercarriage warning lights operated normally.

This accident is still under review.

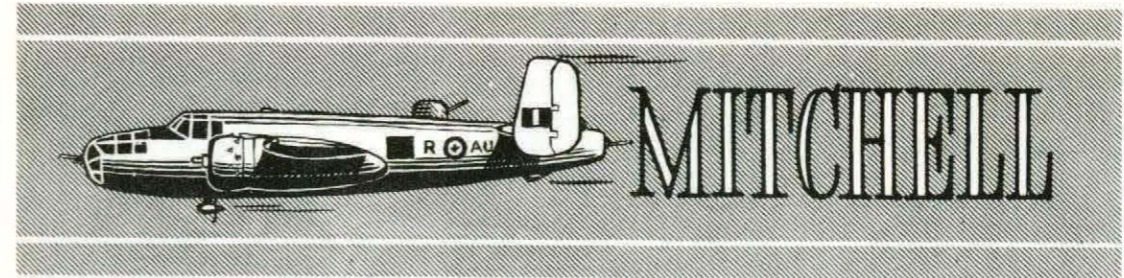
● NO. 9 -- DOWNWIND

This pilot, upon completion of a night instrument flight, made visual contact over his destination at 3,000 feet. Landing instructions were received from the tower, the runway in use being 03. The pilot made a rapid descent and commenced his approach on runway 21. No check was made by the pilot during the approach to ascertain his magnetic heading. The aircraft landed 1/3 down the runway and as the braking action was poor, ran off the end, causing damage to the port engine nacelle.

Although the pilot claims that the "lead in" lights were lit on runway 21, no evidence has appeared, as yet, to substantiate his claim.

This case is still under investigation.

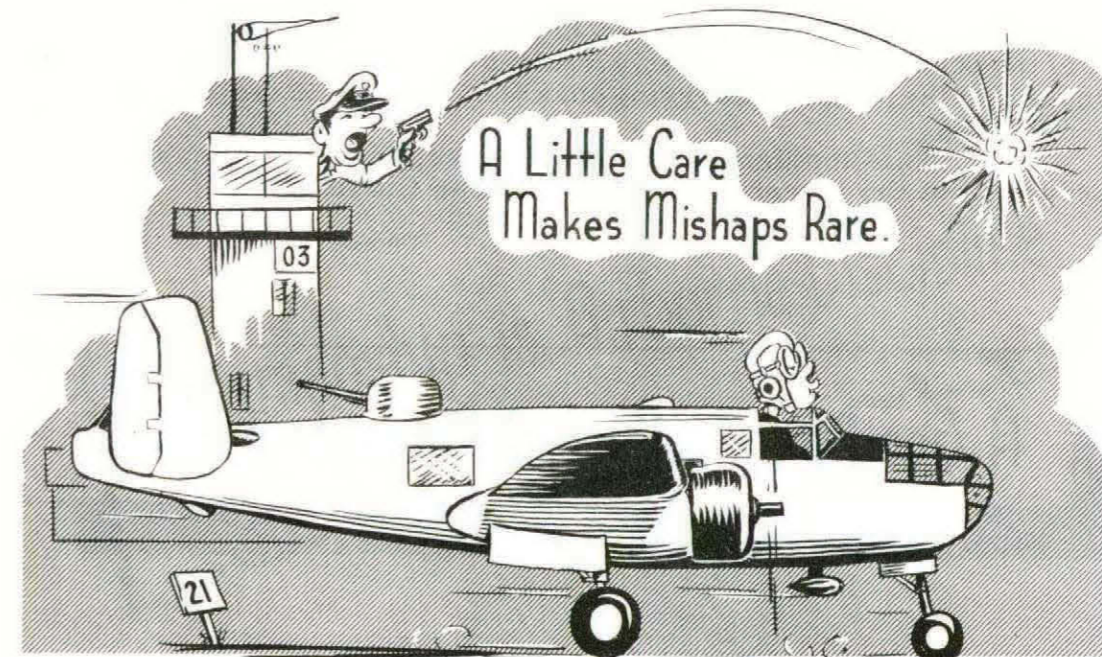
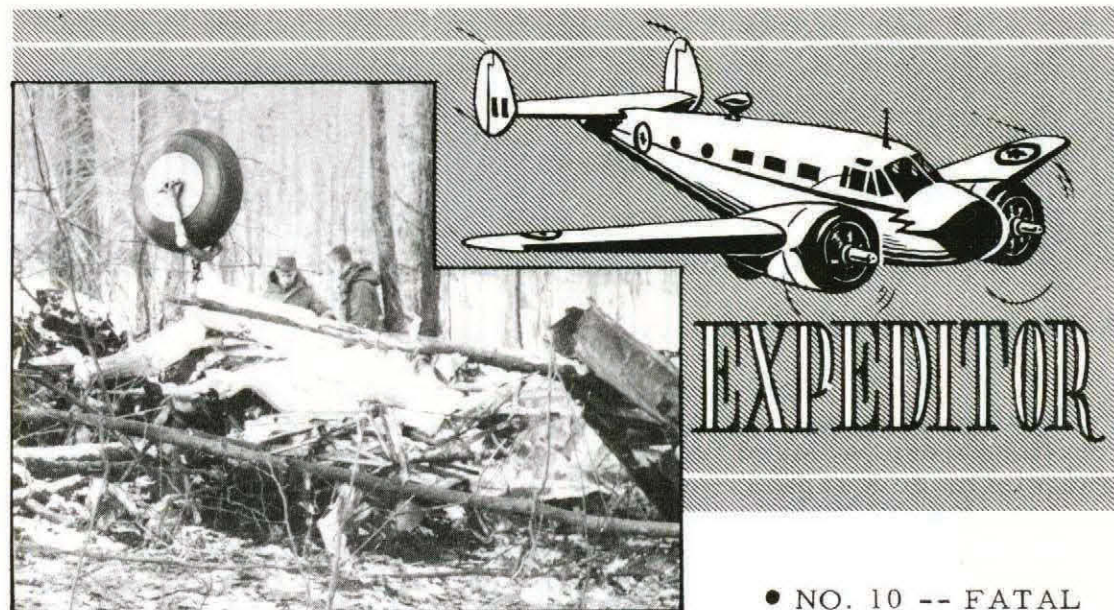
• NO. 10 -- FATAL

This aircraft departed on an IFR flight plan with a "met" ceiling of 1100 feet and the visibility one mile in rain and fog. After take-off, the pilot reported the ceiling as 400 feet. Two or three minutes later the pilot requested a "course to steer" from the VHF "Homer". Two courses were passed but the last course not acknowledged by the aircraft. After being airborne for approximately five minutes the aircraft crashed into a hill at the 525 foot level and killed six of the occupants and seriously injuring the sole survivor. It would appear that the pilot was carrying out a wide circuit of the aerodrome.

This accident has been assessed provisionally as "cause obscure" but the investigation has not been finalized.

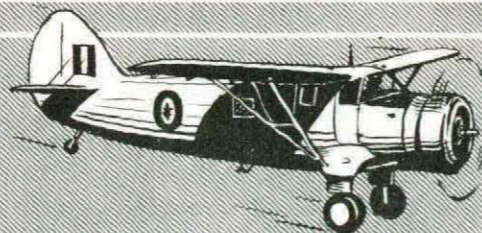
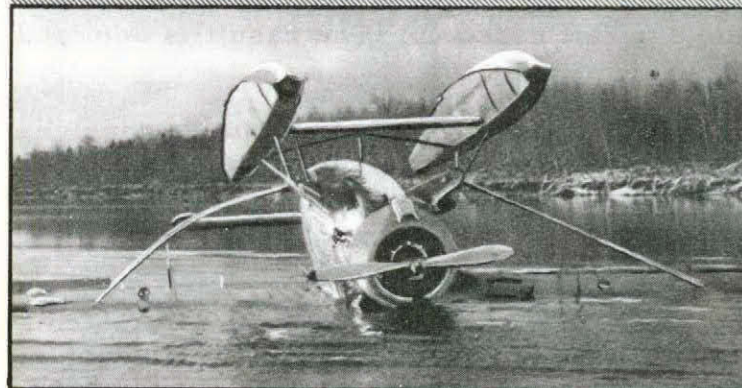
• NO. 13 -- FLOATS IN THE AIR

This aircraft was proceeding to a water base for the purpose of changing from floats to wheels. Shortly after touching down (while carrying out a "glassy water" landing) the aircraft struck a sand bar and turned over on its back.

The primary cause of this accident has been assessed as pilot error with lack of proper briefing as a secondary cause.

Due to the pilot being inexperienced no disciplinary action was taken in this case.

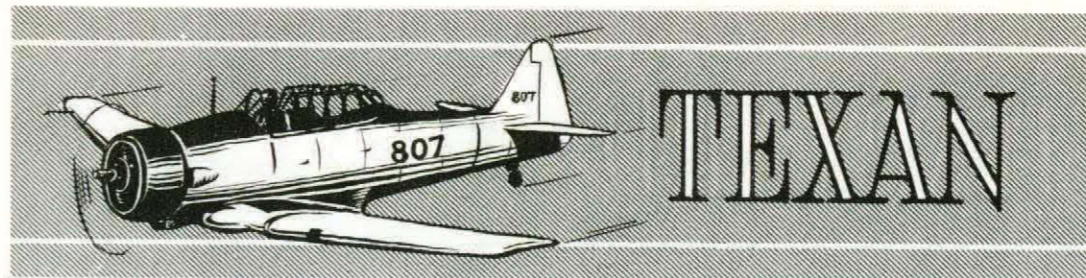
• NO. 14 -- COCKPIT CHECKS

The pilot attempted a night landing with his undercarriage not fully down. Upon throttling back, the warning horn sounded and the pilot took overshoot action but not in time to prevent damage to the propeller when it struck the ground. The aircraft completed another circuit and landed successfully.

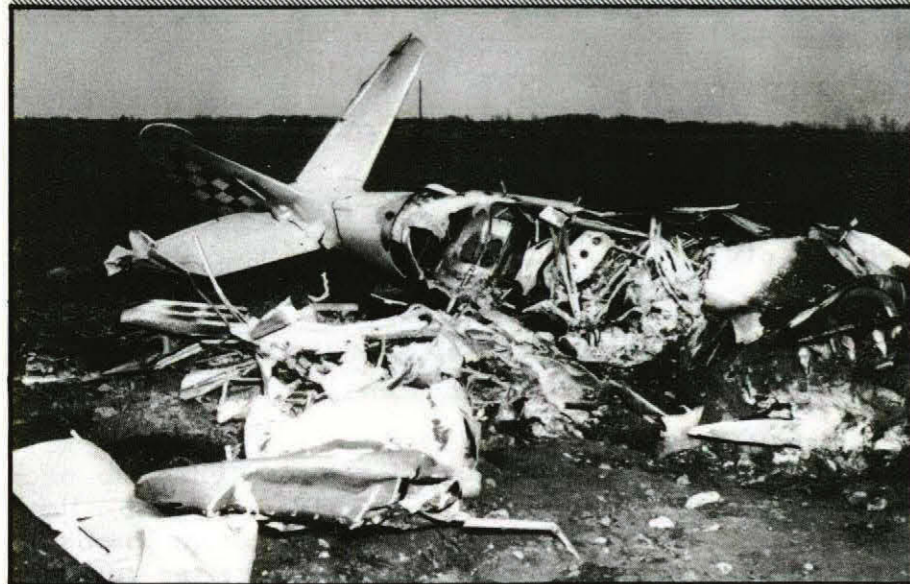
● NO. 16 -- CONTRARY TO REGULATIONS

The pilot was authorized to carry out a dual dive bombing exercise and was designated as leader of a three-plane formation. While waiting for permission from the bombing range to commence the exercise, the leader of the formation began "tail chasing" his Number 2. After making several attacks, the pilot did a sharp climbing "wingover" to the right and passed under his Number 2 in a diving vertical bank. The pilot did not recover from this manoeuvre and the aircraft crashed, killing both occupants. His last attack had been carried out at 2,000 feet.
