CRASH COMMENT

APRIL - DECEMBER, 1952

ISSUED BY
ACCIDENT INVESTIGATION BRANCH
R.C.A.F. HEADQUARTERS OTTAWA ONT.

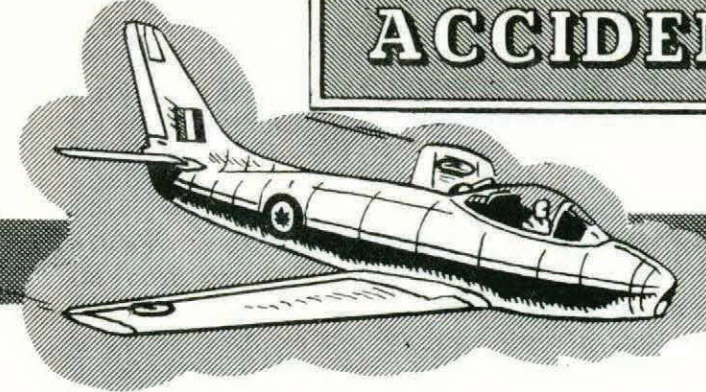
NO. 1 -- ANOXIA ?

SABRE

Shortly after reaching altitude for a formation cross-country flight, it was noticed that this aircraft began to fly erratically, lag behind, then disappear. The pilot was killed instantly when the aircraft crashed into a hillside. Although the cause of the accident cannot be definitely established, the evidence of erratic flight at an altitude of 42,000 feet, substantiated by evidence of recovery attempts being made when close and in full view of the ground, strongly indicate that anoxia was the cause. A secondary assessment of "Maintenance" was coded when it was found that the oxygen regulator fitted had exceeded its normal life period.

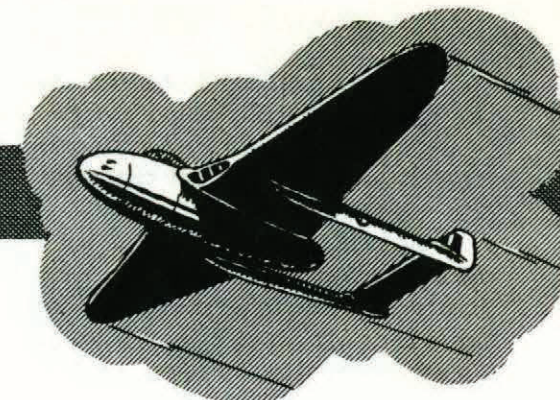
NO. 16 -- HIGH-SPEED STALL

VAMPIRE

The pilot started a run onto the target during air-to-ground firing and on his final dive-in approach, made a turn to port then immediately rolled to starboard. After the roll, the aircraft flattened out momentarily then commenced another roll to starboard, at which time it struck the ground and was completely destroyed. The pilot was killed instantly.

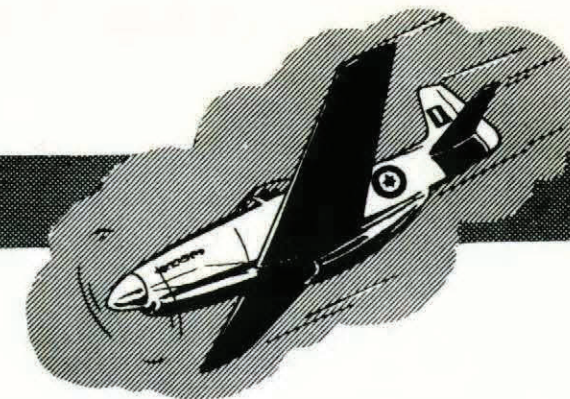
NO. 20 -- TARGET FIXATION?

MUSTANG

While undergoing summer training with his squadron, the pilot was carrying out an HE dive-bombing exercise. The aircraft was seen to enter the attacking dive from an altitude of approximately 7,500 feet. The two HE bombs were released at or above the safety release height of 1,500 feet and exploded on impact. However, the pilot failed to institute recovery action and the aircraft continued its dive to a point approximately 400 feet above the surface of a lake. As it levelled out, a wing failed and the aircraft which was rolling to port, crashed into the lake. The pilot was killed instantly.

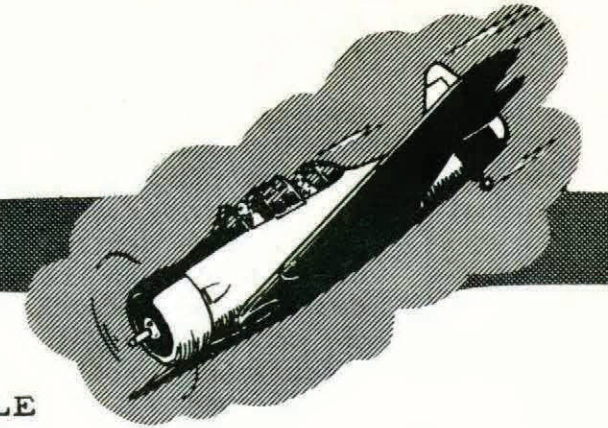
NO. 24 -- THIS IS UNBELIEVABLE

HARVARD

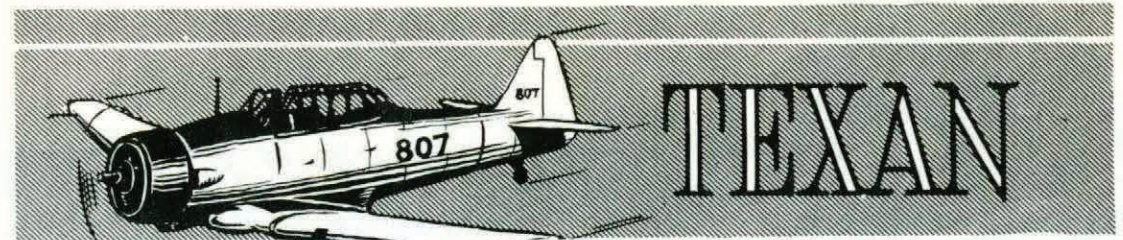
NO. 38 -- POOR RECOVERY TECHNIQUE

Two students were authorized to carry out a mutual instrument practice flight which included recovery from unusual positions under the hood. In the course of recovery from an unusual position, the pupil at the control apparently exceeded the "g" limitations. This action caused a buckling of the mainplane. Particularly poor judgement was displayed by both pilots for commencing to do aerobatic manoeuvres after discovering that the mainplanes had been wrinkled. On return to base the aircraft was landed without further incident.

The accident is attributed to poor judgement on the part of the safety pilot in permitting the pilot under the hood to take unnecessarily violent recovery action from an unusual position.

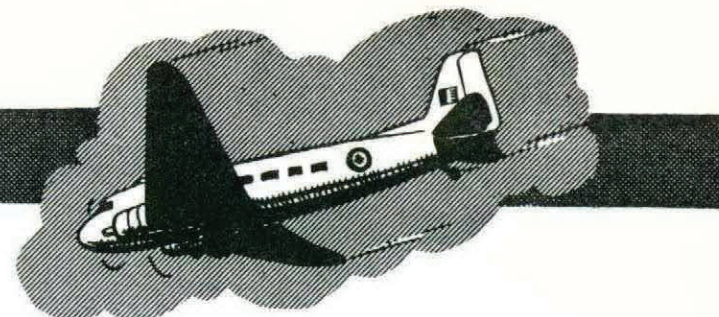
NO. 44 -- ANOTHER FATAL STALL

DAKOTA

While engaged in an insect-spraying operation from an altitude of 100 feet, the pilot executed a sharp turn with approximately 80 degrees of bank in order to track over a ground marker. The aircraft stalled in the turn, crashed and burned. The three crew members were killed.
