CRASH COMMENT

SECOND QUARTER, 1953

ISSUED BY
DIRECTORATE OF FLIGHT SAFETY
R. C. A. F. HEADQUARTERS, OTTAWA, ONT.

ACCIDENT RESUMÉ

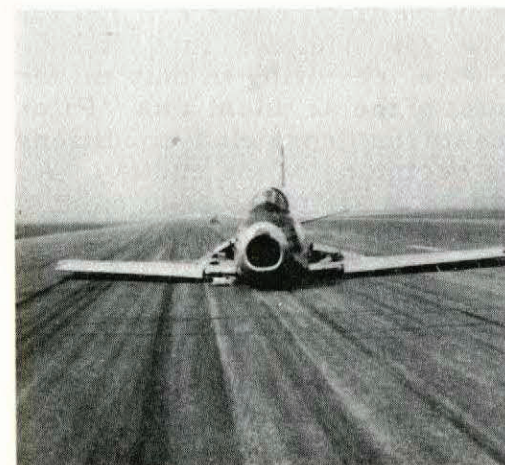
1 -- UNDERSHOOT

The leader of a four plane formation made a tight break and approach. The pilot fearing he would land on the right hand side of the runway attempted to further tighten his turn to the left. The Sabre stalled, striking the ground short of the button in a level attitude. This "B" category crash was caused by "Pilot Error". The pilot pulled his approach too tight and allowed his airspeed to drop to the stalling point. Mitigating factors in this accident were the poor visibility due to haze, and the lack of markings to clearly indicate the end of the runway.

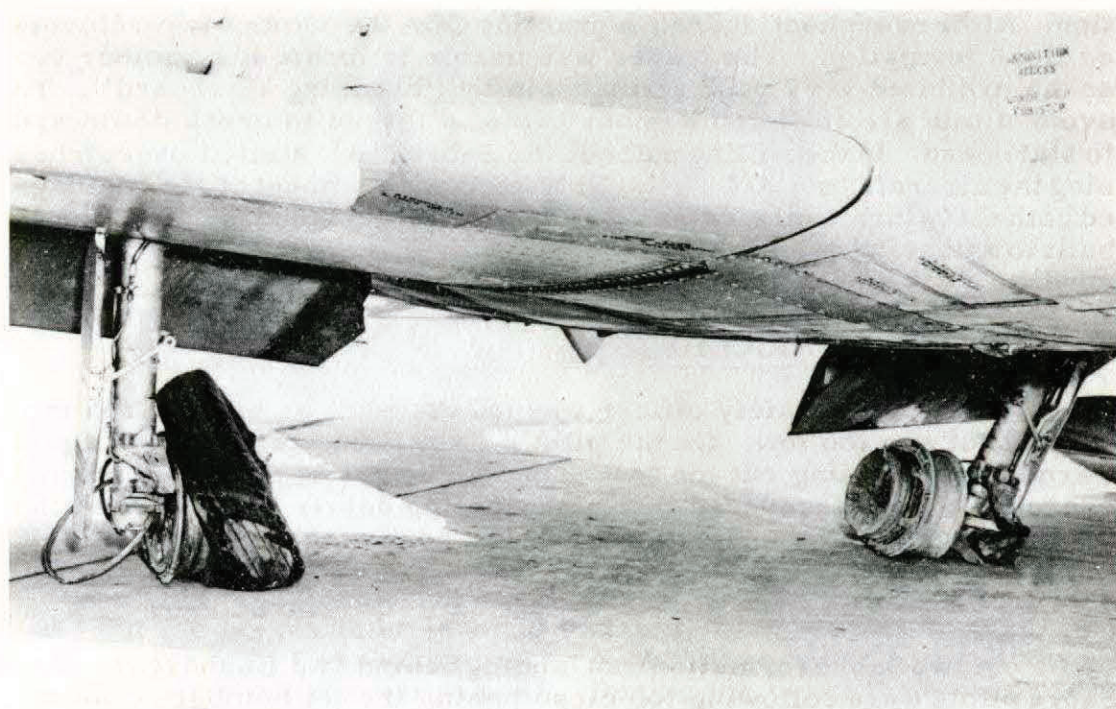
After completing a high level formation flight and nearing his base, the leader of a three plane Sabre formation heard peculiar noises behind the cockpit accompanied by instrument fluctuations and vibration. The pilot believed a flame out was imminent. He received emergency clearance and elected to make a straight in approach. He crossed the button at 160 to 170 knots but decided an overshoot was too risky. Upon harsh application, the brakes seized and both tires blew out. The aircraft ran off the runway and was seriously damaged. The board of inquiry assessed the cause of this accident as "Pilot Error". When the pilot decided to make an emergency landing he was in a suitable position to make a forced landing into wind. Instead, he elected to land downwind even though power was available throughout the emergency. When the tires blew out the pilot did not attempt to maintain control by use of the nosewheel steering. Technical examination of the aircraft and engine, failed to reveal the noises, vibration and instrument fluctuations observed by the pilot.

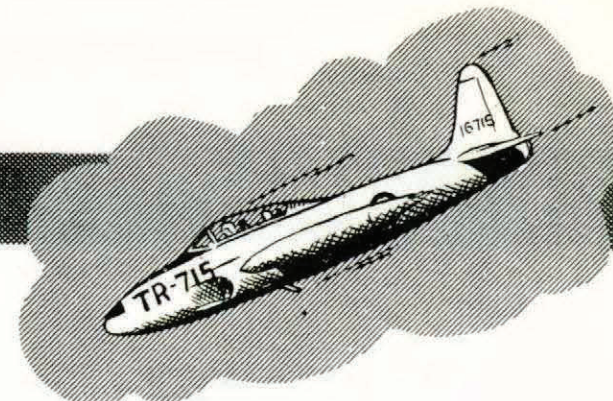
11 -- FAULTY MAINTENANCE

On take-off the captain of a Silver Star heard a series of loud explosions and noted the RPM climbing above 105%. The fire warning light for the plenum chamber came on and the pilot immediately closed the throttle and braked the aircraft to a stop on the runway. The Silver Star was shut down and abandoned. Technical investigation revealed the fuselage fuel vent line had not been connected at the flexible connection after repairs to the aircraft. This permitted fuel from the fuselage tank to be vented directly into the plenum chamber when the engine was operating under a high RPM throttle setting. Considerable damage resulted from the fire. The cause of this accident was careless maintenance.

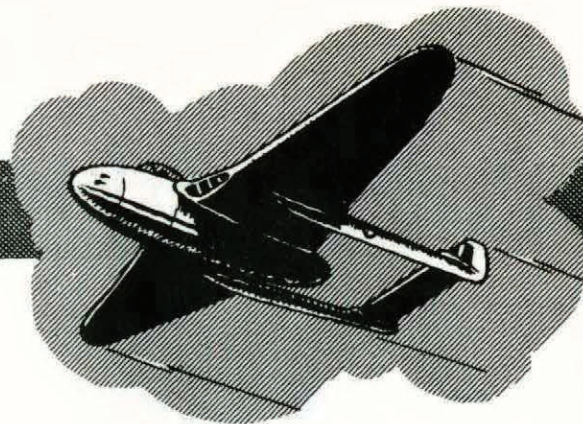
13 -- MUSH, MUSH

Number two in a two plane formation lifted his Vampire off with the leader and immediately selected undercarriage up. The Vampire mushed onto the runway, damaging the undersurface, then bounced into the air. The pilot completed the circuit and made a successful landing. He violated command instructions by retracting the undercarriage before reaching a height of 50 feet and before having attained sufficient flying speed to remain airborne.

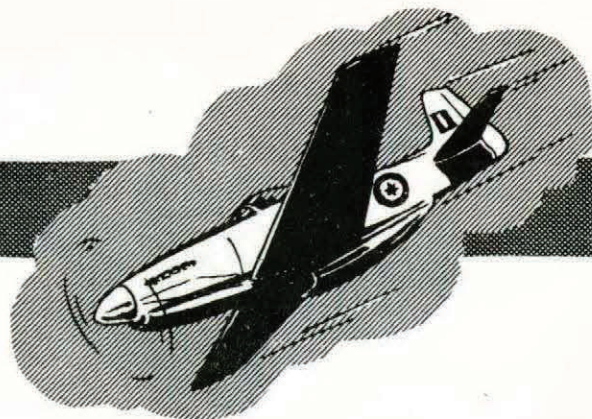
17 -- THIS WAS A MUSTANG!

The pilot allowed his airspeed to drop dangerously low on the approach. The Mustang stalled and crashed on the beginning of the runway. The port wing struck the runway and folded upwards as it split. The undercarriage was sheared off, followed by fire which completely destroyed the aircraft. The pilot escaped without injuries. The cause of this accident was "Pilot Error". The pilot displayed extremely careless airmanship, in that he could not recall whether he used flap during the approach, and he failed to check his airspeed on final.

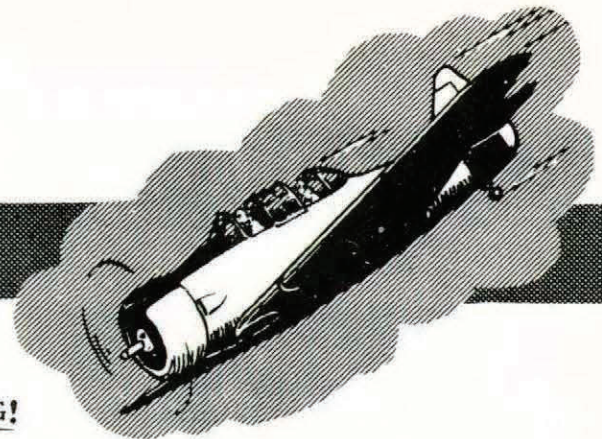
20 -- AN UNUSUAL LANDING!

The student pilot was attempting a three point landing. The Harvard ballooned badly with a very nose high attitude. The aircraft reached a height of about 30 feet and then stalled. The right wing struck the ground first and the resulting crash split the fuselage behind the rear cockpit. The aircraft was a "write-off". The pilot escaped injuries. The primary cause of this accident was "Pilot Error" because the pilot should have overshoot after the bad bounce rather than try to correct the landing. The secondary cause has

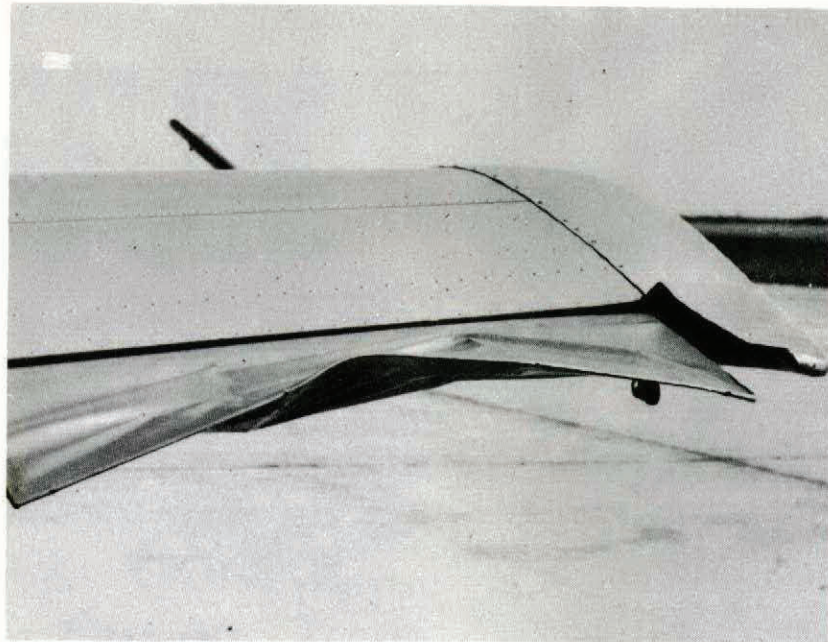
Two student pilots led by an instructor were practising formation flying. On a turn to port in echelon starboard number 3 lost sight of number 2. Instead of following his briefing orders, number 3 continued turning port, descending at the same time. The inevitable resulted. Number 3's port wing collided with the starboard wing of number 2. Once again there must have been no available accommodation in the Great Beyond because both pilots landed safely at base.

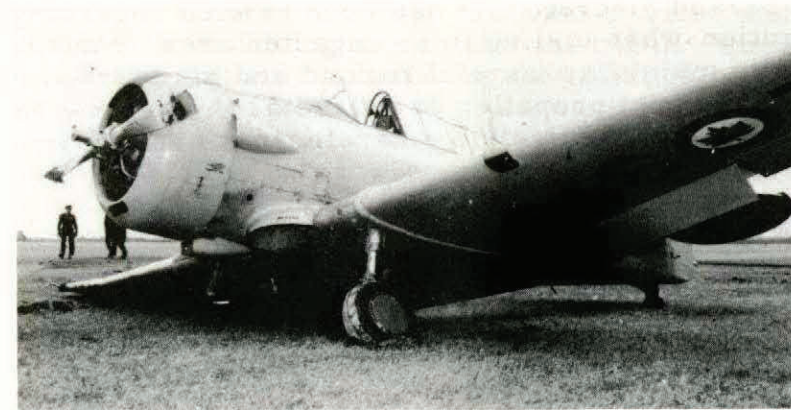
After making a wheel landing the "Hazard" swung to starboard. The pilot overcorrected and the aircraft swung to port. Along with his overcorrection the pilot applied full power. The result is obvious. A vicious swing to port which the pilot could not overcome. Considerable replacement damage resulted.

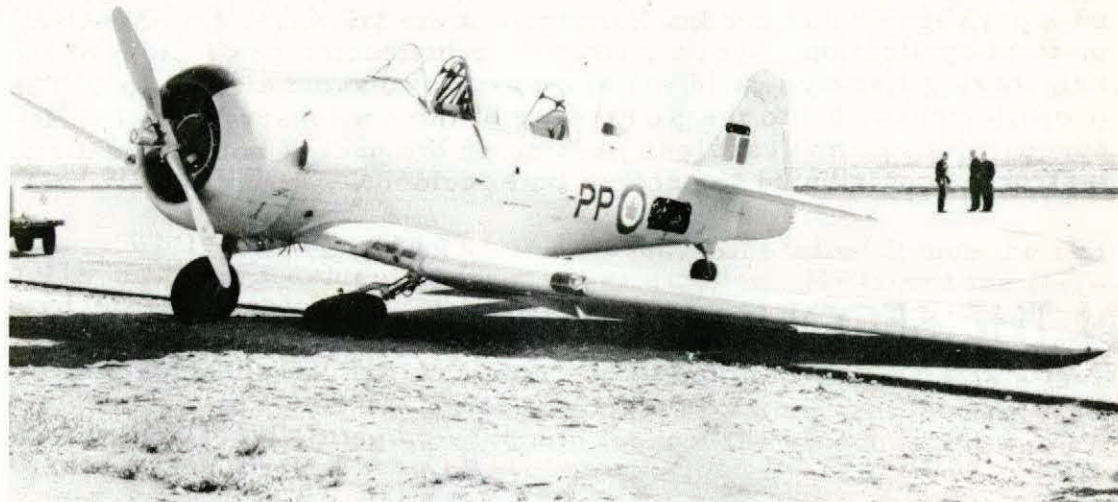
The pilot failed to use crosswind landing technique despite the fact he realized the wind was 35 degrees off the runway at a strength of 20 mph. He lowered full flap and made a three point landing. The Harvard swung to the right and the pilot's corrective action was insufficient to prevent a vicious groundloop. The port undercarriage collapsed destroying the port wing tip, aileron and flap.

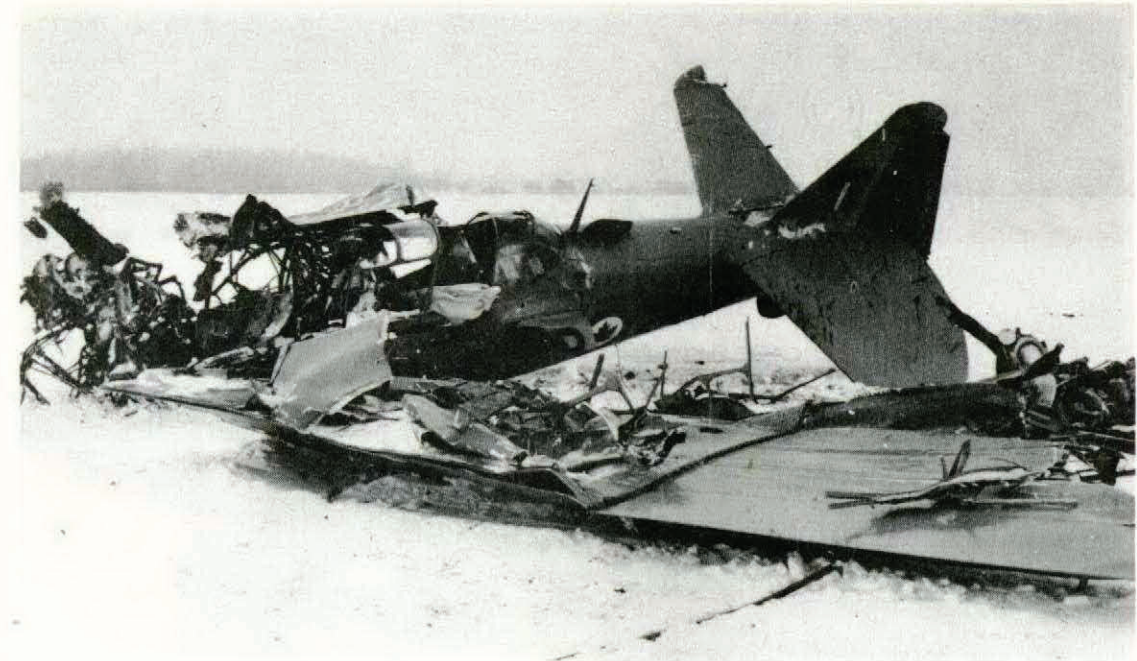
Although this fatal accident occurred in the first quarter 1953, the lessons to be learned from the results of the prolonged investigation are worthy of inclusion in this issue of Crash Comment.

The student pilot took off in the first morning detail to practise solo aerobatics. The weather briefing was given by another student who in turn had been briefed by the weather forecaster on duty. This briefing was not supervised by either the weather forecaster nor an instructor even though the forecast warned of possible fog conditions throughout the area during the morning. An hour after take-off a heavy fog bank moved into the area lowering the visibility to 500 feet. The top of the fog bank was 2500 feet. It is believed the pilot tried to remain visual while attempting to find the station. The Harvard struck the ground and the pilot was instantly killed. It would appear the pilot flew into the ground while attempting to remain visual because the wheels and flaps were in the "Up" position and the engine was in normal cruising power.

The primary cause of this accident has been assessed as "Pilot Error". The pilot did not attempt to use his radio aids to find the station and he did not attempt to climb above the fog and go to an alternate airport. The secondary cause has been assessed as "Briefing" because the student had not been briefed as to the procedure to follow in case weather closed his home station.

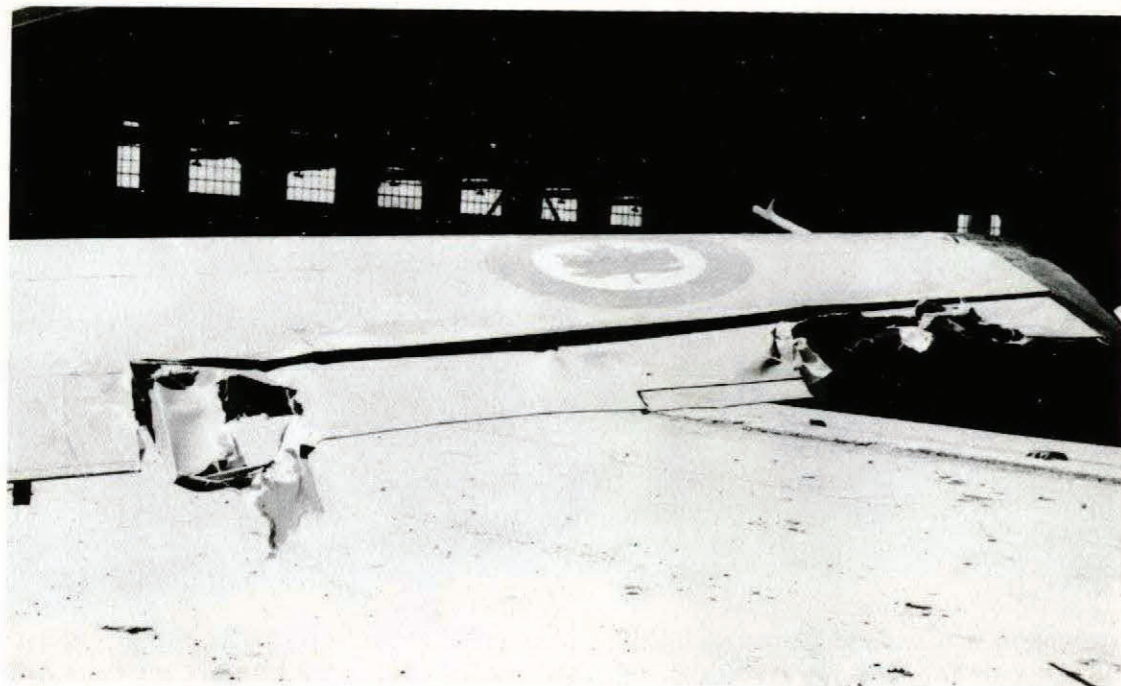
The number four pilot in a four plane Harvard formation was moving into position in echelon starboard. As he was throttling back he heard his engine over-rev. The pilot looked inside the cockpit at his RPM indicator. When he looked out again his port wing was nearly touching the trailing edge of number three's starboard wing. The pilot banked sharply to starboard and the two wings collided. Fortunately both pilots made successful emergency landings at base. The starboard mainplane, flap and aileron of the Harvard which was struck had to be replaced and the port mainplane of the ramming Harvard had to be replaced. This accident was caused by "Pilot Error". A tragic accident can result from a pilot failing to maintain a constant lookout while flying in close formation.

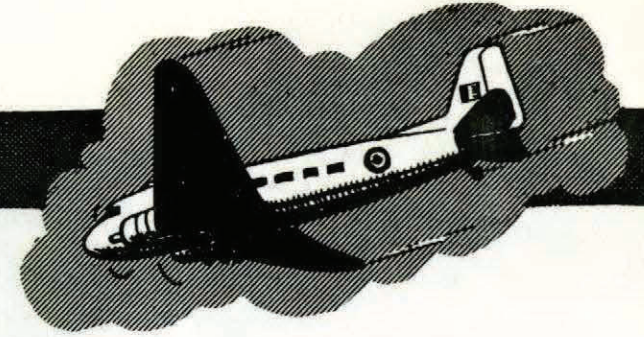
45 -- ANOTHER TAXI ACCIDENT

The co-pilot of this Dakota was occupying the left hand seat. After completing the tarmac check the co-pilot released the brakes without ensuring the taxi area was clear. He tested the brakes as soon as the aircraft began rolling but he applied more starboard brake than port. This swung the Dakota to the right causing the port tip of the tailplane to strike a parked vehicle. Negligence and insufficient lookout claimed another victim.
