Evaluation of Emerging Non-Destructive Inspection Techniques to Characterize Damage Beneath Polymeric Tiles on VICTORIA Class Submarine Hulls

James Owens Owens Aerospace Inc

Contract Report DRDC-RDDC-2014-C42 May 2014

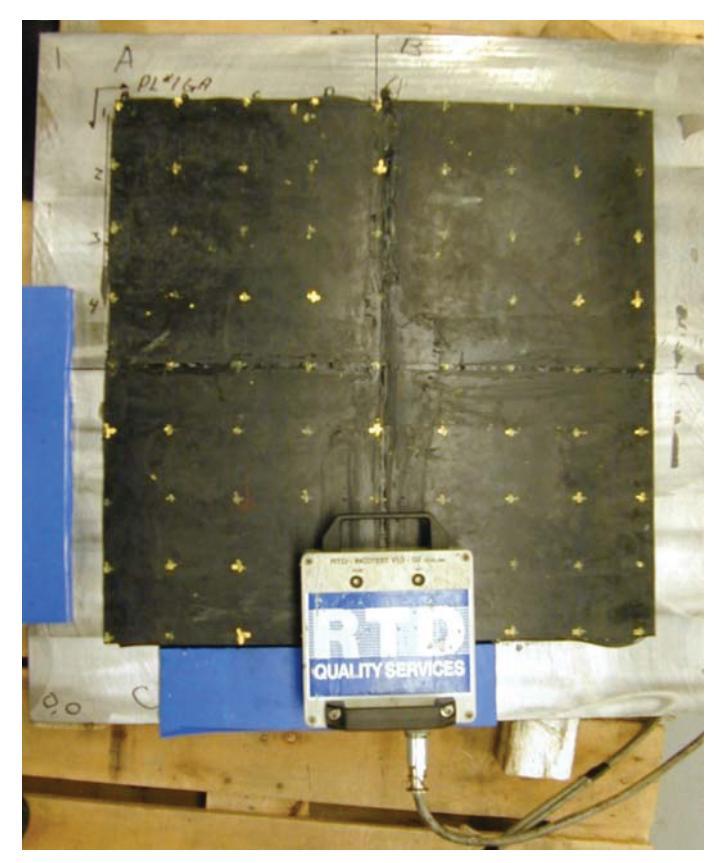
Figure 2: Plate 1 (known defects) – With acoustic tiles and INCO Test Probe

The RTD INCO (Insulated Component) test was performed on three separate steel plates which were each covered by four separate solid rubber tiles (See Figure 2 - Figure 3). The steel plate was meant to represent the hull of the HMCS Victoria class submarines. The rubber tile represented the acoustic/anechoic tiles which cover the submarine hulls. The steel plates were made of Q1N HY80 pressure vessel steel. The plates were machined down to thickness of 30 mm by rough machining with a milling machine. The metal surface defects were made with basic hand tools such as drills and grinders.

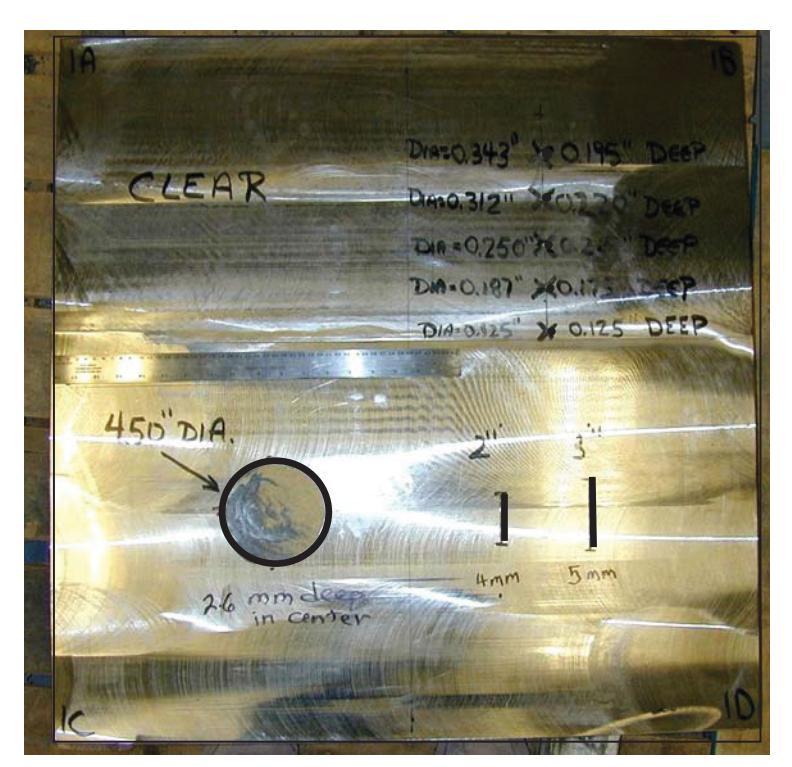
Figure 3: Plate 1 (known defects) – Bare plate and defects (i.e without acoustic tiles)

The damage locations in plate 1 have been superimposed on Figures 6 and 7 to help determine whether an actual indication was detected during the tests. In these two figures, it can be seen that there are three areas which display significant anomalies. The largest of these areas is centered in the upper left corner of Quadrant C. The next most significant anomaly is located in the center area of quadrant B and the third most significant anomaly is located in the middle

In quadrant D it appears that there could be an indication of wall loss due to the two slots cut into the plate since there is a dramatic shift in the contour lines in their immediate vicinity. If in fact there is an indication, it is very gradual and not qualitatively comparable to those shown near the other defects. If in fact the tests are providing an indication for the slots and the drill-pits, they are not readily discernable on the plots. This may be due in part to the coarseness of the grid, but it is more likely due to the relatively large footprint of the probe which tends to provide an average indication of damage.

While there are significant defects close to the areas where the anomalies are observed, the anomalies appear to be somewhat offset from the actual damage areas. In addition the shape of the anomalies appears to be significantly different from those of the actual damage geometry. One observation which is somewhat odd is that the main anomaly region overlaps into quadrant A which is supposed to be defect free. In both of the contour plots for plate 1, there appears to be a significant drop in the contour lines as the edge of the plate is approached. It is suspected that this edge effect is due to either a shortened eddy current path due to the edge, or that there is significant heat damage due to a flame cutting or machining of the plate edge.

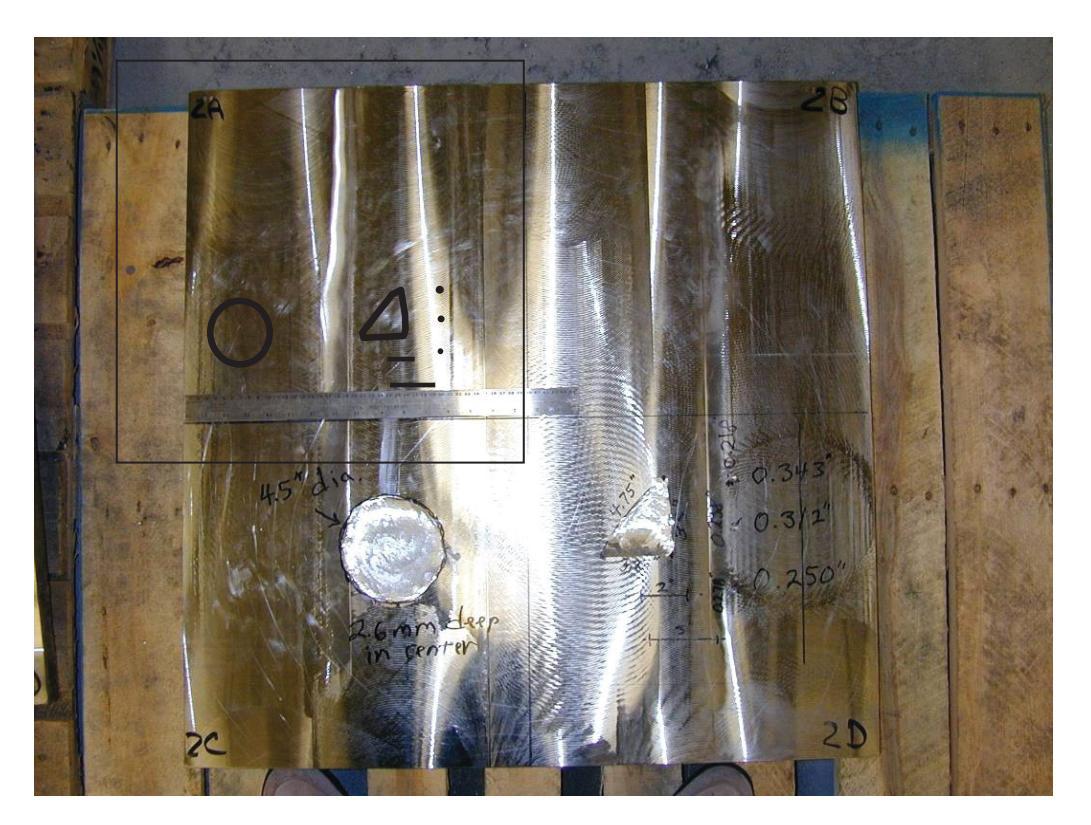
Figure 4: Plate 2 – Bare plate and defects (i.e without acoustic tiles)

Two sets of Pulsed Eddy Current RTD INCO Test data were taken for plate no. 2 (Figure 8) and normalized with respect to plate thickness (Figures 9 and 10). Each of these data sets has been plotted as contours in Figures 11 and 12. Only the lower two quadrants, C and D were tested since these were the only ones with metal defects (See

The damage location in Plate 2 has been superimposed on Figures 11 and 12 to help determine if an actual damage location was detected. In these two figures, it can be seen that there are no sharp anomalies in the thickness contour plots. This may be due to the fact that the footprint is much larger in the unfocused mode which was used in these tests. Again it is interesting to note that the average wall loss indication in the area of the defects is approximately 10% which correlates well with the actual defect sizes.

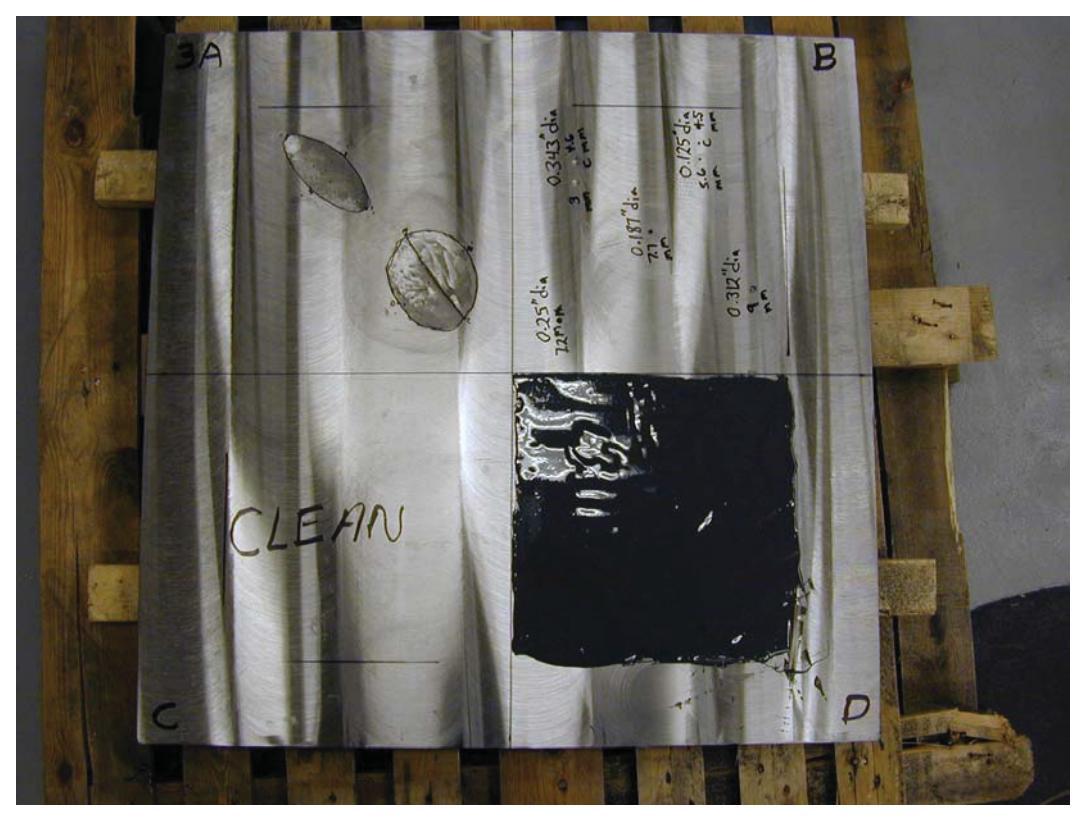
Figure 5: Plate 3 – Bare plate with defects shown

The damage and tile configuration for test panel No. 3 are shown in **Figure 5** and Figure 6. Two sets of Pulsed Eddy Current RTD INCO Test data were taken for Plate No. 3 and normalized with respect to plate thickness (Figures 15 and 16). Each of these data sets has been plotted as contours in Figures 17 and 18. The INCO Test was conducted in focused mode on a refined grid of 2 inch spacing in both the x and y locations. This refined grid was chosen in an attempt to help maximize detectability of the unknown defects in this plate. This 2 inch grid helped ensure that there would be significant probe footprint overlap between sequential readings.

In the two contour plots (Figures 17 and 18), it can be seen that there are three areas which display significant anomalies. The largest of these areas is centered in the middle of the plate. There are also numerous other areas which are characterized by rapid changes in the contours and indicate anomalies in the thickness of the plate.

As observed for Plate No.'s 1 and 2, there appears to be a significant drop in the contour lines as the edge of the plate is approached. Again, it is suspected that this edge effect is due to either a shortened eddy current path near the edges, and/or that it is due to significant heat damage caused by flame cutting or machining of the plate edges.

In Figures 17 and 18, the areas with black circles and ellipses are the areas identified as anomalies in the contour plots. The white circles and ellipses are the outlines of the actual simulated damage in the test plates. Two or three of the anomalies seem to coincide very closely with the actual damage locations. However, there are also 7 or 8 other areas of anomalies identified on the plates at locations where there isn't any damage on the plates.
