RESIDENTIAL COMBUSTION VENTING FAILURE

A SYSTEMS APPROACH

FINAL TECHNICAL REPORT

COUNTRY-WIDE SURVEY RESULTS

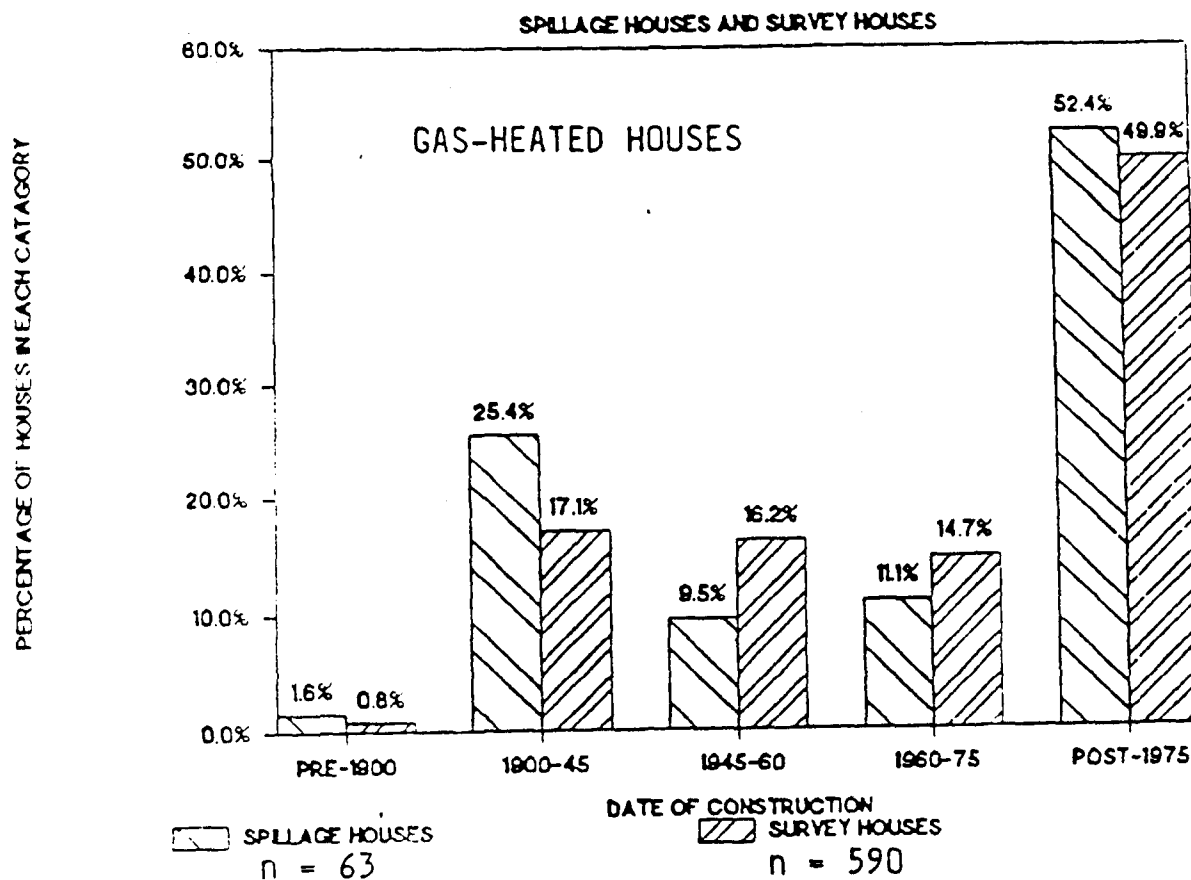
GRAPH 3: Distribution by Date of Construction

Graph 3 presents the distribution of spillage houses and survey houses by date of construction. Both the older and newer houses indicate higher than average spillage incidents. The strongest trend is towards increased problems in the pre-1945 houses, which may be related to chimney deterioration, liners, leaks, poor maintenance and fuel conversions. The higher incidence of spillage in the post-1975 houses is

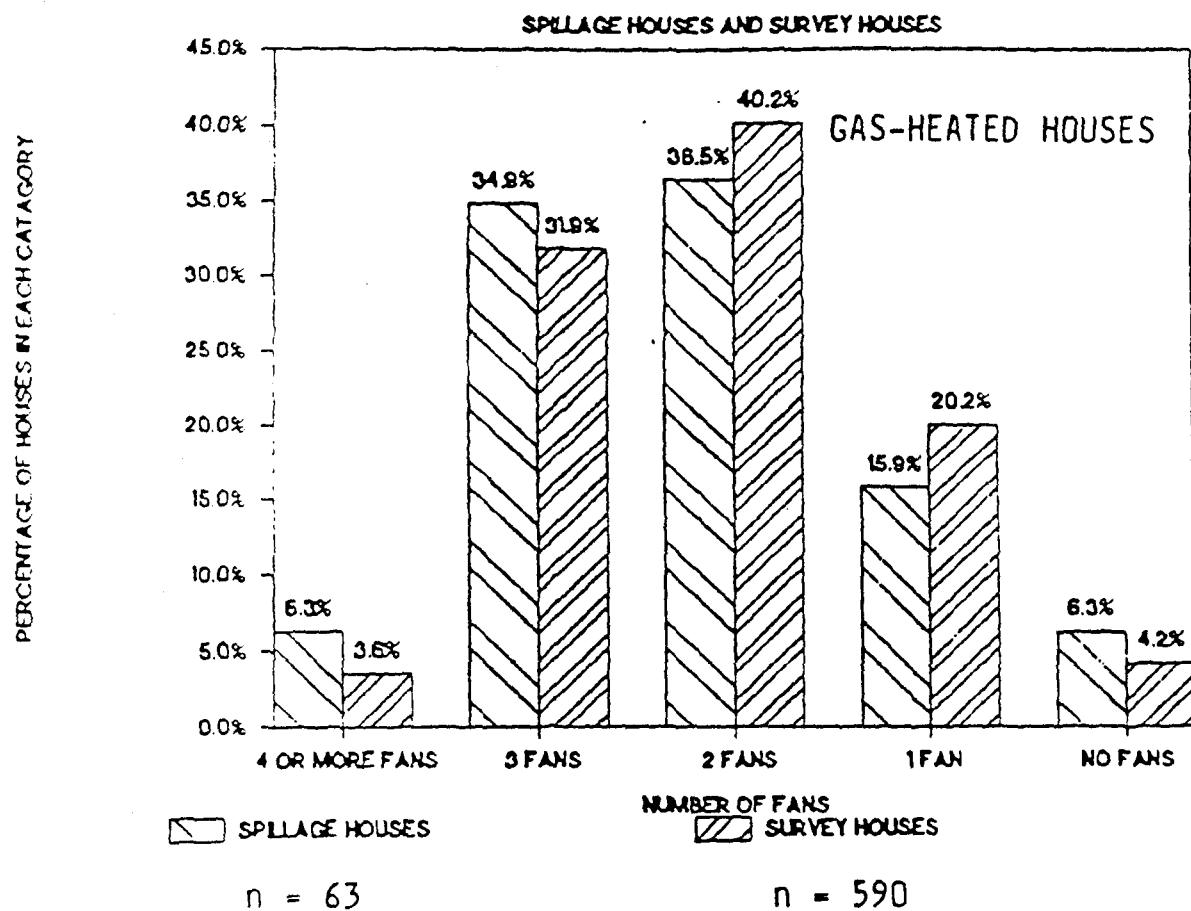
GRAPH 6: Distribution of Houses by Number of Fans

Graph 6 presents the distribution of spillage in survey houses by the number of exhaust fans in the houses. As might be expected, houses with three, four or more fans showed a higher proportion of spillage problems. Presumably, these houses are suffering from house depressurization and backdrafting. Surprisingly, the "no fans" category also showed a higher

proportion of spillage houses. However, "no fans" is a feature which probably overlaps the older house characteristics, a category of houses which also showed a much higher proportion of spillage problems.

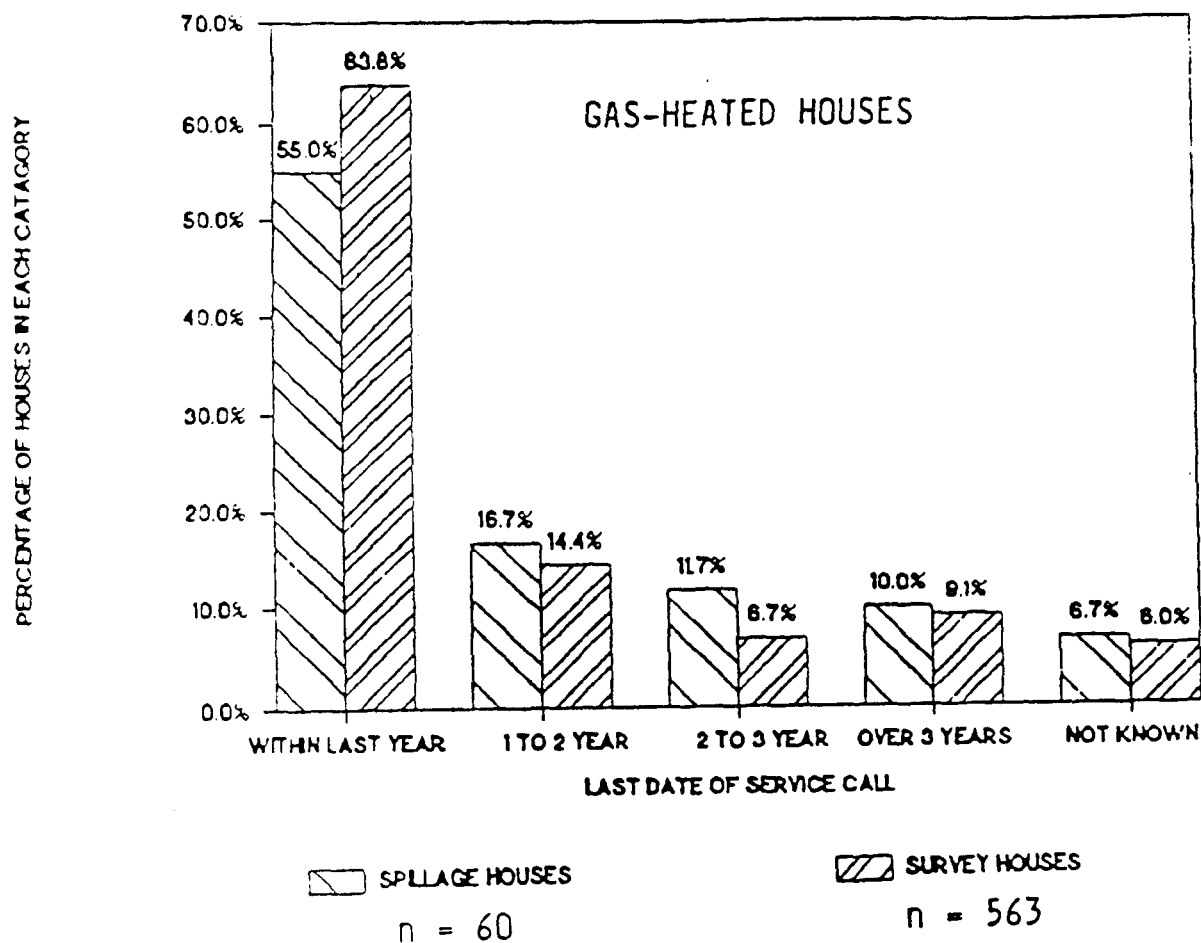
GRAPH 8: Distribution of Houses by Date of Last Service Call

Graph 8 presents the distribution of spillage in survey houses by the date of the last service call. Houses where the appliance has been serviced within the last year show a significantly lower proportion of spillage houses when compared to houses where the last service call was more than one year previous.

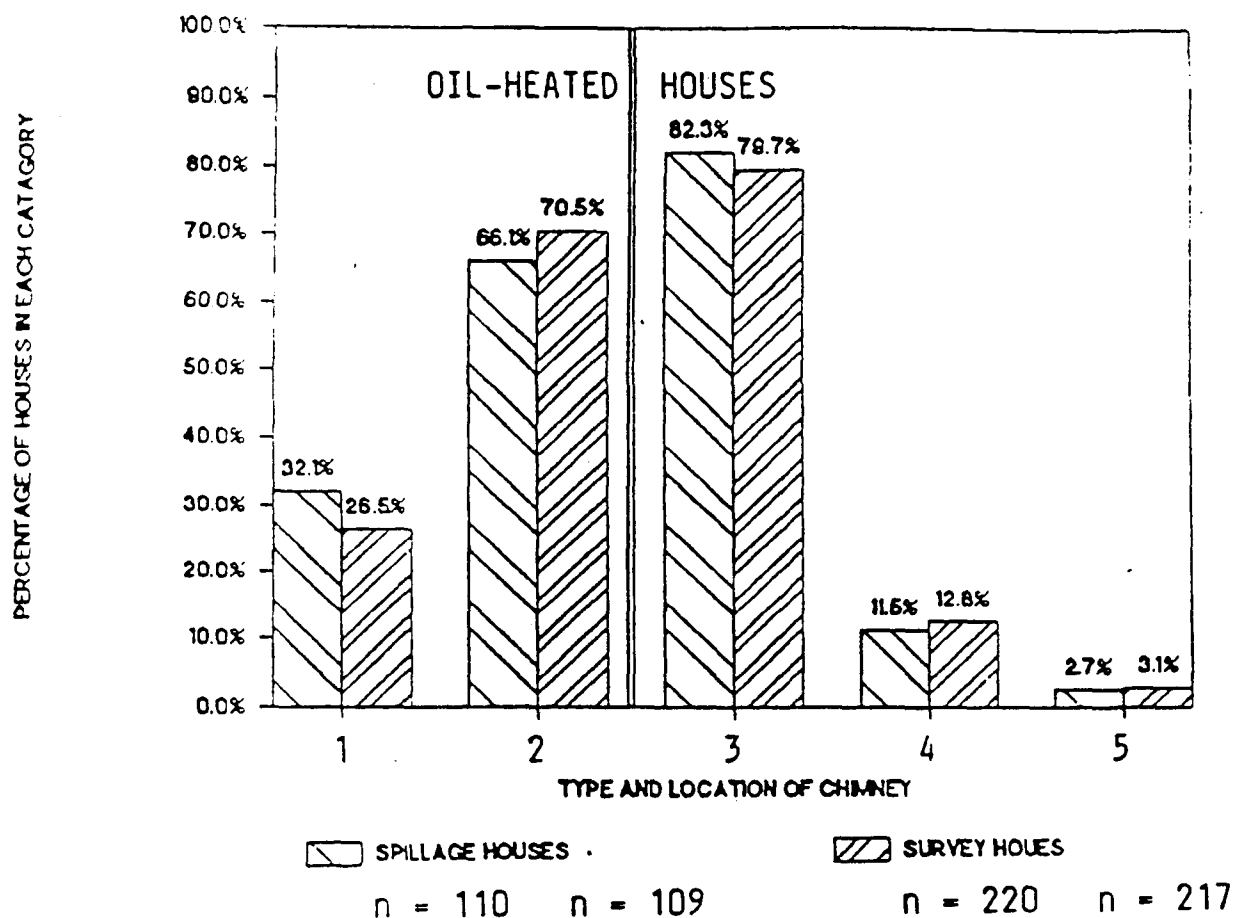
GRAPH 12: Distribution of Houses by Type and Location of Chimney

Graph 12 presents the distribution of oil-heated houses by type and location of chimney. Exterior chimneys appear more likely to experience spillage problems than interior chimneys. Masonry chimneys appear more likely to have problems than metal chimneys, although the variations are not great.

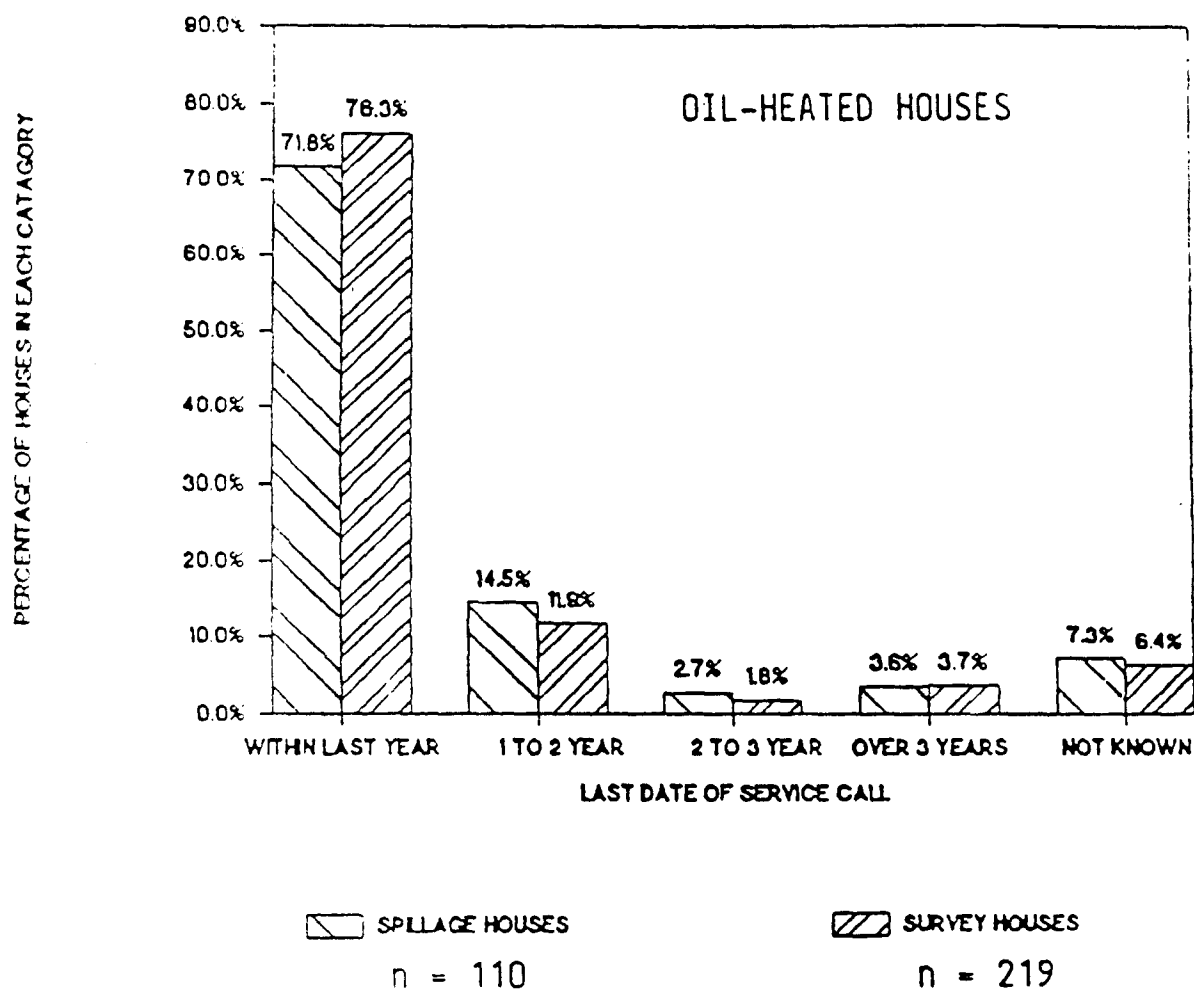
GRAPH 15: Distribution of Houses by Date of Last Service Call

Graph 15 presents the distribution of oil-heated houses by date of last service call. Houses that have had their furnace serviced in the last year appear to have a lower proportion of spillage incidents. The distribution of houses in these categories is almost identical to the gas-heated houses.
