CAM-F (SARCPA LAKE) DEW LINE STATION
CONDITION REPORT
SEPTEMBER 1980

Report No. EA-HQ-80-110

CAM-F (SARCPA LAKE) DEW LINE STATION
CONDITION REPORT

September 1980

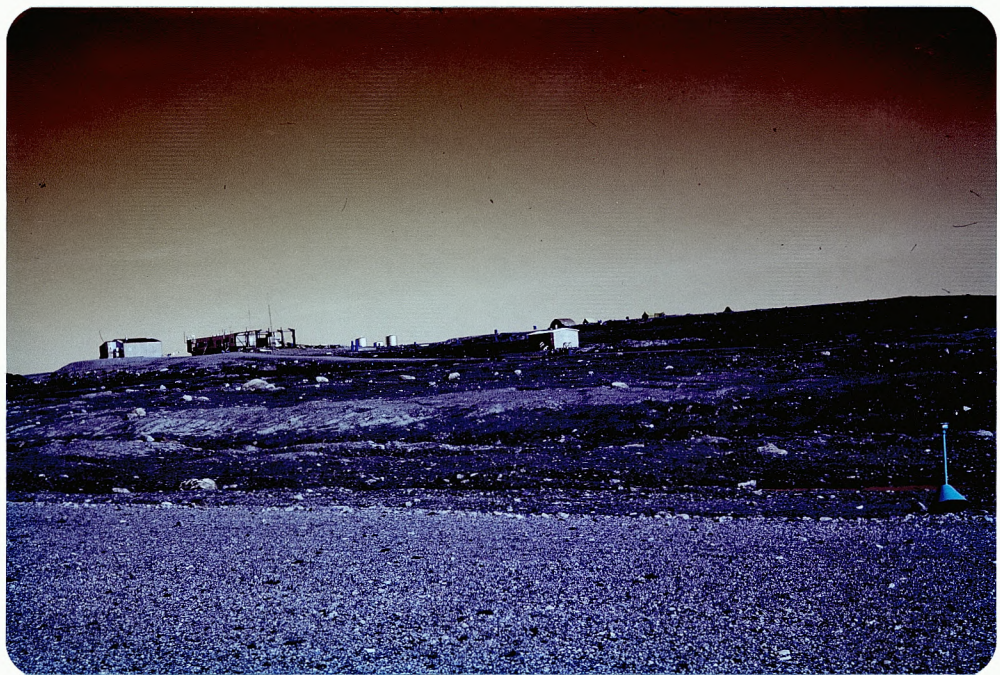
Photo 1 - CAM-F Intermediate Station

CAM-F is located on a hill (elevation 300 m ASL) about 2 km north of the west arm of Sarcpa Lake (Photo 1). Refer to attached map sheet 47A - Hall Beach - Military Grid Reference 17 WMG 0607. The surrounding area consists of moderately mountainous terrain with numerous lakes and rivers notably Sarcpa Lake and Kingora River (Photo 2).

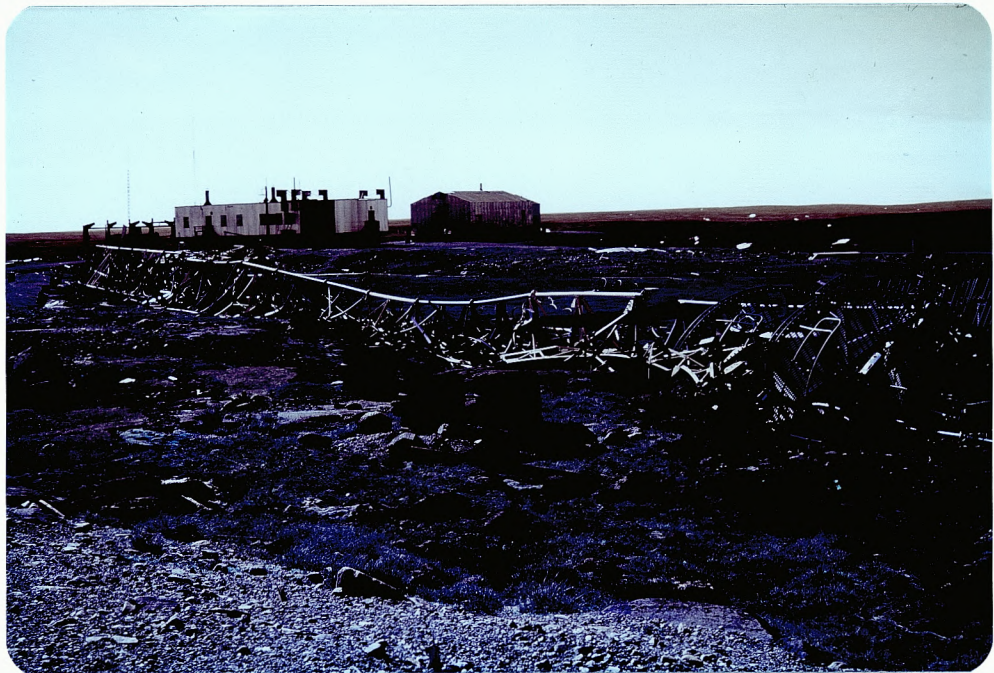
Photo 3 - 400' AA Antenna

As-built drawing LAP-1 "CAM-F Site Development" shows the lay-out of the station. The train building, warehouse, garage and POL tanks are located on top of the hill. The NANR House is approximately 200 m south-east along the Water Road. The 400 ft. AA antenna has been felled along a north-west alignment away from its base resulting in an unsightly wreck of twisted silver and orange metal and cable (Photo 3). The 100 x 3600 ft. airstrip is on a north-west, south-east alignment about 300 m south of the building site.

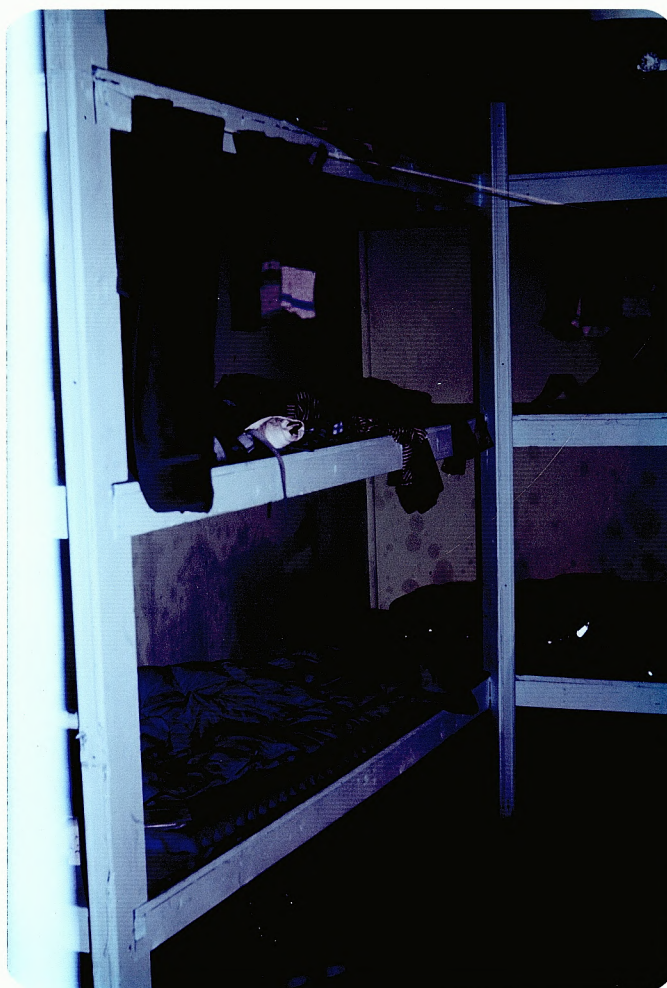
Photo 18 - Water Storage and Snow Melting Room

Plumbing systems were non-operational. The original system has been almost entirely dismantled and disposed of in pieces on the ground to the north of the Train Building. This apparently has been carried out by the York University group in order to provide more living and working space. The Water Storage and Snow Melting Room has been converted to a bedroom (Photo 18). The tanks and all other equipment have been removed except for one of the water tanks which has been cut open to use as storage. New interior walls have been added. The main room contains three triple decker bunk beds with "foamie" mattresses and one table. The smaller room contains two triple decker bunk beds.

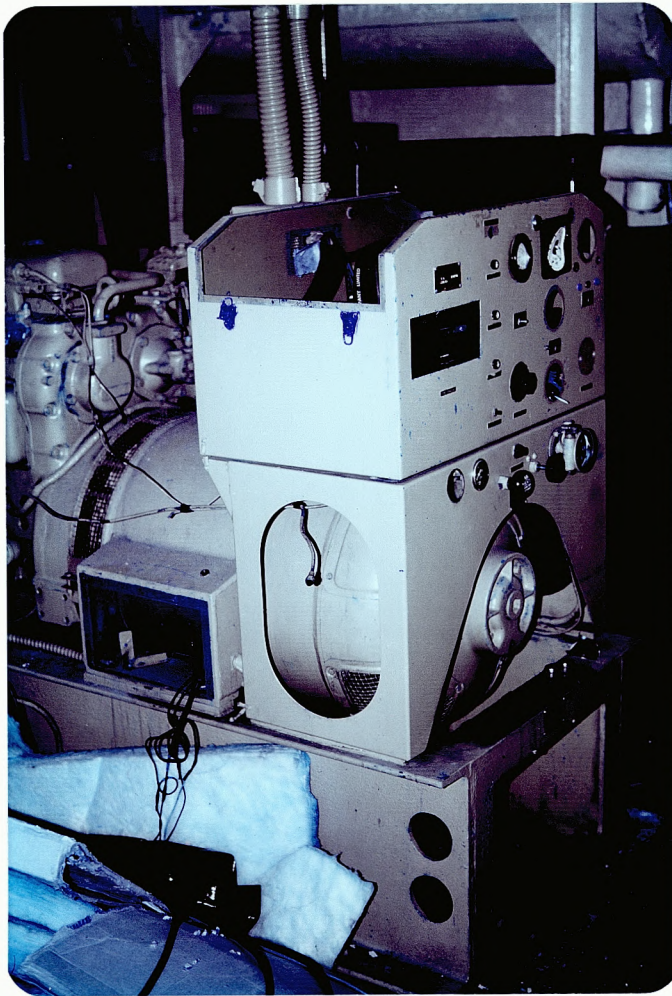
Photo 19 - Diesel Generator

While electrical wiring and lighting were largely in tact, the original generating equipment was non-operational. Restricted power service was supplied to the building from a three kilowatt Onan electrical generator rated at 220/240 volts located in the Warehouse with power carried to the Train Building by an overhead power line. This generator was bought for CAM-F by Environment Canada. The original generators and other equipment in the Power and Heat Room have been rendered unserviceable (Photo 19). While some parts were damaged or missing, the remainder of the generators were in good condition and probably could be repaired. Much of the wiring in the Power and Heat Room has been cut (Photo 20).

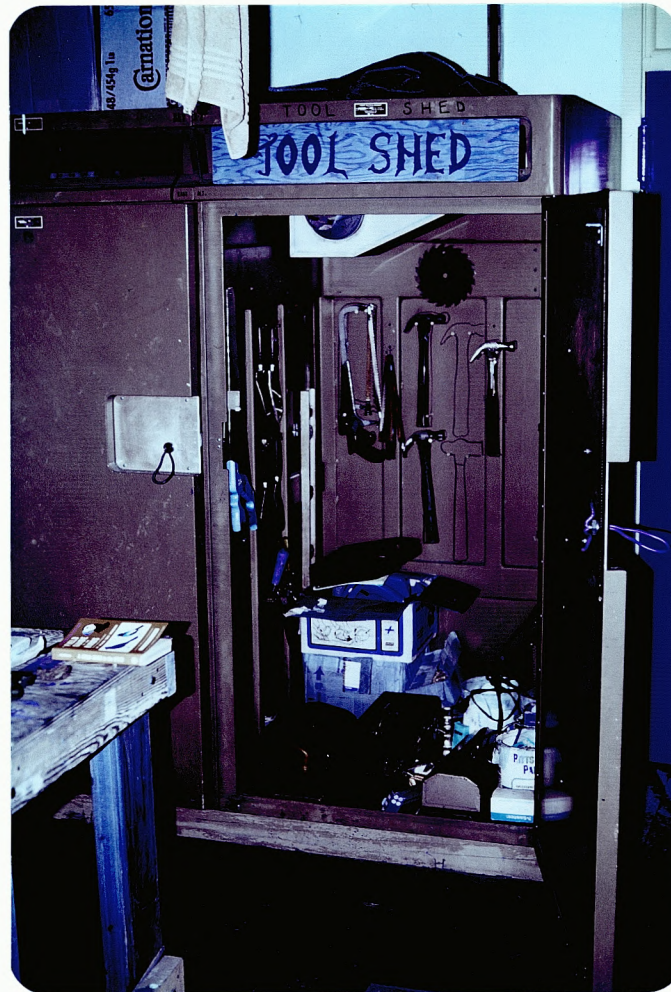
Photo 21 - Equipment Room cabinets

The communications equipment in the Equipment Room has largely been removed. Part of this equipment was probably removed by DEW Line personnel while part was removed subsequently and dumped on the ground to the north of the Train Building. The equipment cabinets are in place and used to store equipment belonging to the York University summer school (Photo 21). The Equipment Room itself was in use as a science workshop by the York University students (Photo 22).
