FOX-B (MID-BAFFIN) DEW LINE STATION  
CONDITION REPORT  
SEPTEMBER 1980

Report No. EA-HQ-80-109

FOX-B (MID-BAFFIN) DEW LINE STATION  
CONDITION REPORT

by D.E. Rodger  
Municipal Services Divison  
Technical Services and Contracts Branch

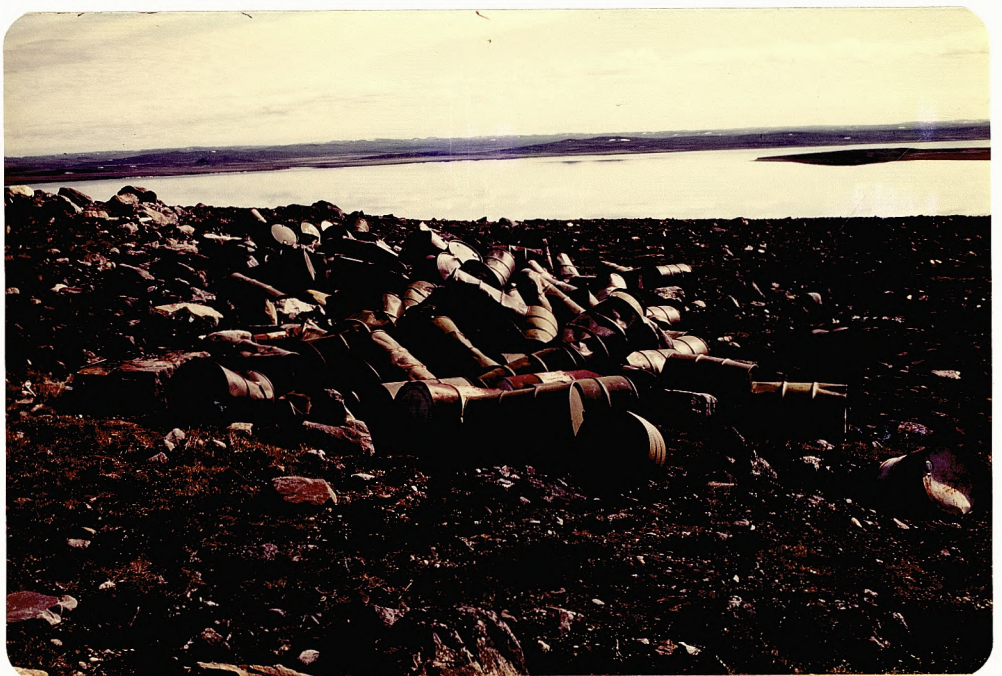
Other than the natural aesthetics of the location, the most notable characteristic of the grounds was the amount of garbage around. Scattered sometimes in piles and sometimes randomly at various locations were numerous fuel drums, fuel dumped on the ground, three piles of wrecked vehicles, a poorly developed landfill and large quantities of assorted lumber and broken equipment in various conditions (Photos 8-11). The one large and four small Atwell structures between the garage and the POL tanks may also be considered garbage. It should be noted however that some of this material is salvageable for re-use as building material.

Photo 8 - Oil drums near Garage

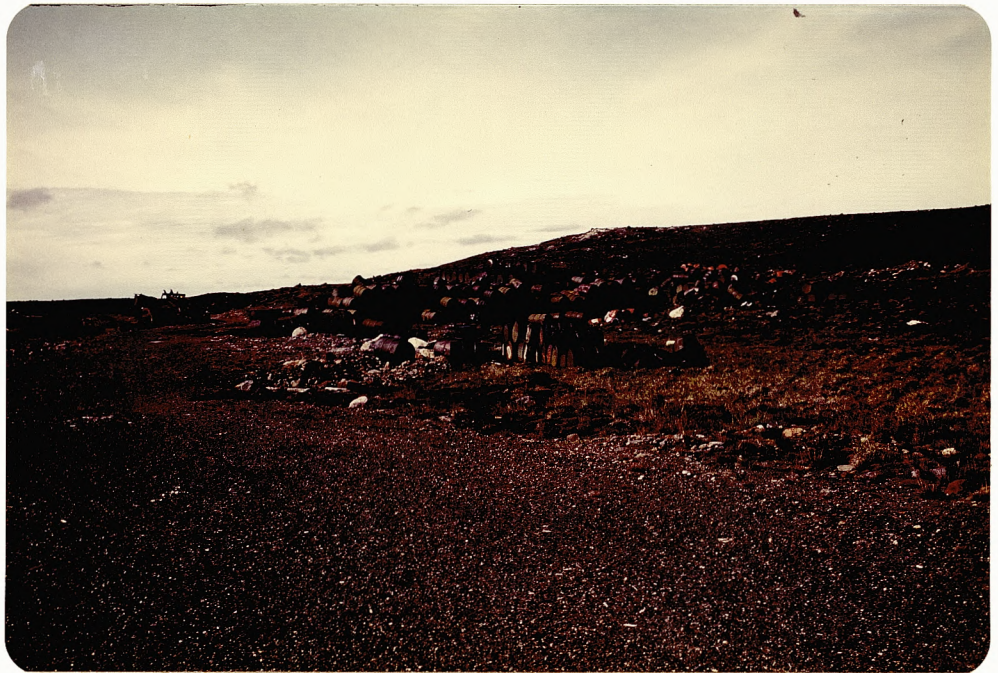
Photo 9 - Oil drums near NANR House

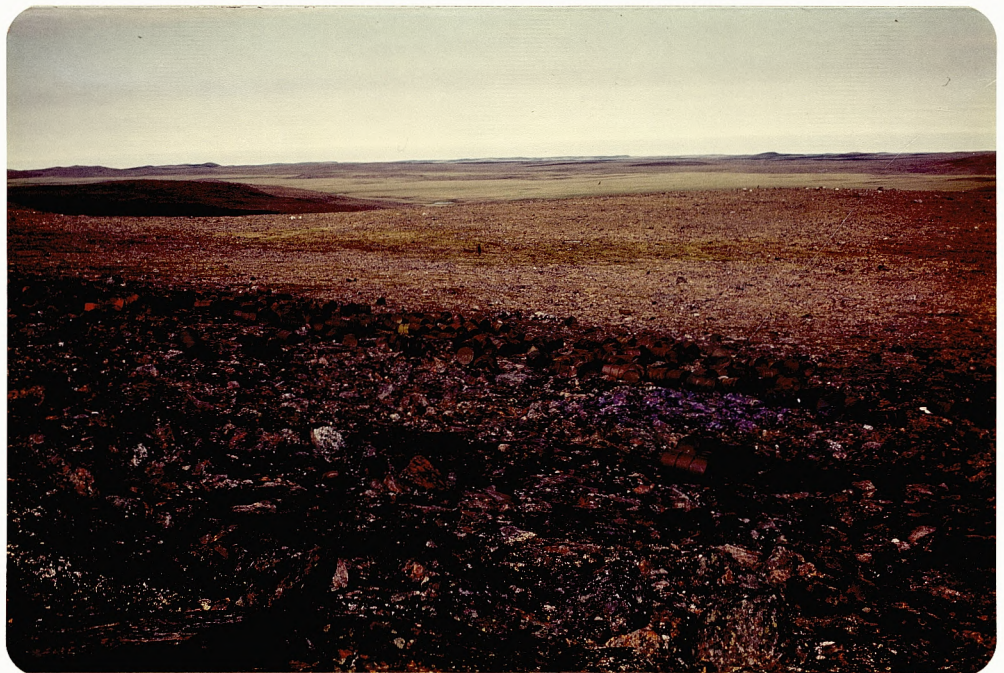
Photo 10 - Oil drums near Landfill

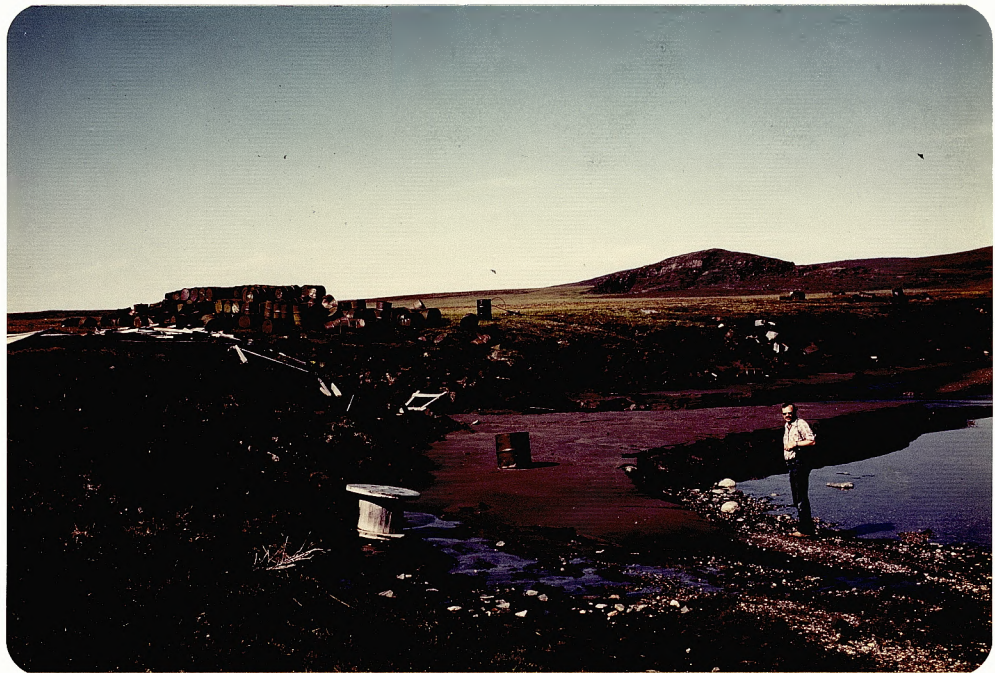
Photo 11 - Oil drums near Nadluardjuk Lake

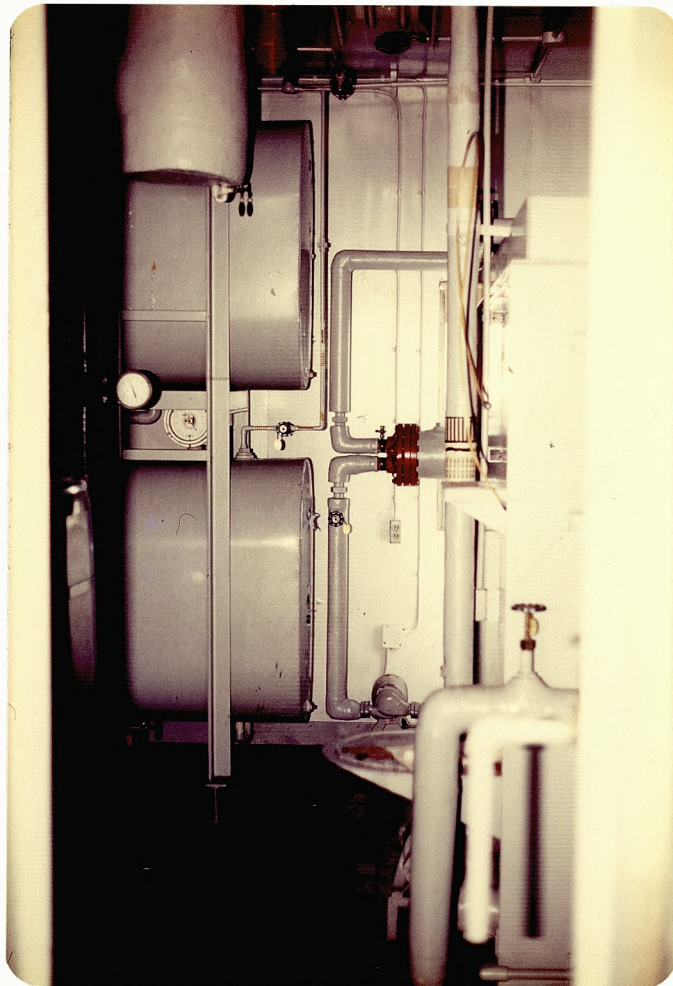
Plumbing systems were non-operational but all installed equipment appeared to be in place and in tact. It is suspected that sewer and water systems were drained when closing down the facility, but not altered or damaged. In brief, the Water Storage and Snow Melting Room contained two 2500 gal. water storage tanks and one 2500 gal. snow melting tank, all with water meters and an alarm system, a chlorinator, a 30 gal. make-up tank, pumps, water boiler, and two 275 gal. fuel tanks (Photo 20). The room also contained four CO<sub>2</sub> cylinders for the fire protection system. It was estimated that one of these was full, one half full, and two empty. A clothes dryer was missing. The Tank Room contained a sewage tank, a waste water tank, sewage ejector, three 10 hp. motor/5 kw. generators, and other associated equipment (Photo 21).

Photo 20 - Water Storage and Snow Melting Room

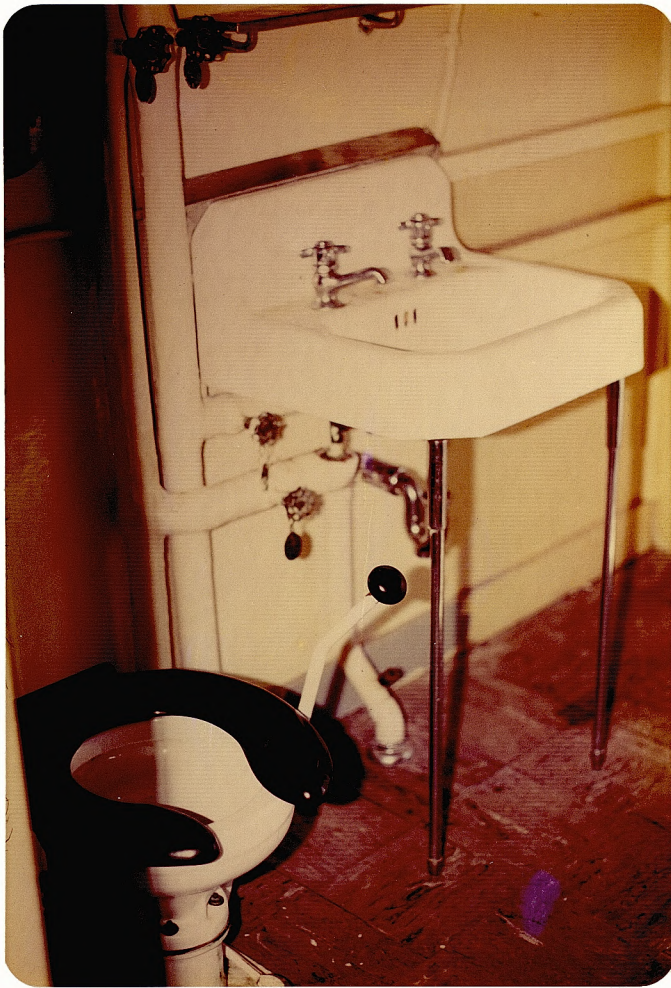
The Kitchen water system was in tact including a 100 gal./1500 w. hot water tank and one stainless steel sink (Photo 22). Bathroom fixtures were also in place including a porcelain sink and toilet and a stainless steel shower stall (Photo 23). To the extent that pipes were accessible, there was no indication of leaking or corroded pipes or of inadequate bracing or support.

Photo 23 - Bathroom

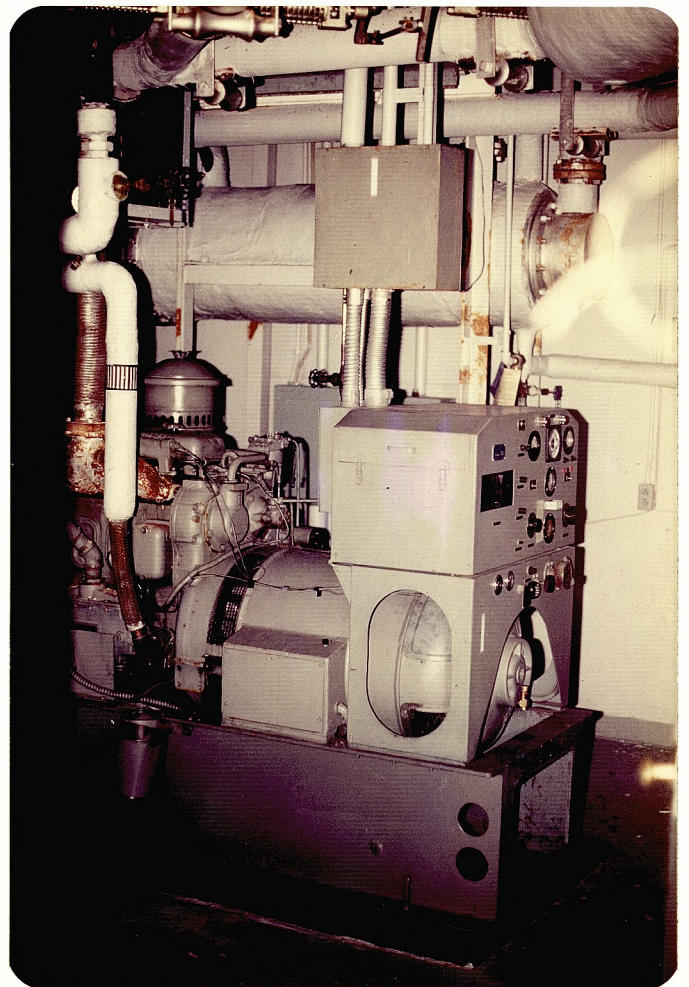
Electrical equipment and wiring appeared to be in tact and serviceable. No operational tests were carried out. The Power and Heat Room contained two General Motors diesel driven 50 kw. generators with 4000 hours and 3097 hours of operation shown on each (Photo 24). Starting batteries were not in place, presumably among those in the landfill. The power switchboard was also in tact. Two fuel tanks contained 140 gal. and 75 gal. of diesel fuel according to gauges. All wiring and lighting (fluorescent) were in tact. The room also contained four CO<sub>2</sub> cylinders with unknown quantities. The fire alarm has been pulled. All other panels, wiring, lighting and alarm equipment in the building appeared untouched.

Photo 24 - Power and Heat

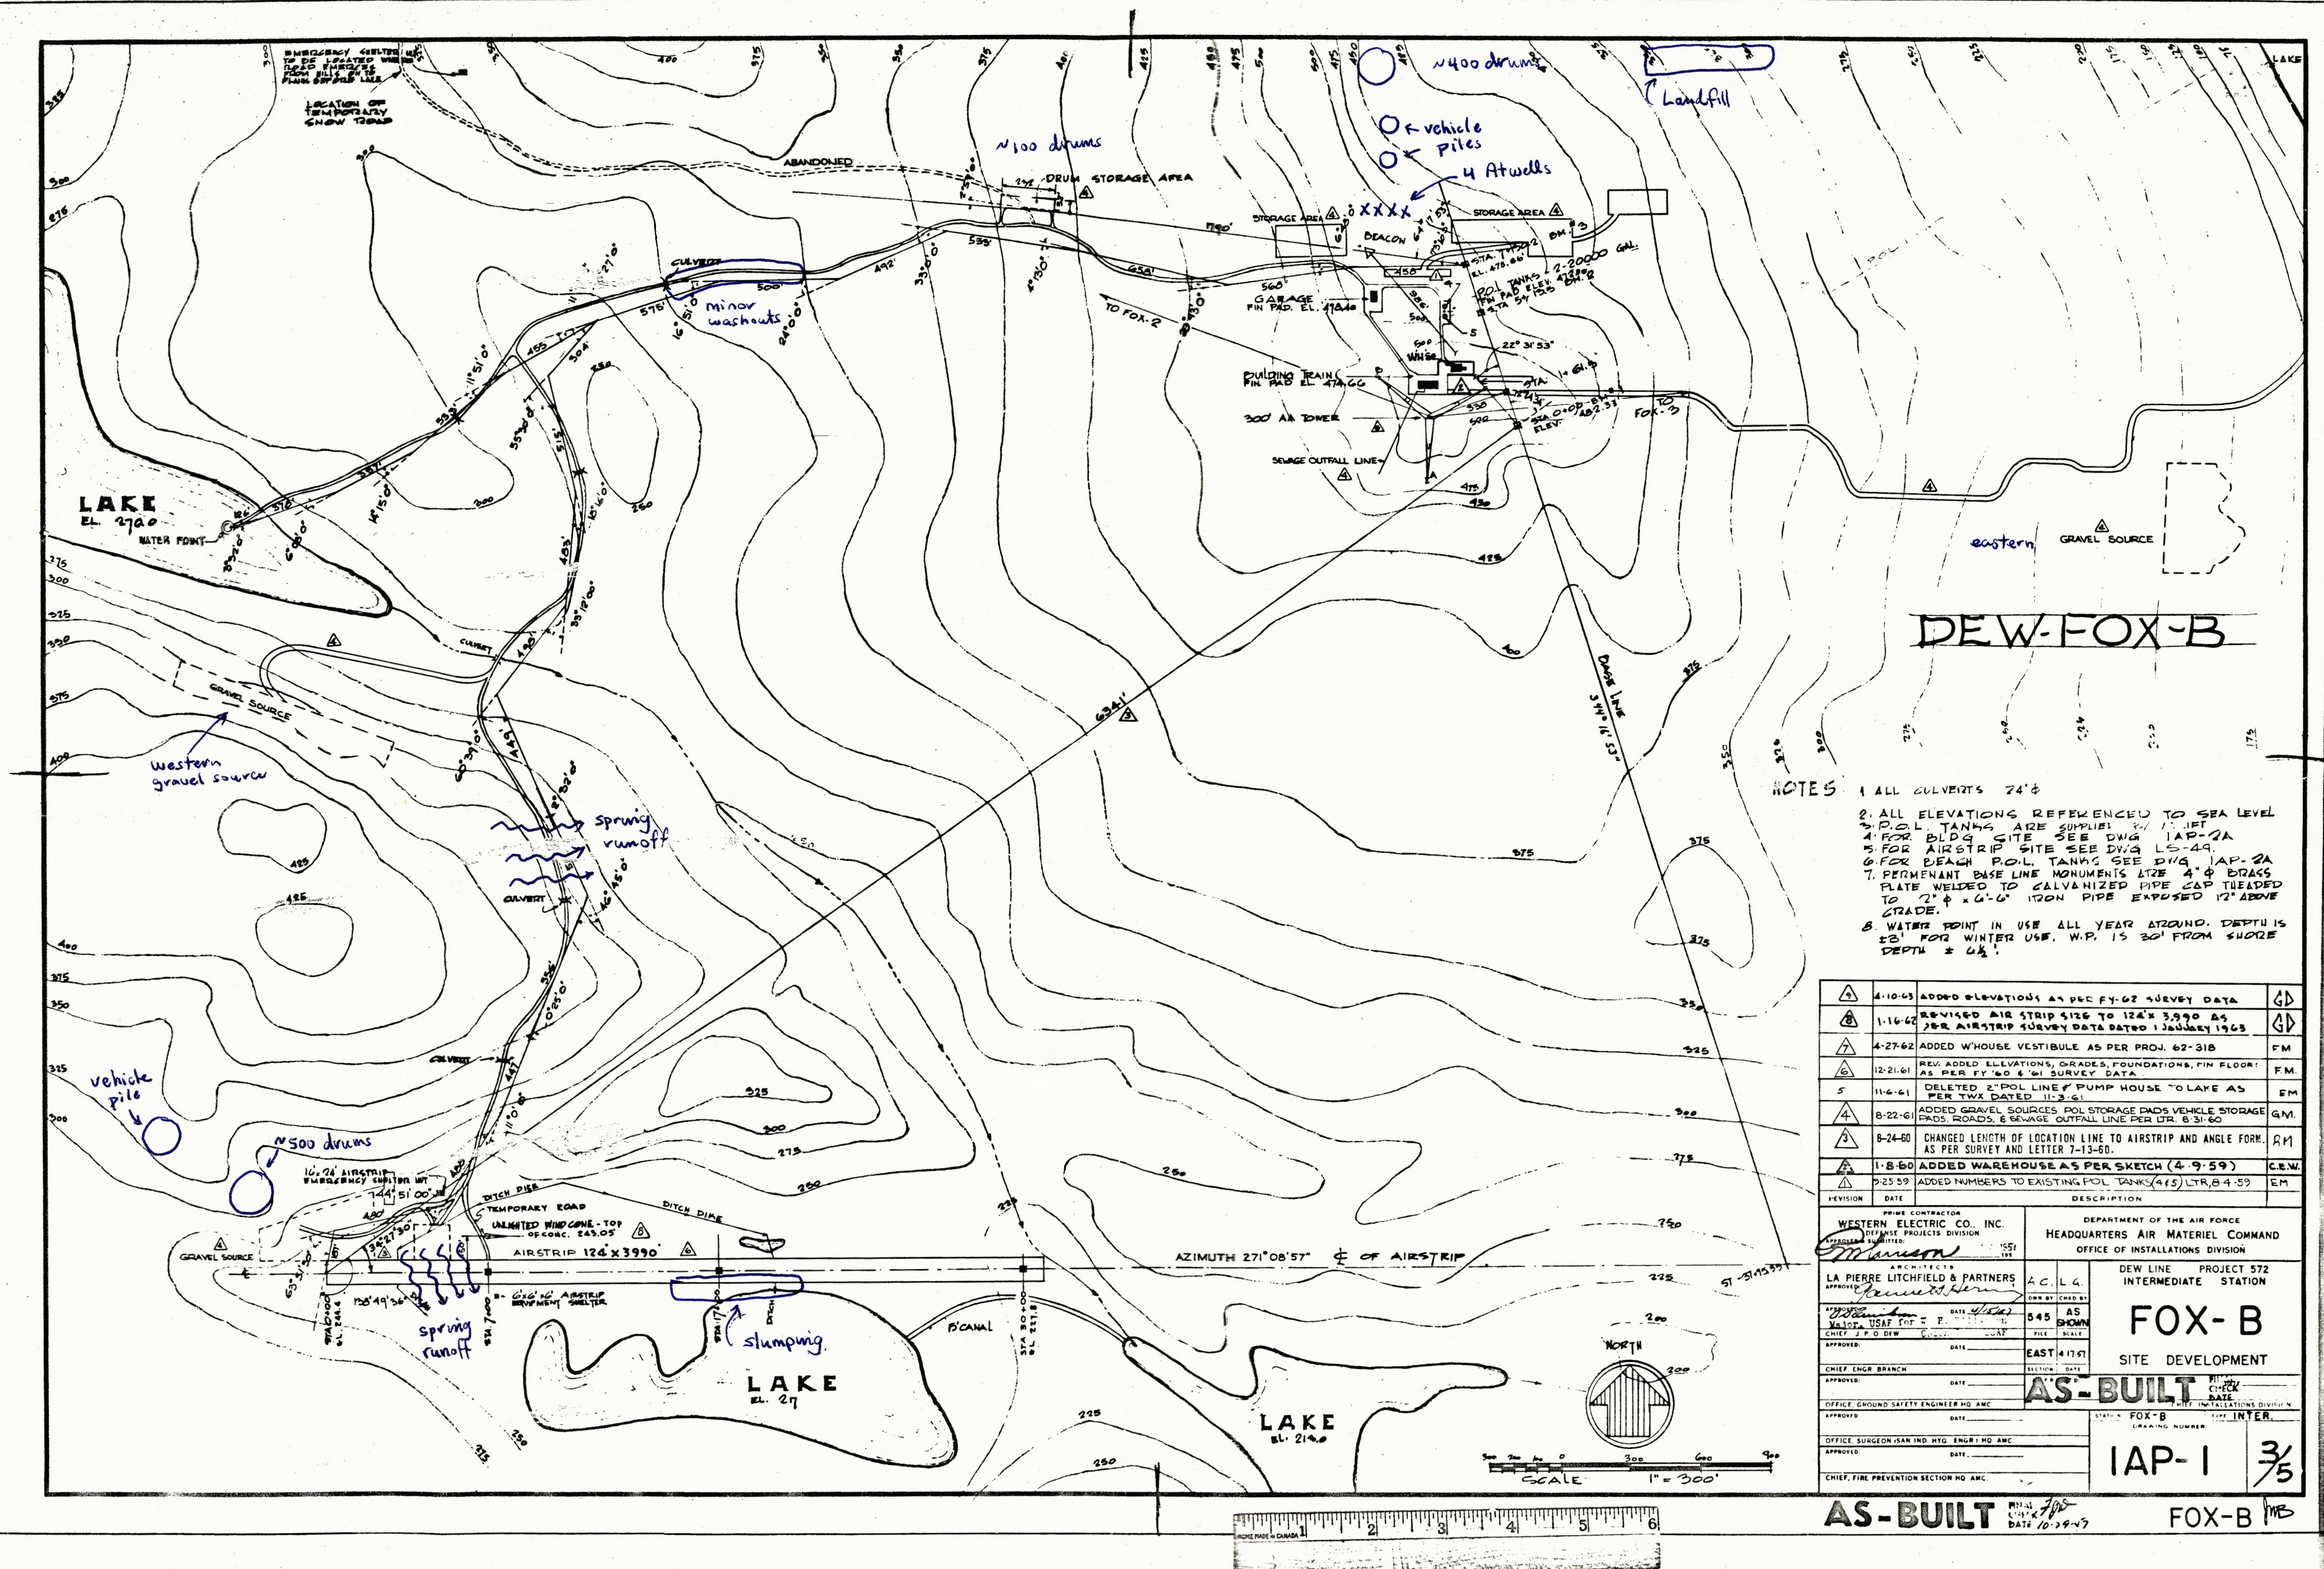
The two POL tanks at the main building site were in excellent condition (Photo 34). Each has a 20,000 gal. capacity. It was estimated that combined they contained approximately 300 gal. at the time of the visit. The pump house between the tanks including the interior equipment was in tact.

Photo 34 - POL Tanks and Pump House
