# AVIATION INVESTIGATION REPORT A15H0002

## **Collision with terrain**

Airbus Industrie A320-211, C-FTJP

Halifax/Stanfield International Airport

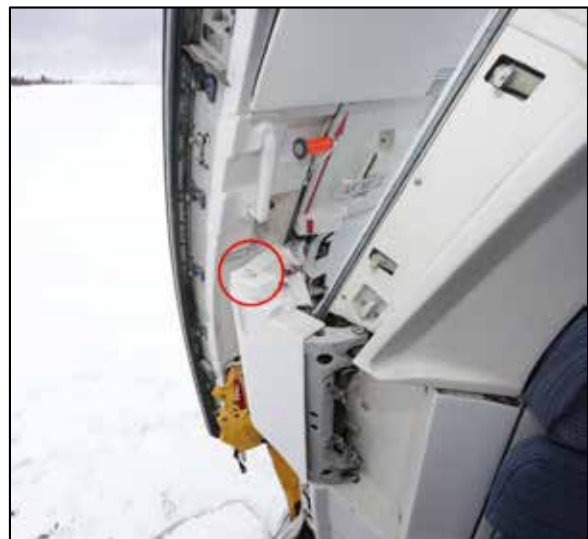
Figure 5. Gust lock release pushbutton (circled) on the L1 door

A vertically oriented pushbutton releases the gust lock when pushed downward. Once the gust lock is released, the door is free to move. The pushbutton to release the L1 door gust lock is located on the door support arm, adjacent to the attendant station (Figure 5).

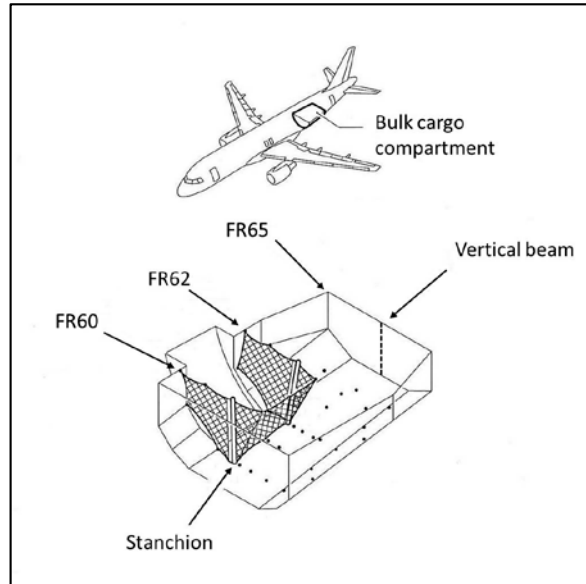
Figure 6. Bulk cargo compartment with aft door nets  
(Source: Airbus Industrie, with TSB annotations)

Door nets are installed forward and aft of the bulk cargo compartment door, at FR60 and FR62. These nets have one-piece stanchions that extend between the cargo compartment floor and ceiling (Figure 6).

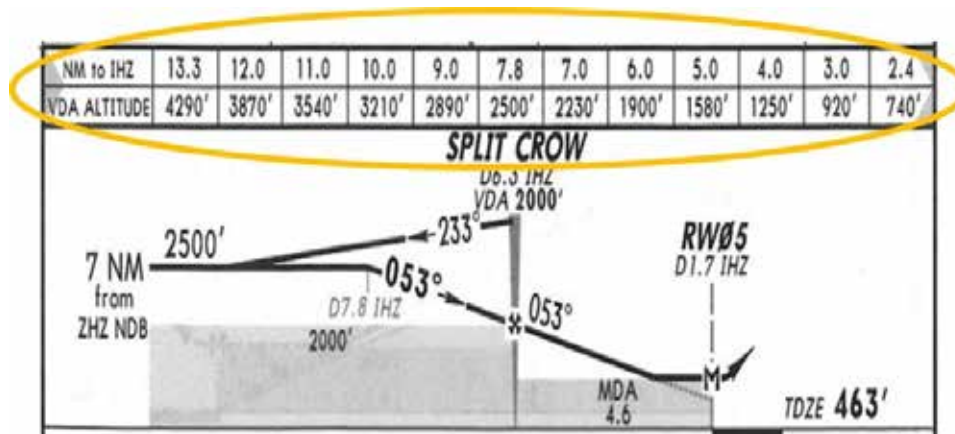
Figure 14. Distance/altitude table for Halifax/Stanfield International Airport (Source: Jeppesen approach chart)

At Air Canada, the use of the distance/altitude table on the Jeppesen chart as a monitoring tool is not cited during pilot training for LOC/non-precision approaches.

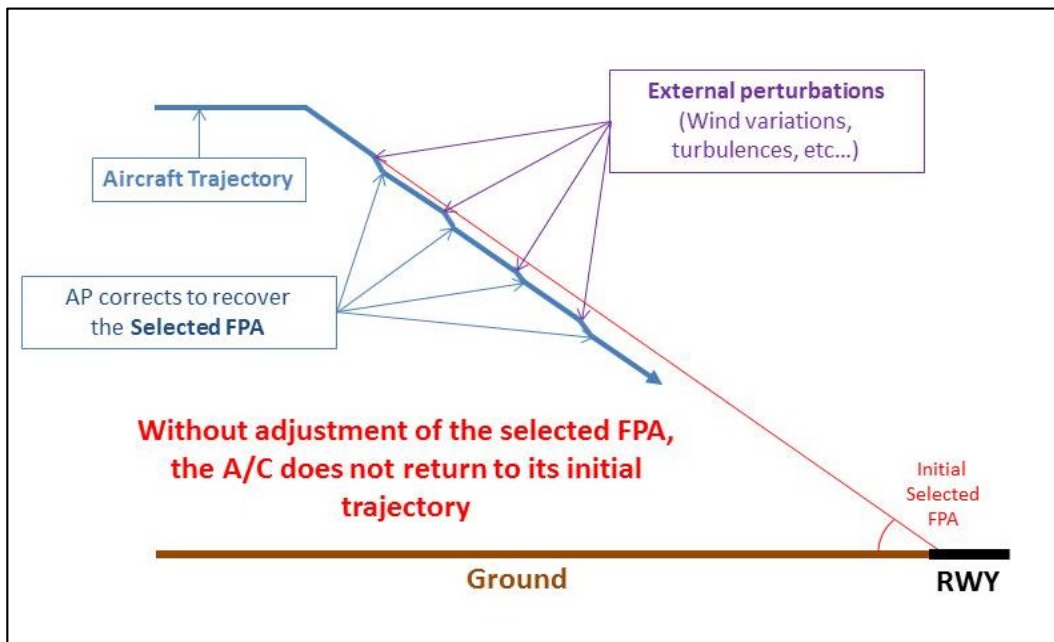
Figure 15. Example of flight profile with flight path angle (FPA) affected by perturbations (Source: Airbus Industrie)

When flying with the FPA guidance mode, external perturbations, such as wind variations or turbulence, can cause the aircraft to move away from the selected FPA initial approach path. If these perturbations result in momentary changes to the aircraft’s vertical trajectory,<sup>81</sup> then the autopilot will recover the selected FPA, effectively paralleling the initial trajectory (Figure 15).

If the perturbations cause the aircraft to move below the initial approach path, then once the autopilot captures the selected FPA, the aircraft will continue to descend, but on a flight path that is below and parallel to the initial approach path. If these perturbations continue throughout the descent and the flight crew makes no adjustments to recover the initial approach path, then the altitude discrepancy between the initial and actual flight paths will continue to increase, resulting in the aircraft flying below the published approach vertical profile. This actual flight path will result in a low indication on the airport's approach slope indicators. A go-around must be initiated unless the flight crew estimates that only small corrections are necessary to rectify minor deviations from stabilized conditions.

The Airbus FCOM does not offer guidance on how to make adjustments to the FPA; for example, it does not indicate how large the adjustment should be or for how long the adjustment should be made in order to return an aircraft to the selected flight path. For a flight in FPA guidance mode, Air Canada's practice was that, once the aircraft was past the FAF, the flight crews were not required to monitor the aircraft's altitude and distance from the threshold, nor to make any adjustments to the FPA.
