# AVIATION INVESTIGATION REPORT

## A15P0217

### **Loss of control during night approach and near collision with terrain**

Sikorsky S-76C+ (helicopter), C-GHHJ

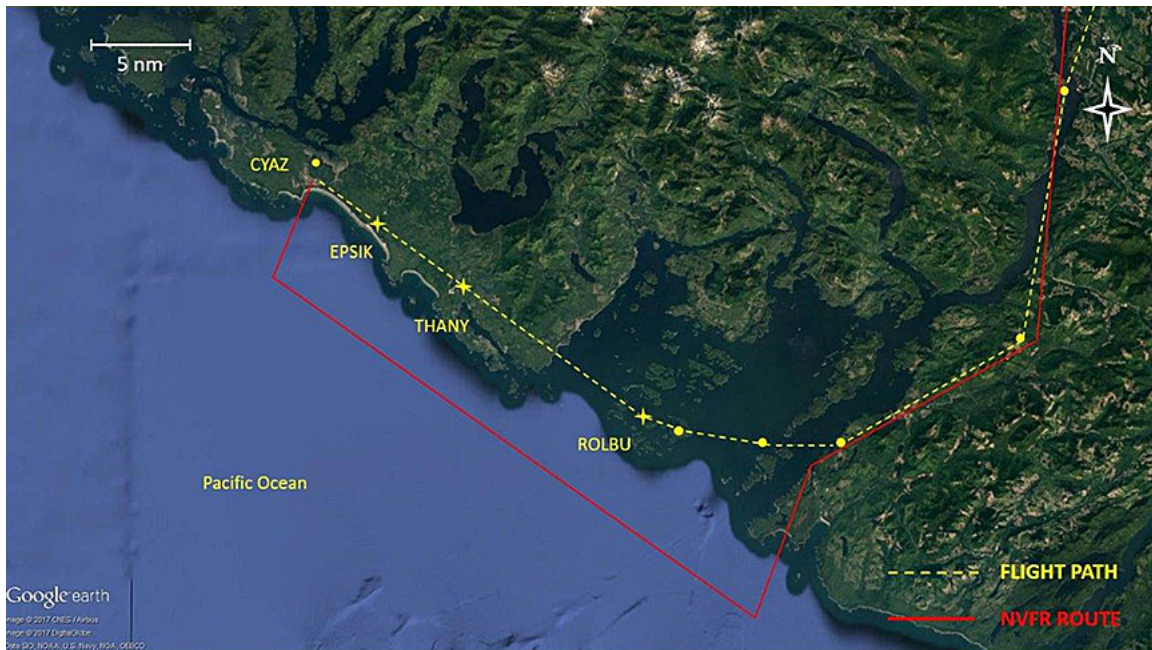
Figure 2. Night visual flight rules route and the helicopter's flight path (Source: Google Earth, with TSB annotations)

At 0232, the PF started to slow the helicopter and began a descent to 900 feet ASL. One minute later, the PM completed the final approach checklist. After crossing waypoint EPSIK (Figure 2) at 0237:06, the helicopter continued to slow and descend, levelling at 620 feet ASL as the PF maintained speed at 85 knots indicated airspeed (KIAS).
