AVIATION INVESTIGATION REPORT

A16A0041

Nose landing gear failure on landing

Beechcraft 1900D, C-FEVA

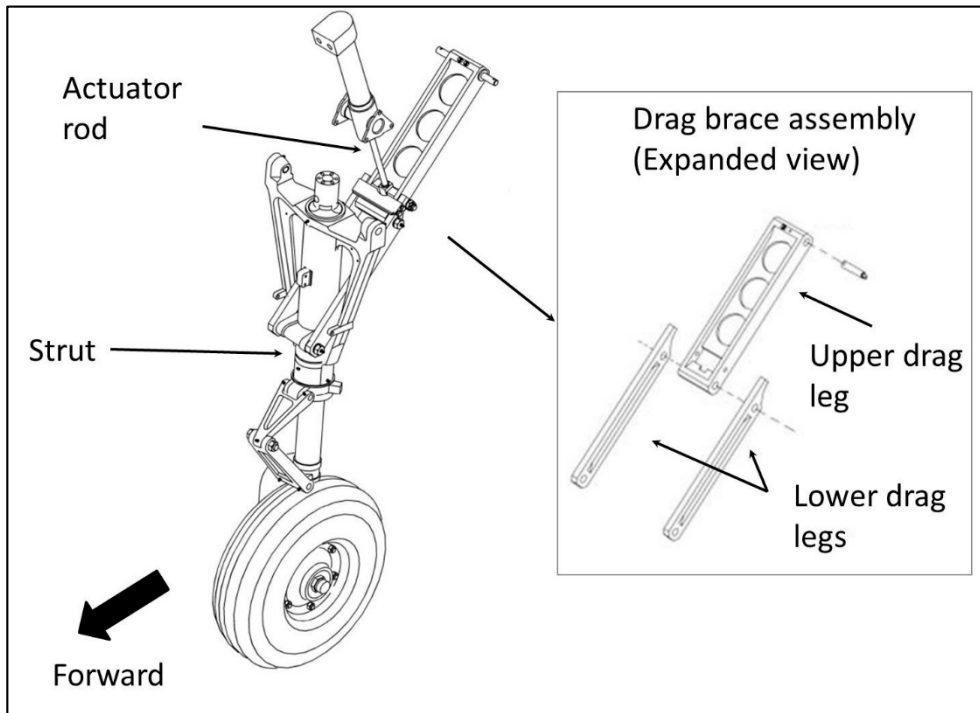
Figure 1. Beechcraft B1900D nose landing gear and expanded view of drag brace assembly
(Source: Textron Aviation, with TSB annotations)

The NLG drag brace assembly, which consists of an upper drag leg and 2 lower drag legs, is installed between the strut and structural components within the wheel well (Figure 1). The actuator is installed between the upper drag leg and structural components within the wheel well. When the actuator is retracted, it causes the drag brace assembly to fold upward, which causes the strut to pivot rearward into the wheel well.

When the NLG is extended, the upper drag leg and the 2 lower drag legs align. The drag brace assembly then acts as a rigid component of the landing gear assembly to take drag forces and keep the strut in position.
