## AVIATION INVESTIGATION REPORT A16W0126

### **Loss of power and collision with trees**

Bell 206B (Helicopter), C-GHHU

Fox Creek Airport, Alberta, 12 nm SW

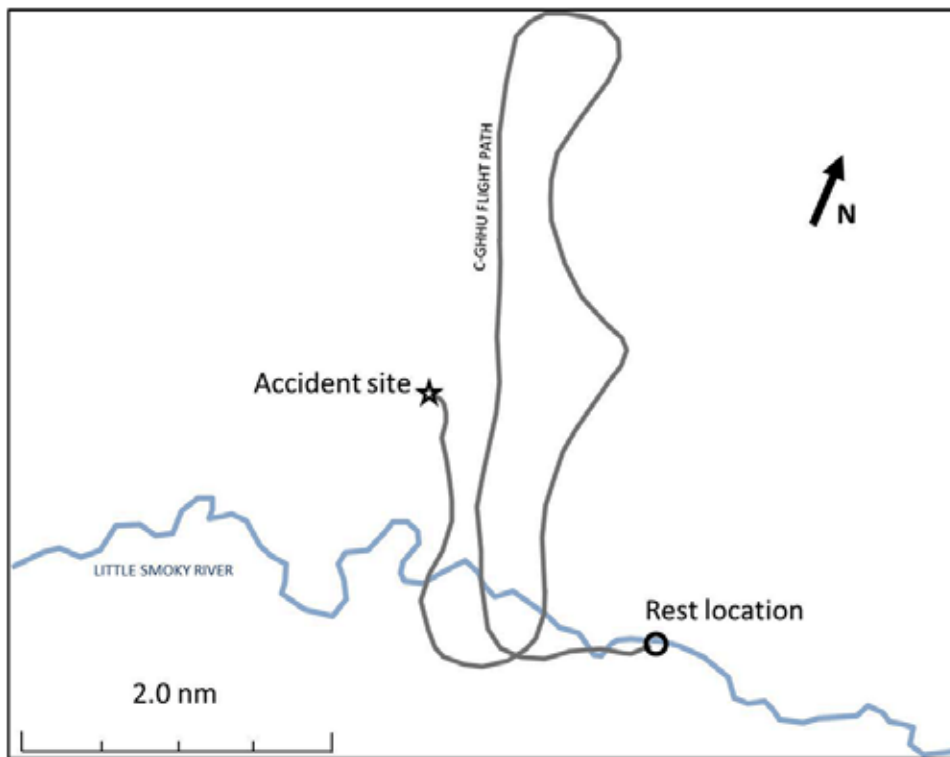
Figure 2. Flight path of C-GHHU from the rest area on Little Smoky River to the accident site

As the helicopter proceeded northbound, 1 of the surveyors identified the line as incorrect and indicated the need to reposition 1 line to the west. The pilot carried out a right turn and flew the helicopter approximately 4 nm south. The pilot then completed another right turn to roll out on the correct survey line (Figure 2). Moments later, at 1520, while flying at 58 mph in a descending left turn, approximately 160 feet above ground level (AGL), C-GHHU lost all engine power. This was immediately followed by a decay in  $N_R$  and a descent. The engine-out and rotor-low-rpm warning horns did not activate, and no warning lights illuminated on the annunciator panel.<sup>6</sup> Within 2 to 3 seconds, the aircraft descended and struck the trees. The heading at the time of impact was 246° magnetic. The helicopter came to rest suspended by the trees that it collided with, in a nose-high position, listing approximately 60° to the left and with its forward section approximately 7 feet above the ground; it did not strike the ground, but the aft portion settled to the ground.
