RAILWAY INVESTIGATION REPORT

R15T0173

Non-main-track runaway, collision and derailment

Canadian National Railway Company

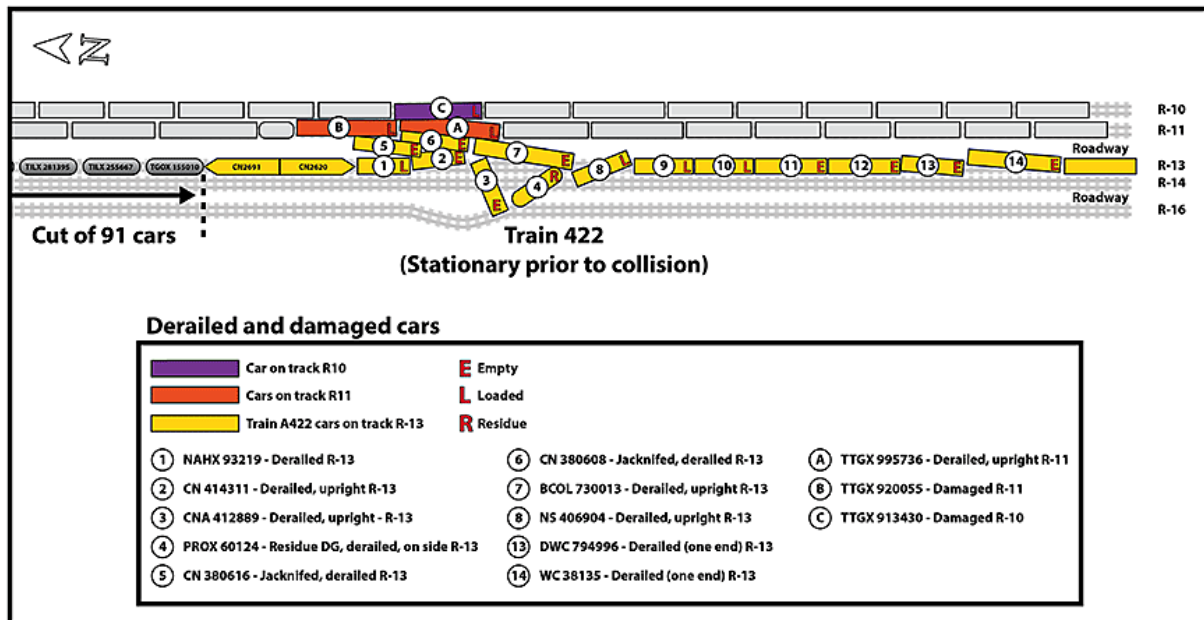
Figure 3. Site diagram

The collision occurred about 5900 feet south of switch 18. The force of the collision shoved both head-end locomotives on train 422 about 350 feet back onto its consist, resulting in the derailment of the 1st to 8th cars and the 13th and 14th cars behind the locomotives. The 3rd car (empty box car CNA 412889) diverged westward across track R-14 and a roadway, and displaced 60 feet of track R-16. The 5th and 6th cars (empty covered hopper cars CN 380616 and CN 380508) jackknifed vertically and then fell eastward and struck 2 loaded multi-level auto carrier cars (TTGX 920055 [damaged] and TTX 995736 [damaged and

derailed]) that were stationary on adjacent track R-11. Multi-level auto carrier car TTGX 913430 on track R-10 was also damaged. Six freight cars were destroyed. Approximately 585 feet (180 m) of track from tracks R-13, R-14 and R-16 was damaged (Figure 3). None of the cars of the uncontrolled cut of cars derailed.

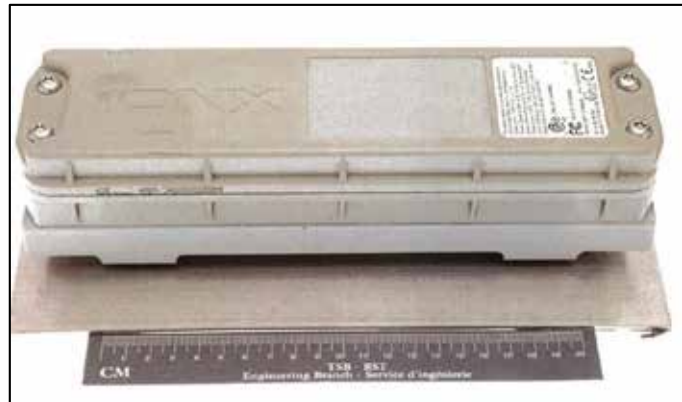
Figure 9. IONX data acquisition unit

Tank car TILX 281395 was also equipped with an IONX data acquisition unit (the unit) telemetry device. The unit was installed on the top centre of the tank near the manway entrance (Figure 9). The unit was recovered and sent to the TSB Engineering Laboratory to extract any available data from the unit in support of the investigation.

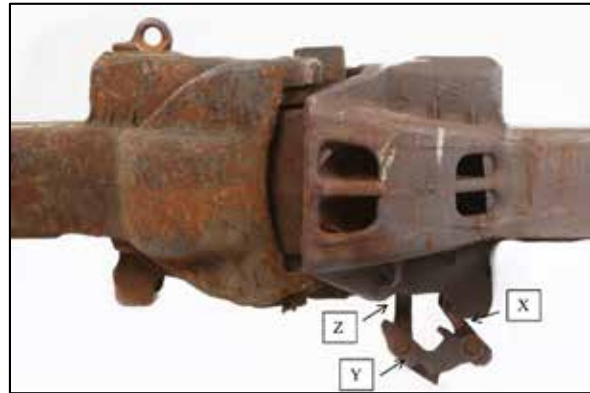
Figure 14. Lock-lift assembly installed detailing toggles X, Y, and Z

The lock-lift assembly consisted of 3 parts: toggle X, toggle Y and toggle Z. Toggle X sits on the trunnion at the bottom of the coupler body (Figure 14). Toggle Z engages with the tail of the locking block. Toggle Y, which couples to toggle X and toggle Z, provides the attachment for the uncoupling lever.

The lock-lift assembly exhibited extensive wear in the toggle joints and rivets when compared to a newer assembly (Figure 15). This extensive wear increased the lateral movement of toggle Z.

Anti-creep protection is provided to prevent unintentional uncoupling. An anti-creep test was performed on the coupler assembly in accordance with the AAR guidelines. The anti-creep protection functioned as intended. However, when closing the knuckle, the toggle Z pin of the lock-lift assembly occasionally jammed in the locking block hole, preventing the block from dropping into place (Figure 16).

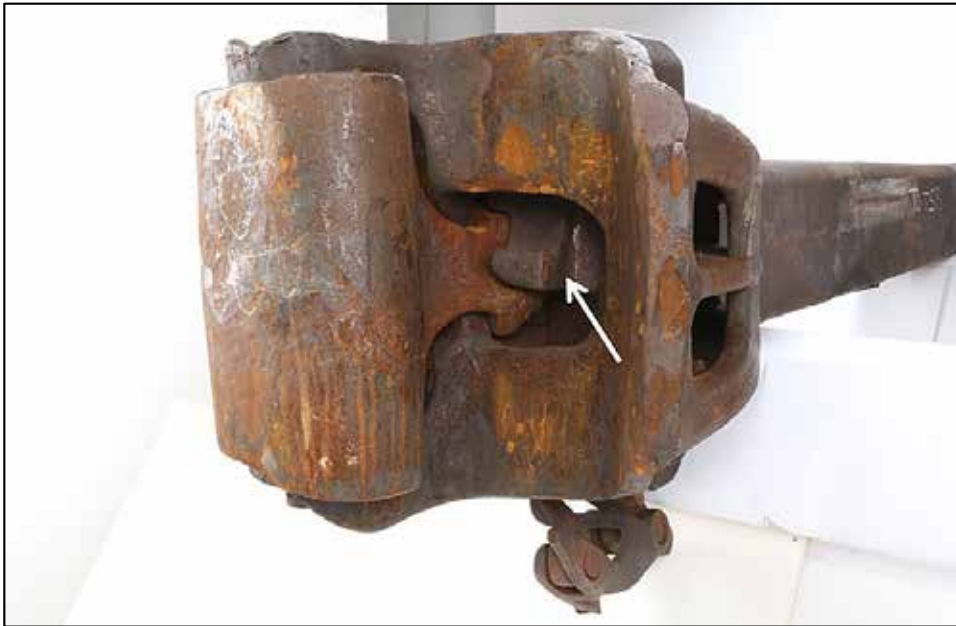
Figure 18. Locking block fully engaged

When the toggle Z pin of the lock-lift assembly jammed in the locking block hole, the locking block only partially engaged with the tail of the knuckle (Figure 17 and Figure 18).

Since the uncoupling lever hangs on 1 side of toggle Y, a side load is created in the lock-lift assembly during operation. Toggle Z displayed wear on the side and middle of the end pin that is inserted in the locking block hole in the tail of the block. The observed wear on the end pin of toggle Z was consistent with its interaction with the locking block hole and misalignment due to excessive lateral movement of the lock-lift assembly.
