RAILWAY INVESTIGATION REPORT

R16D0092

Crossing collision

VIA Rail Canada Inc.

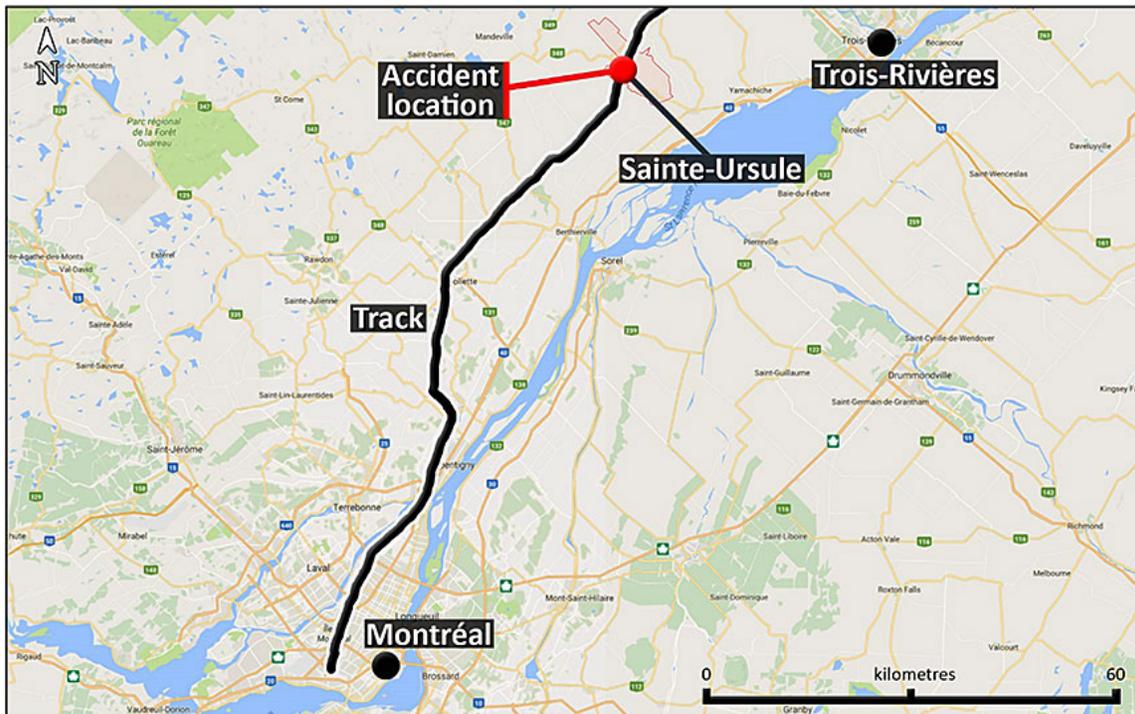
Figure 1. Accident site (Source: Google Maps, with TSB annotations)

At approximately 1605, the train was travelling southward at 60 mph while approaching the Highway 348 crossing, at Mile 75.34 of CN’s Joliette Subdivision (Figure 1). When the train was approximately 2000 feet from the crossing, the crossing warning system was activated. The bell, flashing lights, and gates worked as intended. The OLE sounded the horn, as per existing regulations. The locomotive headlights were turned on bright, the ditch lights were illuminated, and the bell was activated.

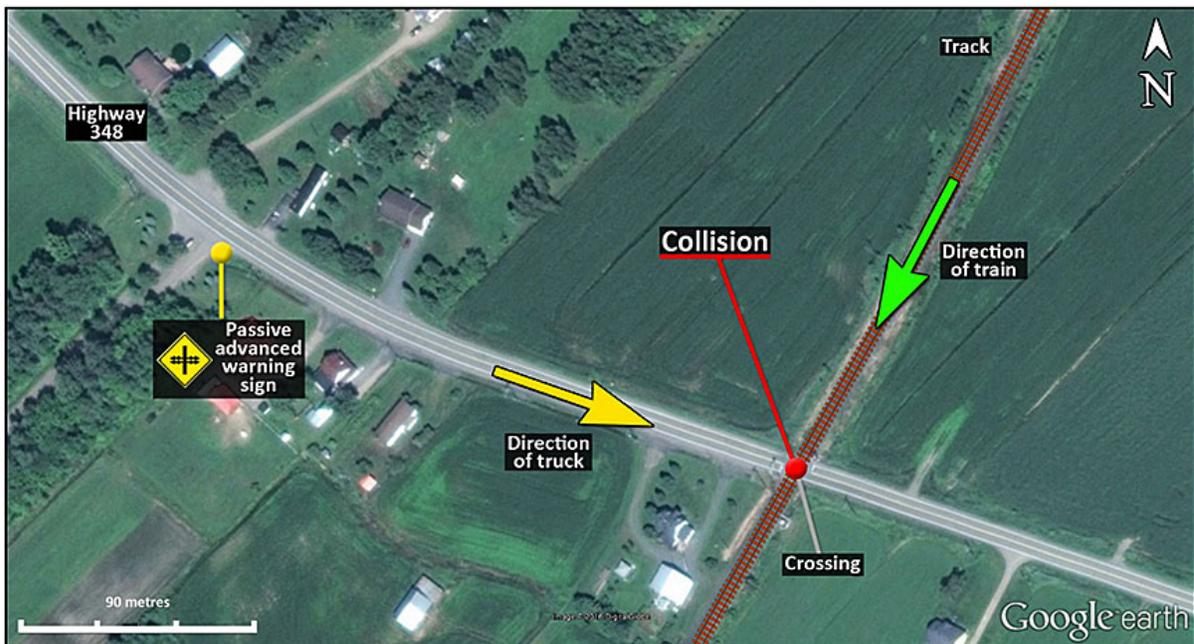
Figure 2. Plan view of the area (Source: Google Earth, with TSB annotations)

At the railway crossing, at Mile 75.34 of the Joliette Subdivision, the speed limit on Highway 348 is 90 km/h. At the crossing, the road is perpendicular to the railway track. Drivers coming from the west must negotiate a left-hand curve that ends approximately 500 feet from the crossing. From the beginning of the curve up to the crossing, the lane separation lines painted on the roadway were in good condition and indicated a no-passing zone. In the curve, approximately 730 feet from the crossing, there was a passive advanced crossing warning road sign (Figure 2). No fresh braking marks were observed on the road surface between the advanced sign and the crossing.

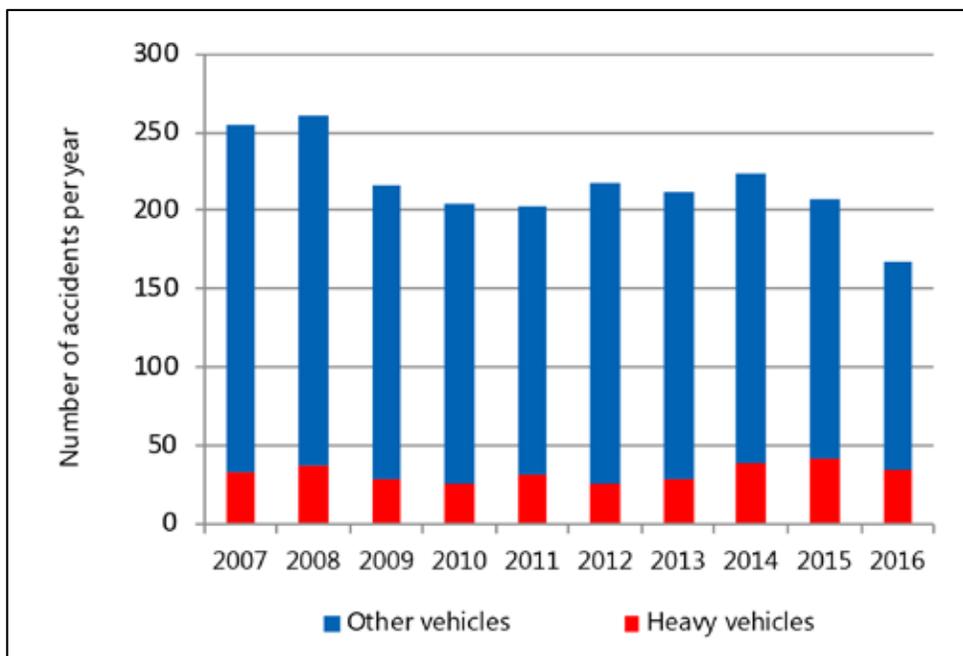
Figure 10. Crossing accidents by vehicle type, 2007–2016

A search in the TSB database determined that, for the 10-year period between 2007 and 2016, there have been 1842 crossing accidents, 325 involved heavy vehicles. The yearly average has remained relatively stable between 2009 and 2014. The number of accidents has decreased since 2014 (Figure 10).
