# MARINE INVESTIGATION REPORT

## M15P0286

### **Capsizing and loss of life**

Fishing vessel *Caledonian*

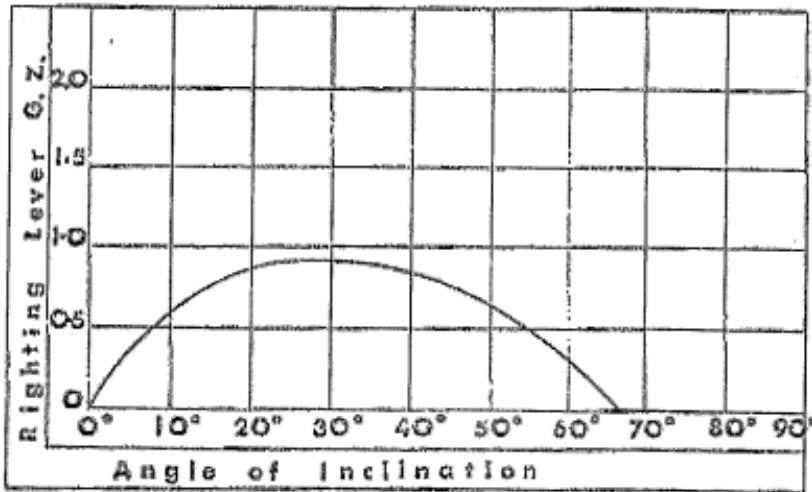
Free Surface	0.32	ft.
K.G. corrected	11.28	ft.
G.M. corrected	3.63	ft.

Angle	10°	20°	30°	45°	60°	75°	90°
Sin $\ominus$	.1737	.342	.5	.6428	.866	.9639	1.00
K N sin $\ominus$	2.56	4.73	6.66	8.75	10.10	10.67	
K $\ominus_c$ sin $\ominus$	1.95	3.86	5.64	7.98	9.77	10.90	
$\ominus$ Z	0.60	0.87	0.91	0.77	0.33	-0.23
