MARINE INVESTIGATION REPORT M16P0162

Collision and sinking

Tugs Albern and C.T. Titan

24 May 2016

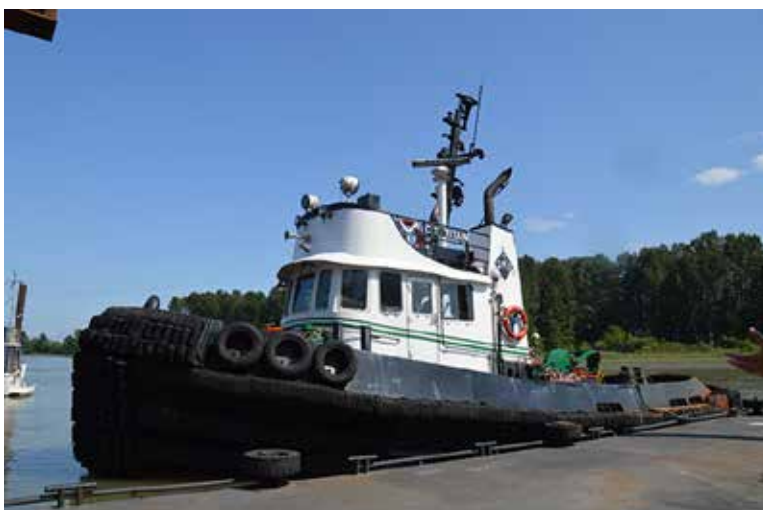
Figure 2. The tug *C.T. Titan*

The *C.T. Titan* is a twin-screw, steel-hulled, pointed bow tug with a rounded stern (Figure 2). The main deck forward of the wheelhouse has a bulwark, and the bow has fenders to protect it during operations such as pushing and log yarding.

The *C.T. Titan* sustained damage to the outer shell plate of its starboard keel cooler. The damage was repaired at a commercial shipyard following the occurrence, and the *C.T. Titan* returned to service on 12 August 2016.

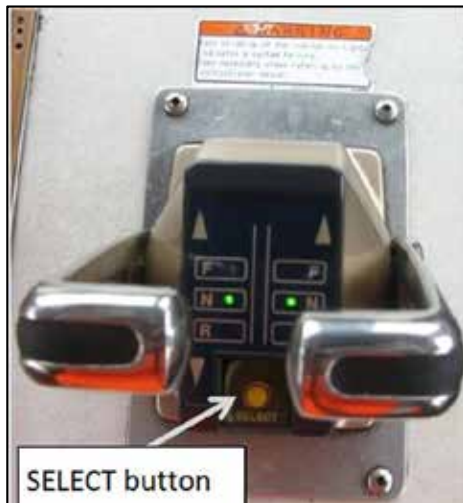
Figure 6. Hand levers on the C.T. *Titan's* propulsion control unit

The *C.T. Titan* has 3 identical propulsion control units, located in the wheelhouse (Figure 5), on the flying bridge, and near the towing winch. Each unit has a hand steering wheel and a jog, and 2 hand levers (Figure 6) that control the port and starboard main engines' revolutions and the propeller shafts' rotational direction individually.

Vessel propulsion can be controlled from only one station at a time.¹⁵ At the station where control is to be transferred, the operator sets the propulsion control levers to neutral (0°) and depresses the yellow SELECT button momentarily. The 2 green neutral (N) lamps illuminate continuously to indicate that the control transfer was successful (Figure 6).

To transfer propulsion control to another control station while the vessel is in gear, the operator goes to the other control station, sets the hand levers to neutral, and depresses the SELECT button. The 2 green neutral (N) lamps illuminate continuously to indicate that the control transfer was successful (Figure 6).

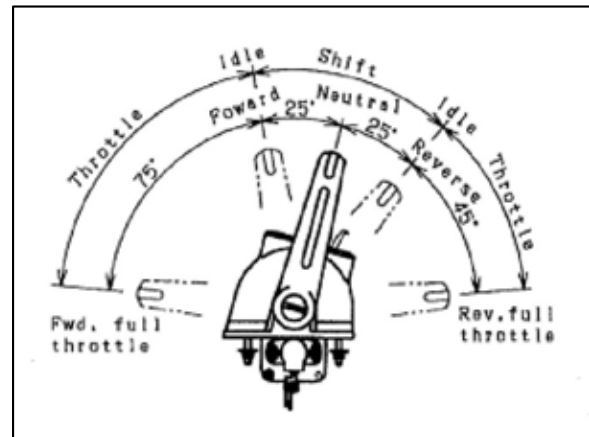
Figure 7. Side view of the propulsion control unit (Source: KE-4a Electronic Control System Instruction Manual)

When the hand levers are positioned between 0° and 25° in either forward or reverse, the vessel is in a neutral idling position (Figure 7). Notches at the 0° and 25° positions provide tactile feedback to help the operator locate these positions by touch when using the hand levers. Green lamps beside the neutral (N) indicator on the propulsion control unit light up when the propulsion control is successfully transferred to another propulsion control unit with the hand levers at the neutral position (0°). Moving the active control station hand levers beyond 25° in either forward or reverse will shift the engines to the corresponding throttle position, and the vessel will accelerate accordingly. Orange lamps beside the forward (F) and reverse (R) indicators on the propulsion control unit will illuminate to indicate that the vessel is in forward or reverse gear and is moving either ahead or astern.
