APPENDIX 3 TO MAIN REPORT

STUDY OF APPLE HILL
ENERGY EFFICIENT HOMES

TASK D - THERMOGRAPHIC SCANNING

FEBRUARY 1984

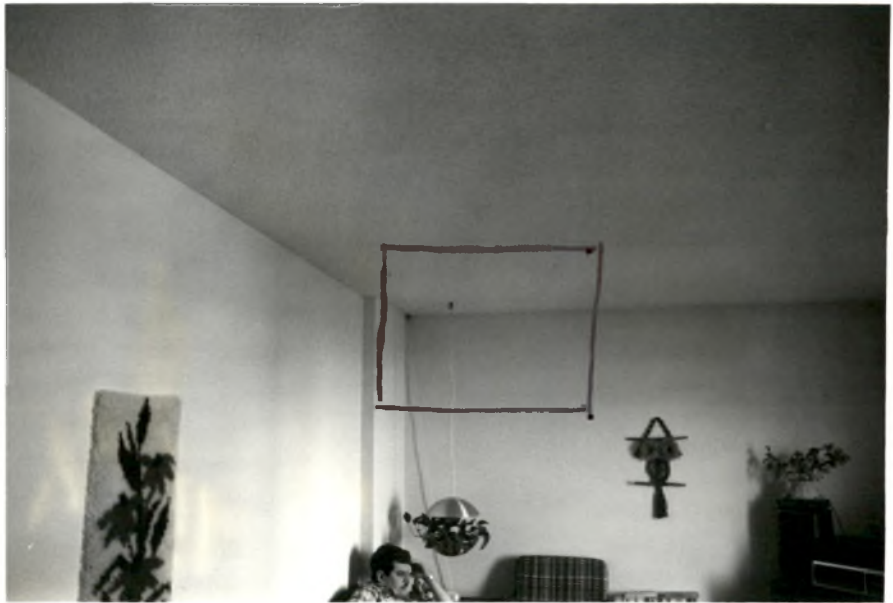
Poor A/V barrier
where inside wall meets
outside wall causing
Air leakage across
ceiling

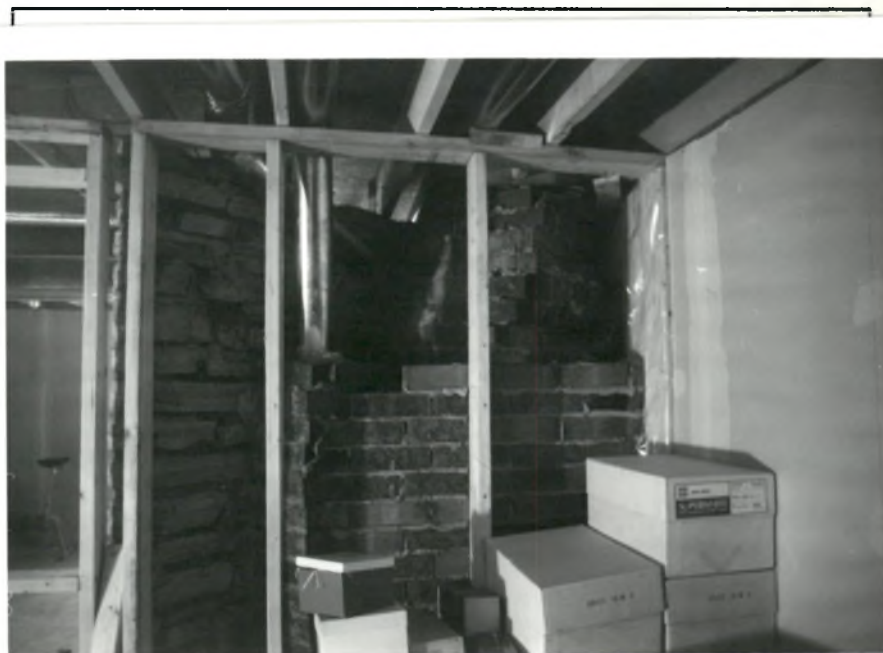
air leakage at
back of fireplace

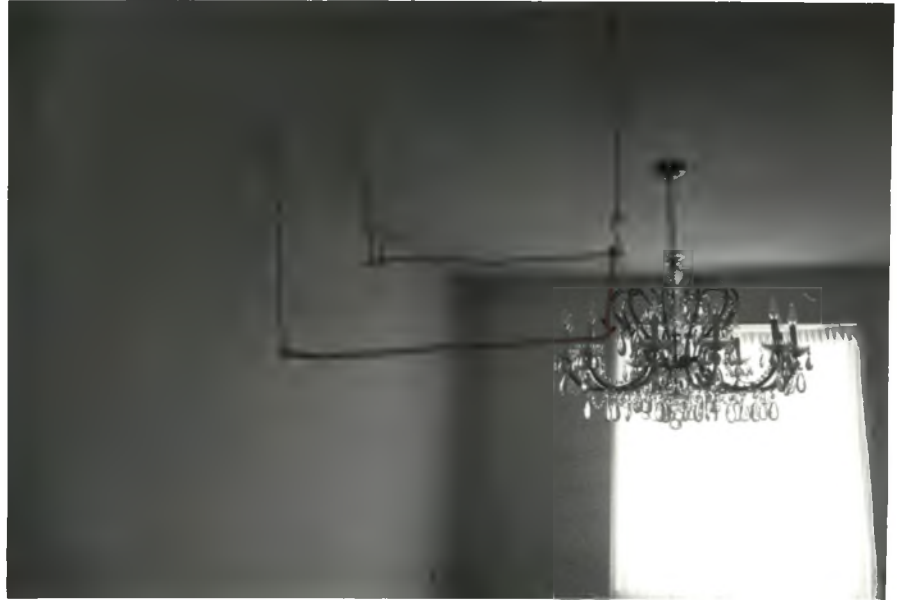
DINING ROOM -
NORTH

Air leakage through
uninsulated ceiling
space.

poor A/W barrier
at plate and
header of 2nd floor

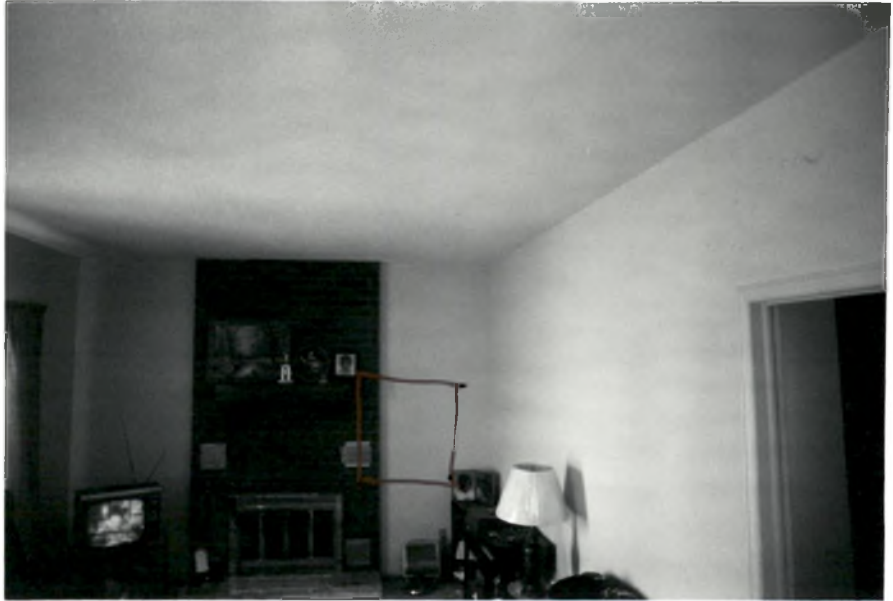
FIREPLACE - EAST
WALL

Air leakage @
fireplace/wall joint.

Inadequate seal
