FIELD MONITORING OF CELLULOSE
IN WALLS - EDMONTON

Prepared for:

Canada Mortgage and Housing Corporation
Project Implementation Division
682 Montreal Road
Ottawa, Ontario
K1A 0P7

January 8, 1990

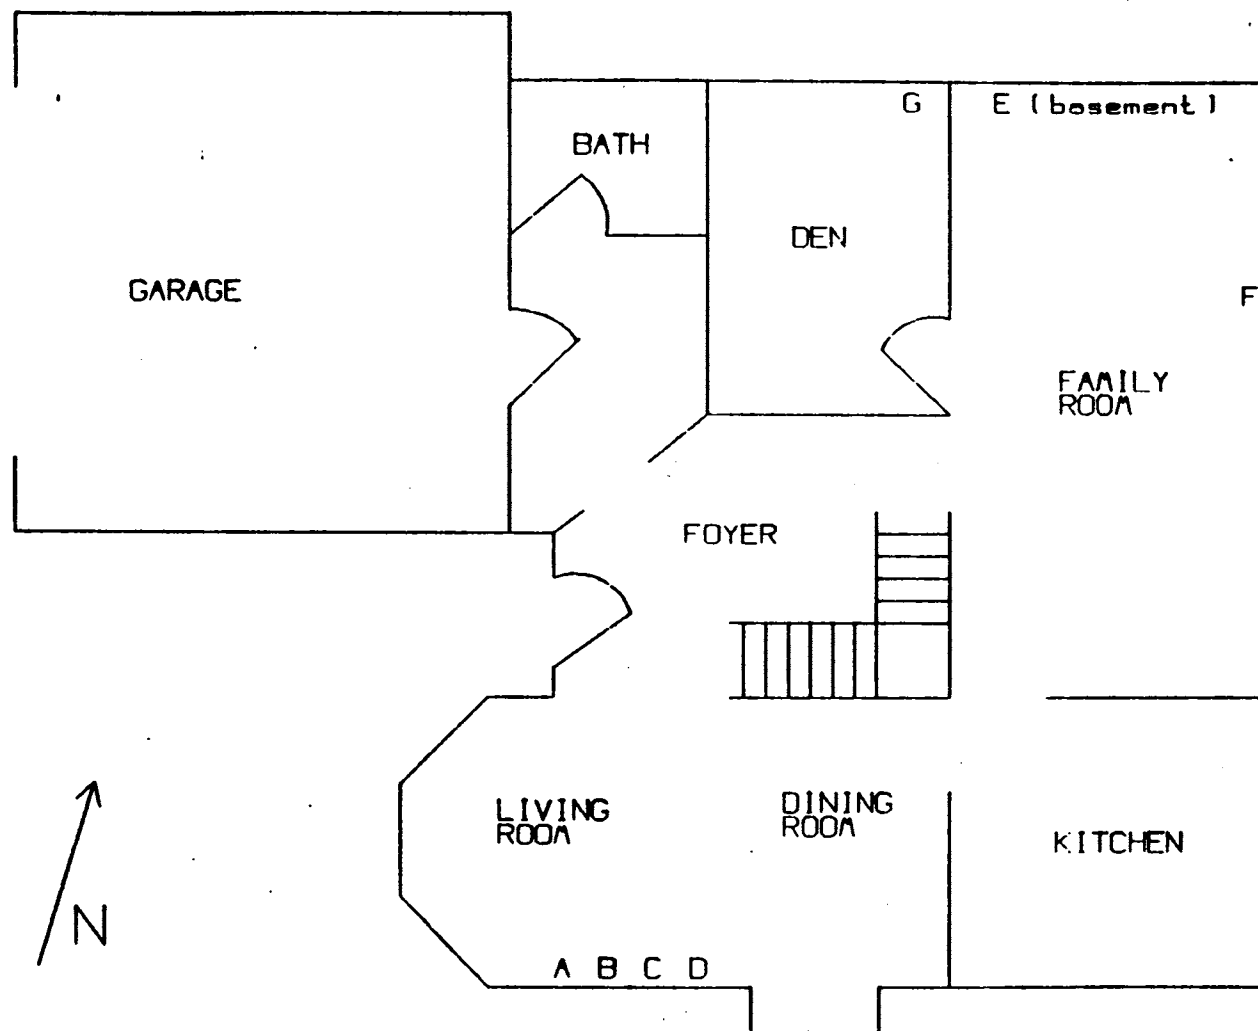
FIGURE 1 - MAIN FLOOR PLAN
SENSOR LOCATIONS

The test house was a typical Alberta residential home constructed of typical wood framed materials and techniques and occupied by a family. It was located in Sherwood Park, Alberta, approximately 20 kilometers east of downtown Edmonton. It was a two-storey, single-detached home, facing west of north west in a residential neighborhood. Single floor area was approximately 130 square meters, as illustrated in Figure 1.

Monitoring locations were established in seven different wall sections or orientations to determine their effect on the drying characteristics of walls. Test sections chosen were those least affected by windows, appliances, interior furnishings and wiring. Wall sections, sensor numbers and locations are summarized by Table 1 and illustrated in Figures 1 and 2.

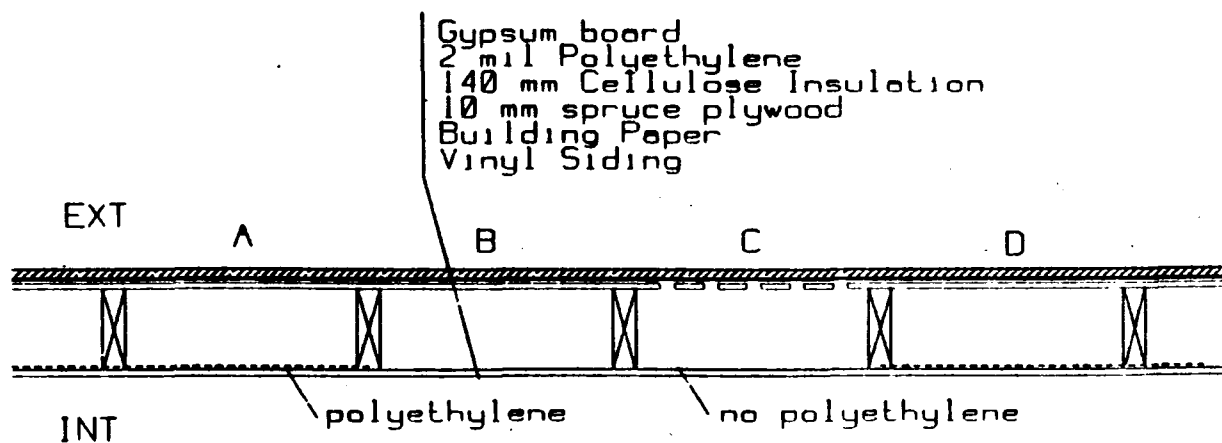
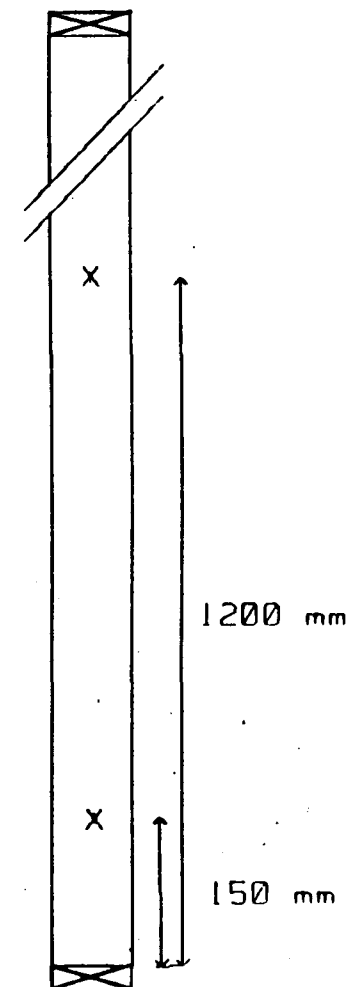
FIGURE 2 - WALL SECTIONS

Wall Sections A, B, C and D were located on adjacent stud cavities of the south wall. The south wall was chosen for detailed comparisons between varied construction techniques, while subjected to similar interior and exterior conditions. Removal of the polyethylene was evaluated in Sections B and C. Section C represented maximum possible ventilation through the exterior wall. Section D represented a tightly sealed cavity with minimum potential for moisture removal. Sections E and F were of standard construction techniques, providing a comparison between east and north facing walls. Section G monitored the basement stud walls.

- Section A - standard construction
- Section B - standard construction without polyethylene
- Section C - standard construction without polyethylene with 7x25 mm vent holes top and bottom
- Section D - standard construction gaps in cavity sealed

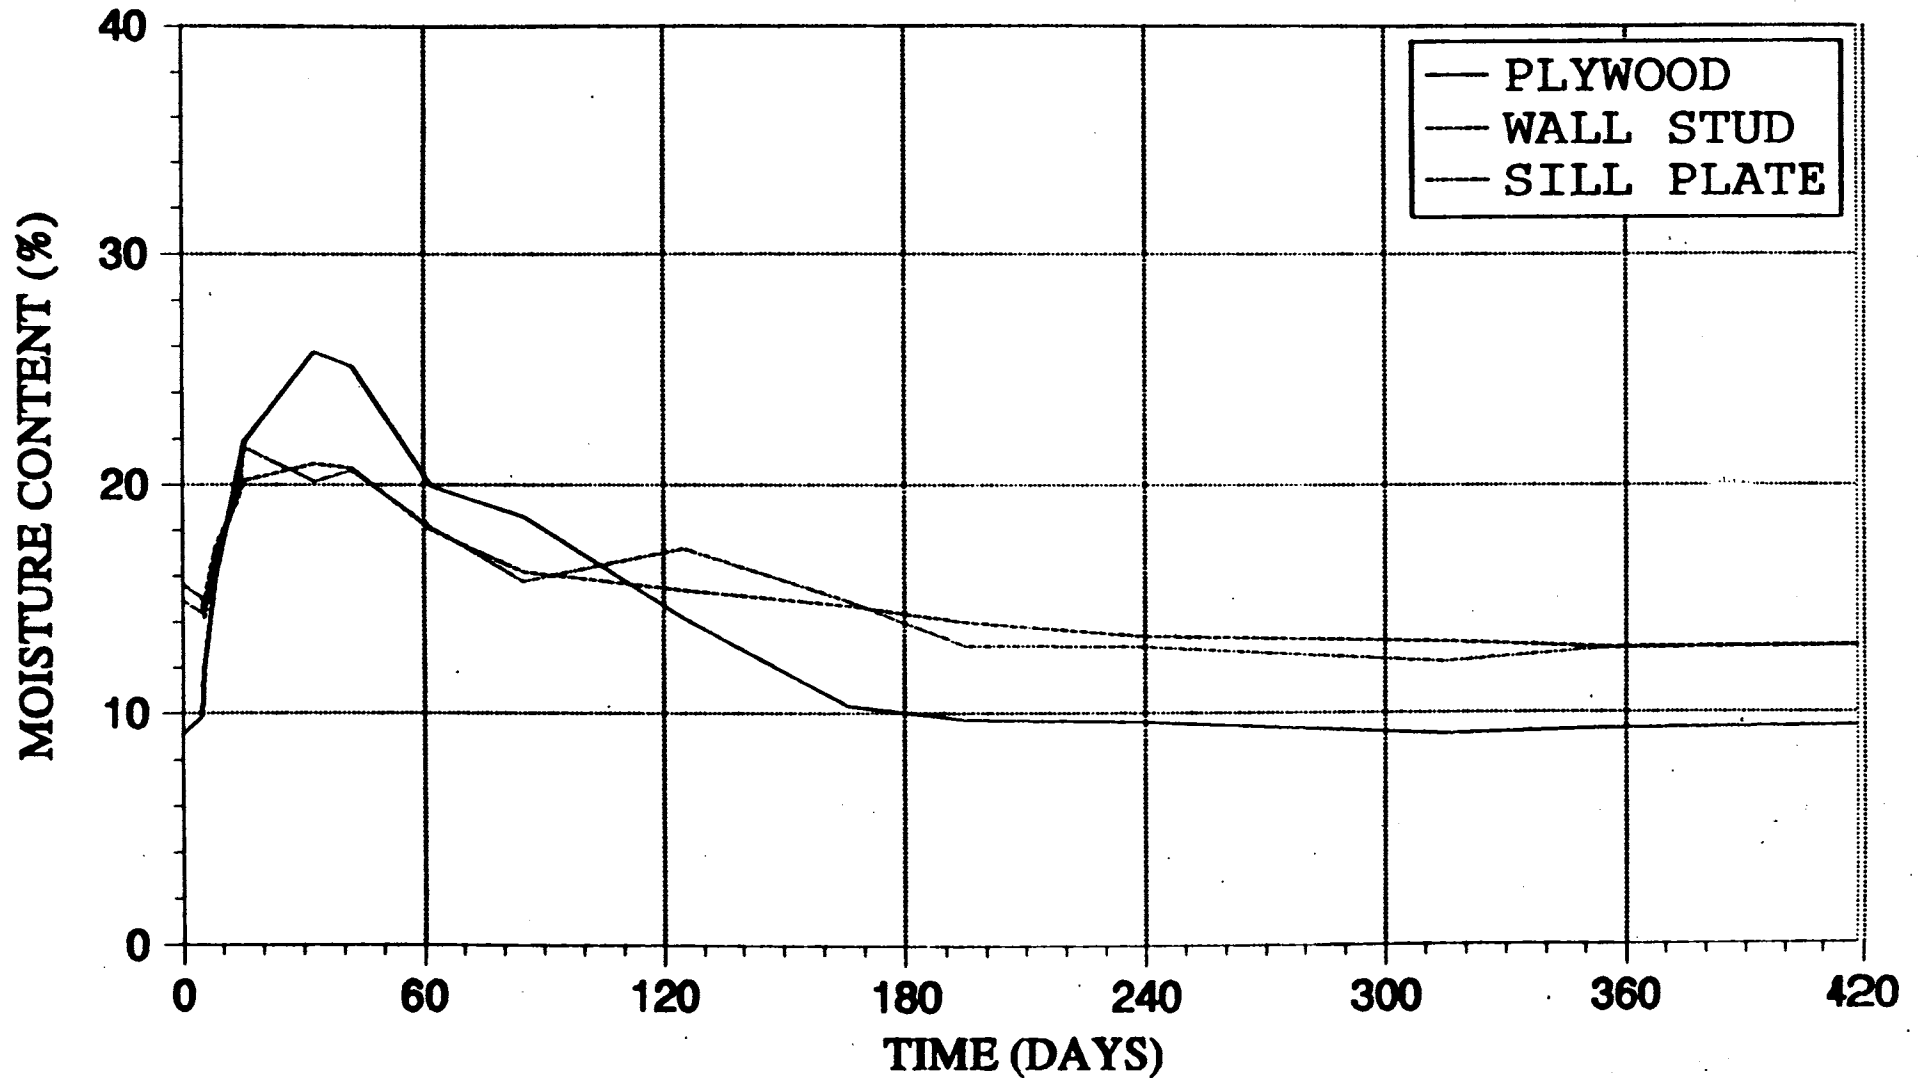
FIGURE 5
SECTION "A" - STANDARD WALL CONSTRUCTION
AVERAGED DATA

Figure 5: Section A - South Wall - Standard Construction.

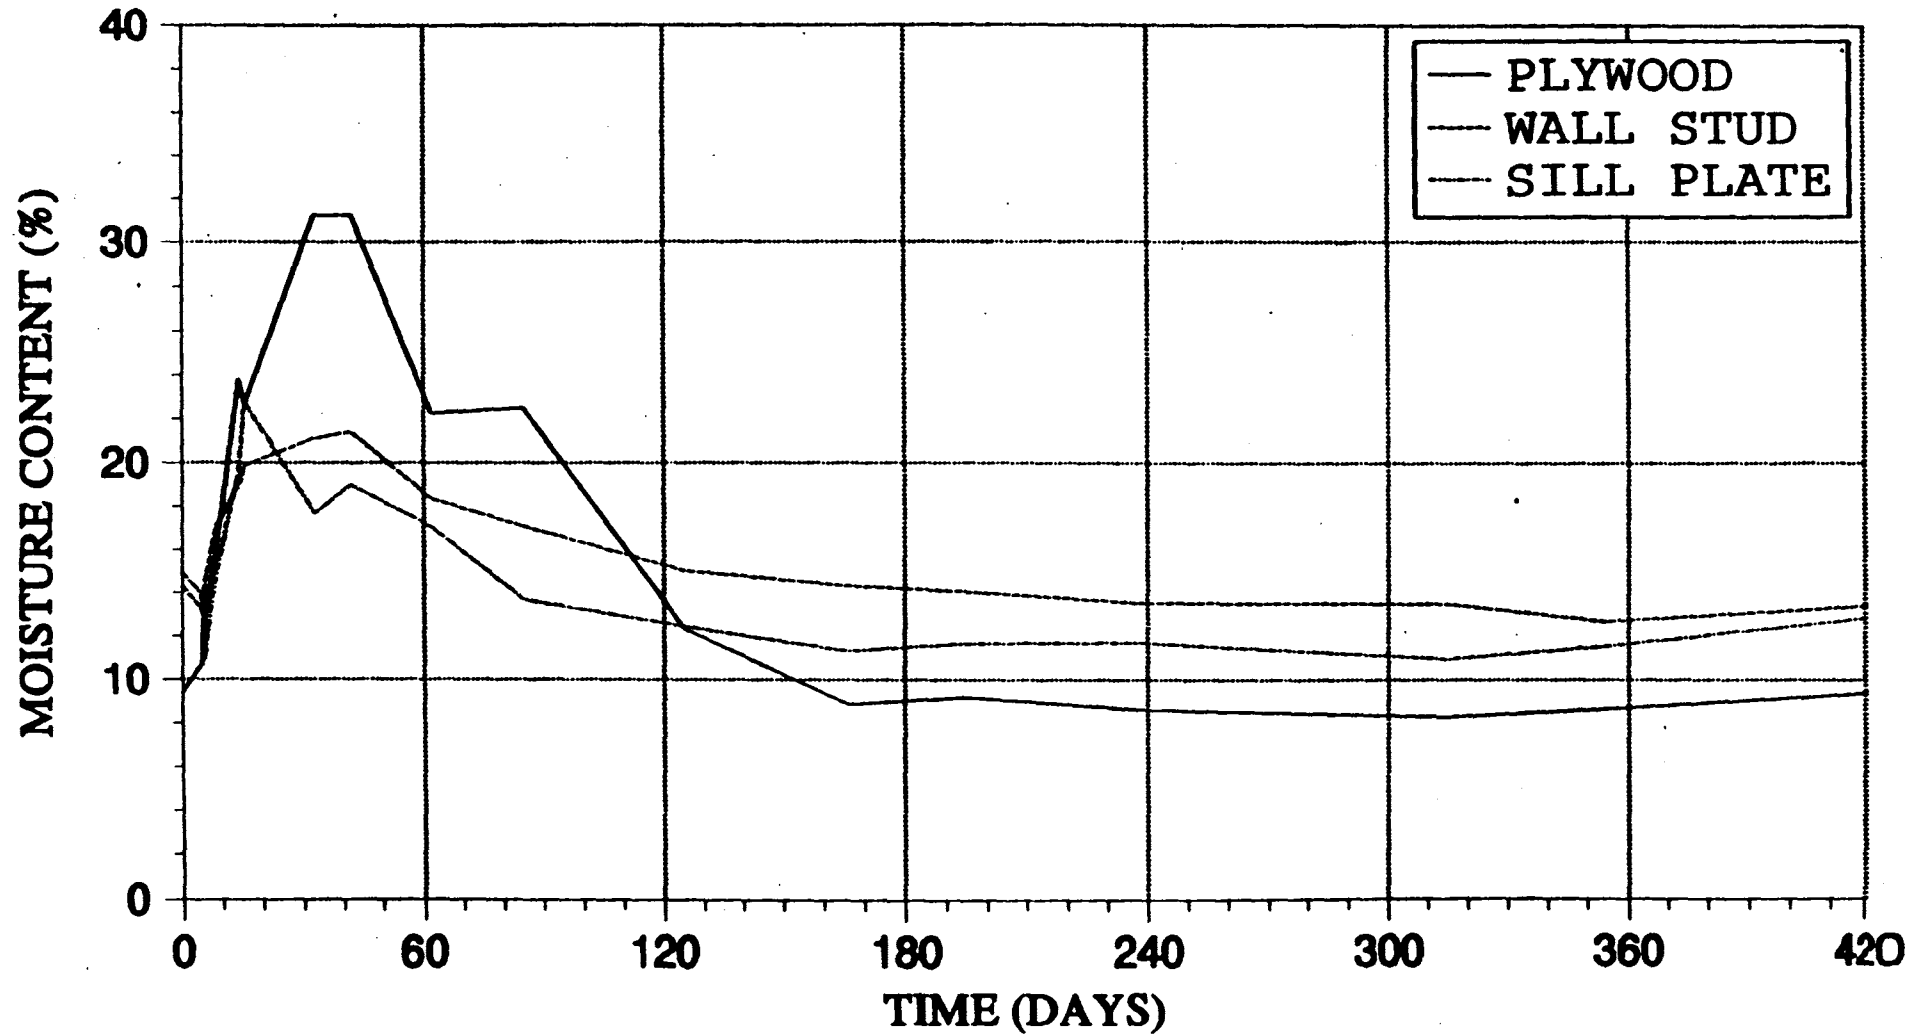
FIGURE 6
SECTION "B" - SOUTH WALL
POLYETHYLENE NOT INSTALLED

Figure 6: Section B - South Wall - Polyethylene not installed.

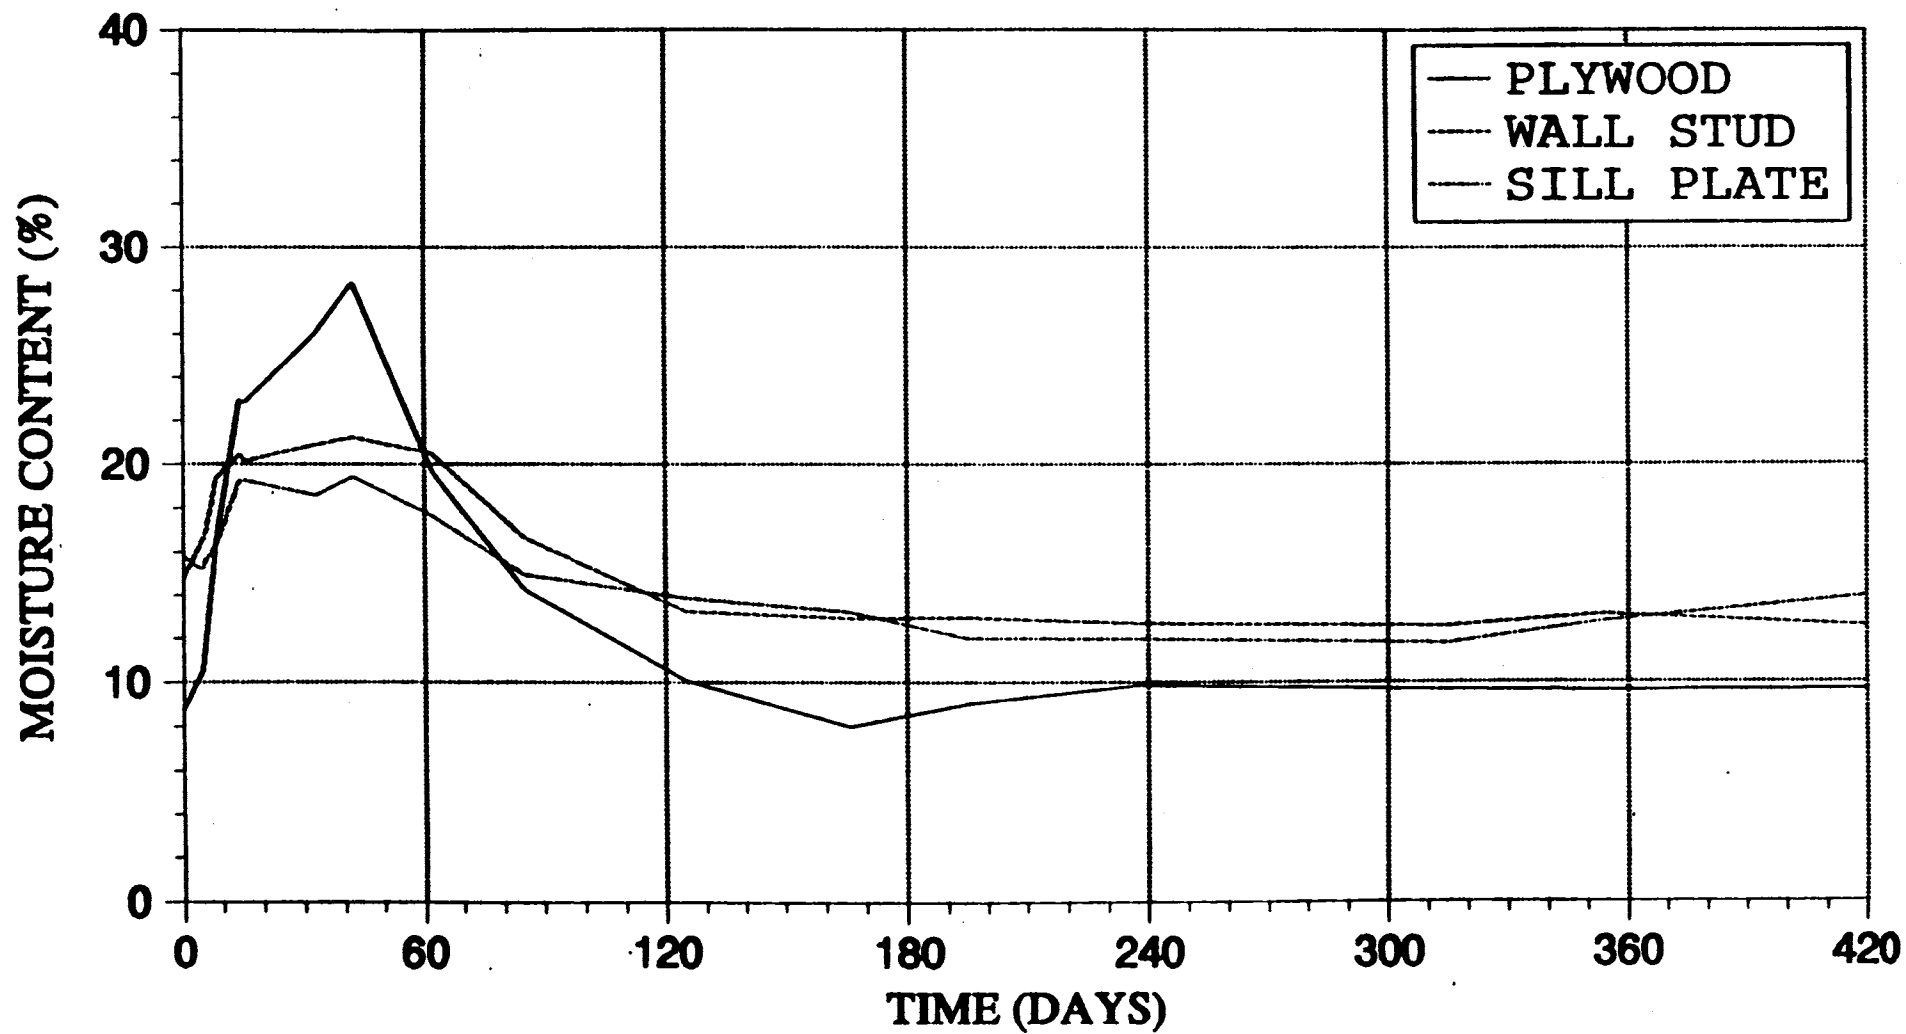
FIGURE 7
SECTION "C" - SOUTH WALL
POLYETHYLENE NOT INSTALLED - VENTILATED

Figure 7: Section C - South Wall - Polyethylene not installed and ventilation holes drilled through sheathing.

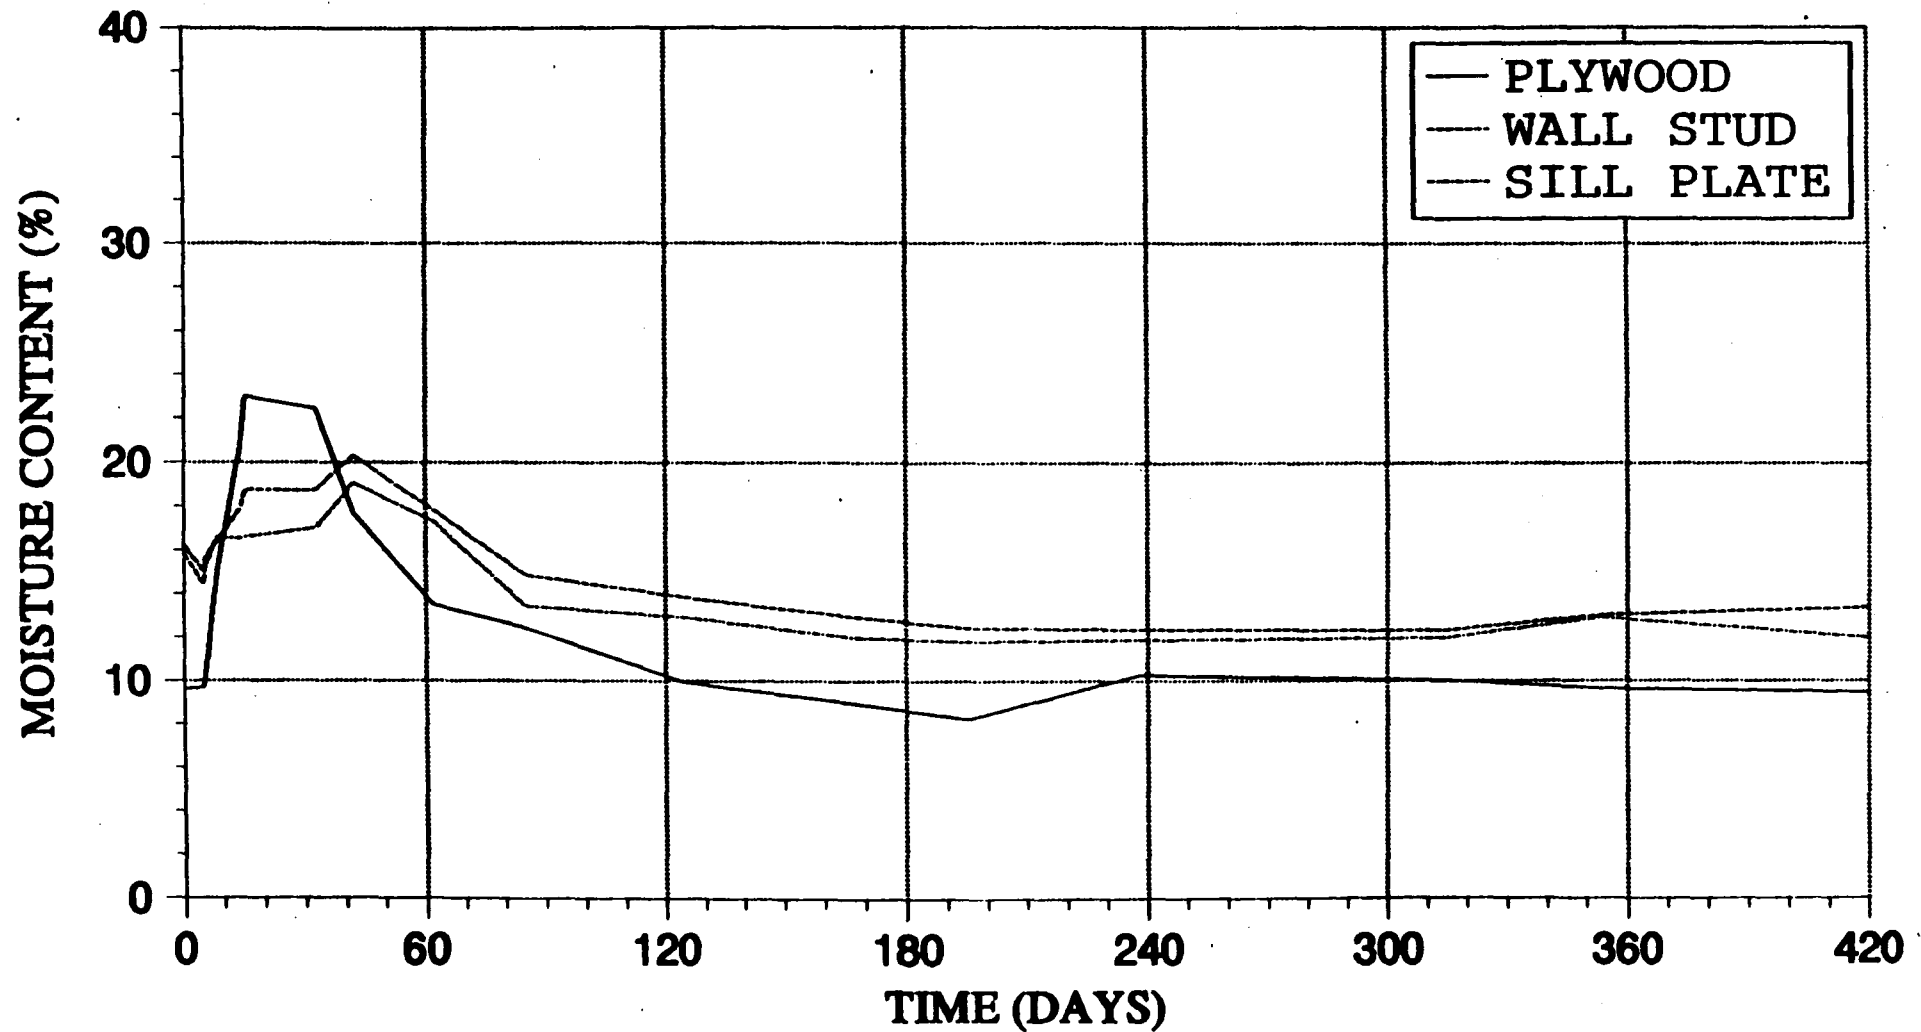
FIGURE 8
SECTION "D" - SOUTH WALL
WALL CAVITY SEALED

Figure 8: Section D - South Wall - Gaps in sheathing & stud sealed.

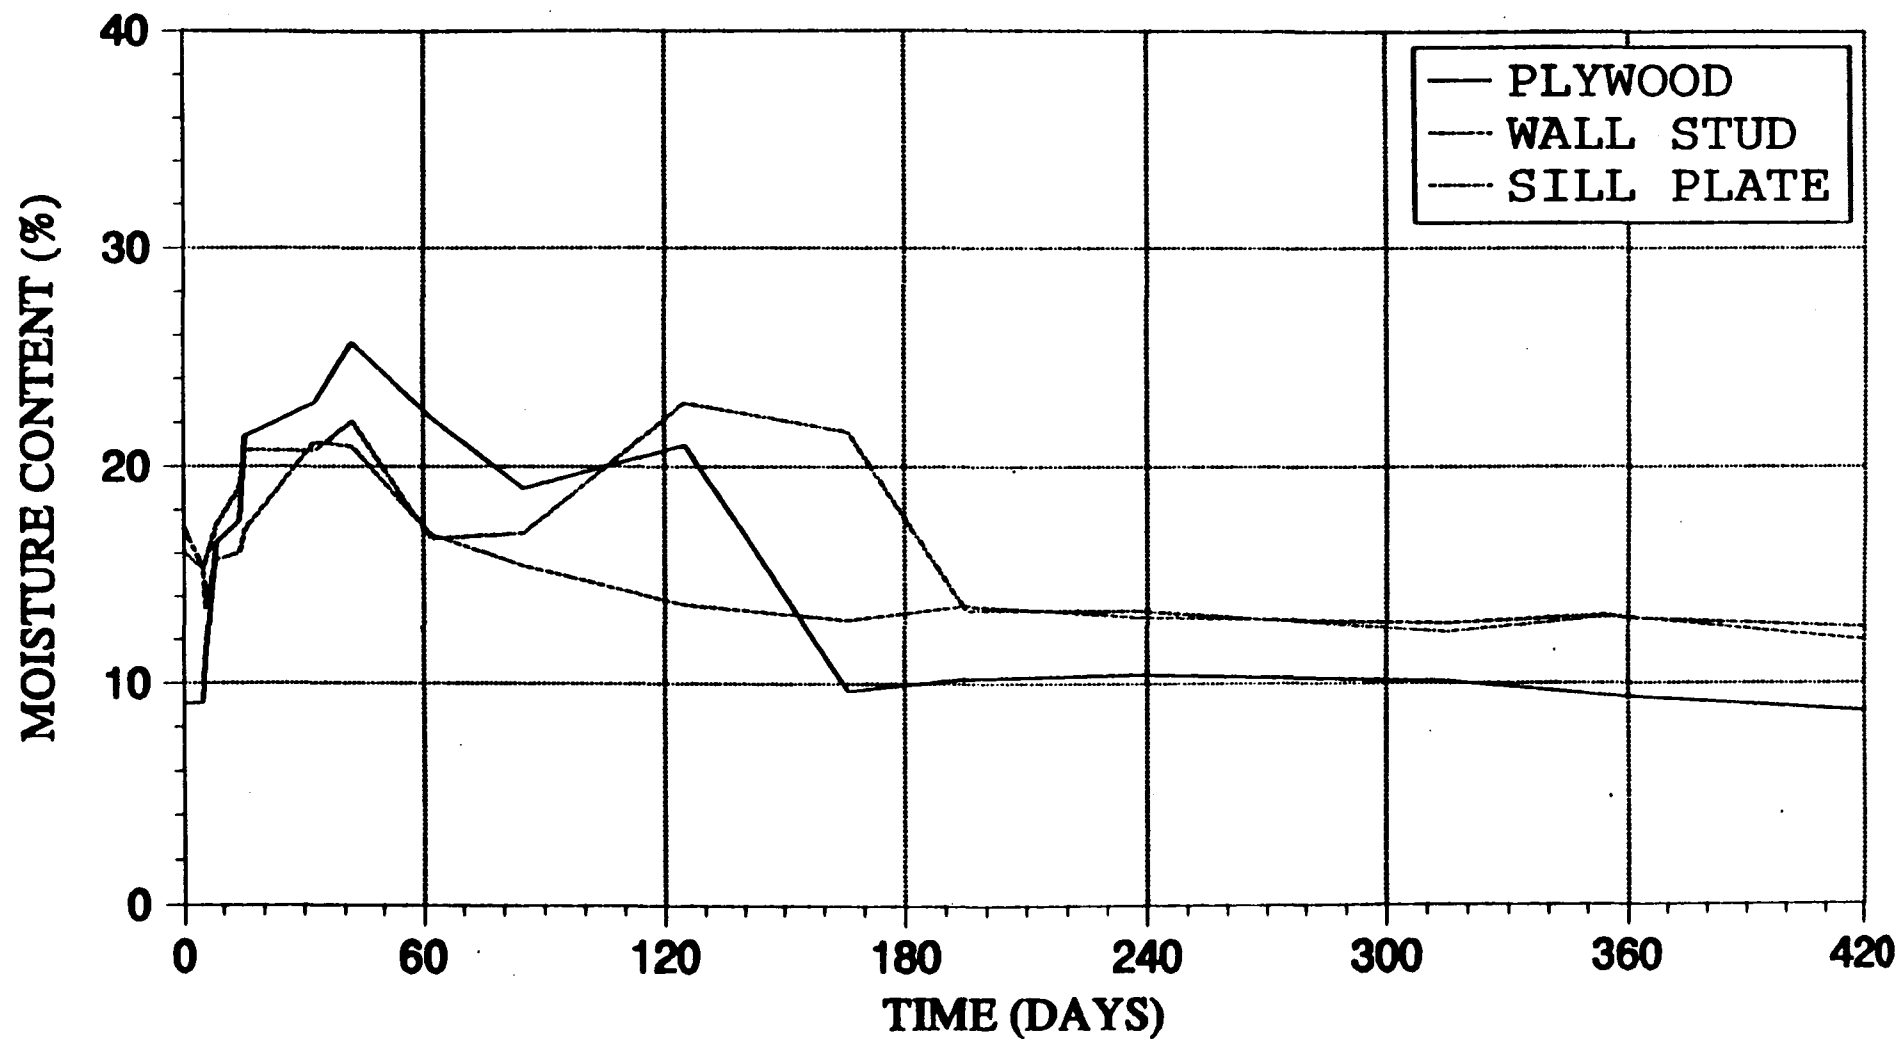
FIGURE 9
SECTION "E" - EAST WALL
STANDARD CONSTRUCTION

Figure 9: Section E - East Wall - Standard Construction.

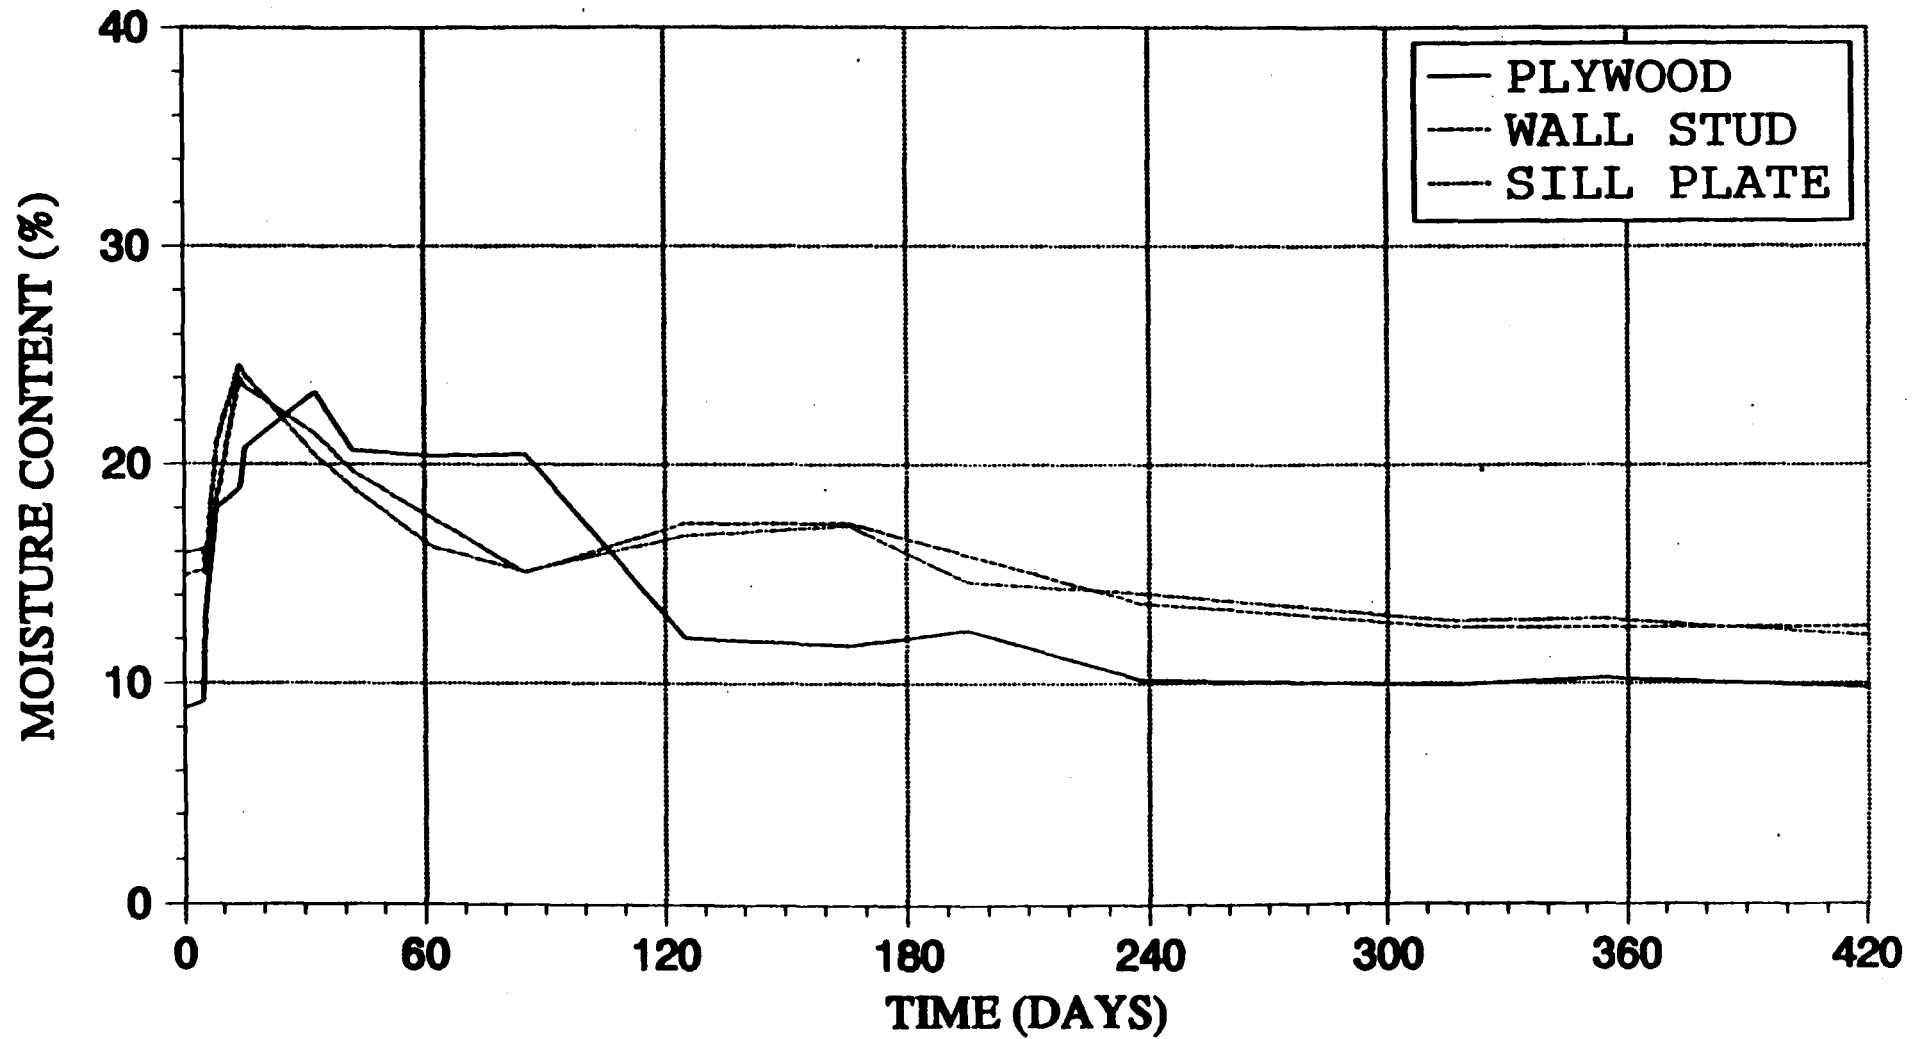
FIGURE 10
SECTION "F" - NORTH WALL
STANDARD CONSTRUCTION

Figure 10: Section F - North Wall - Standard Construction.
