**EARTHQUAKE DAMAGE IN THE  
SAN FRANCISCO AREA AND  
PROJECTION TO  
GREATER VANCOUVER  
JANUARY 1990**

### Earthquake Damage in the San Francisco Area and Projection to Greater Vancouver

Report No. CR-6026.1

Report date: 2 January 1990

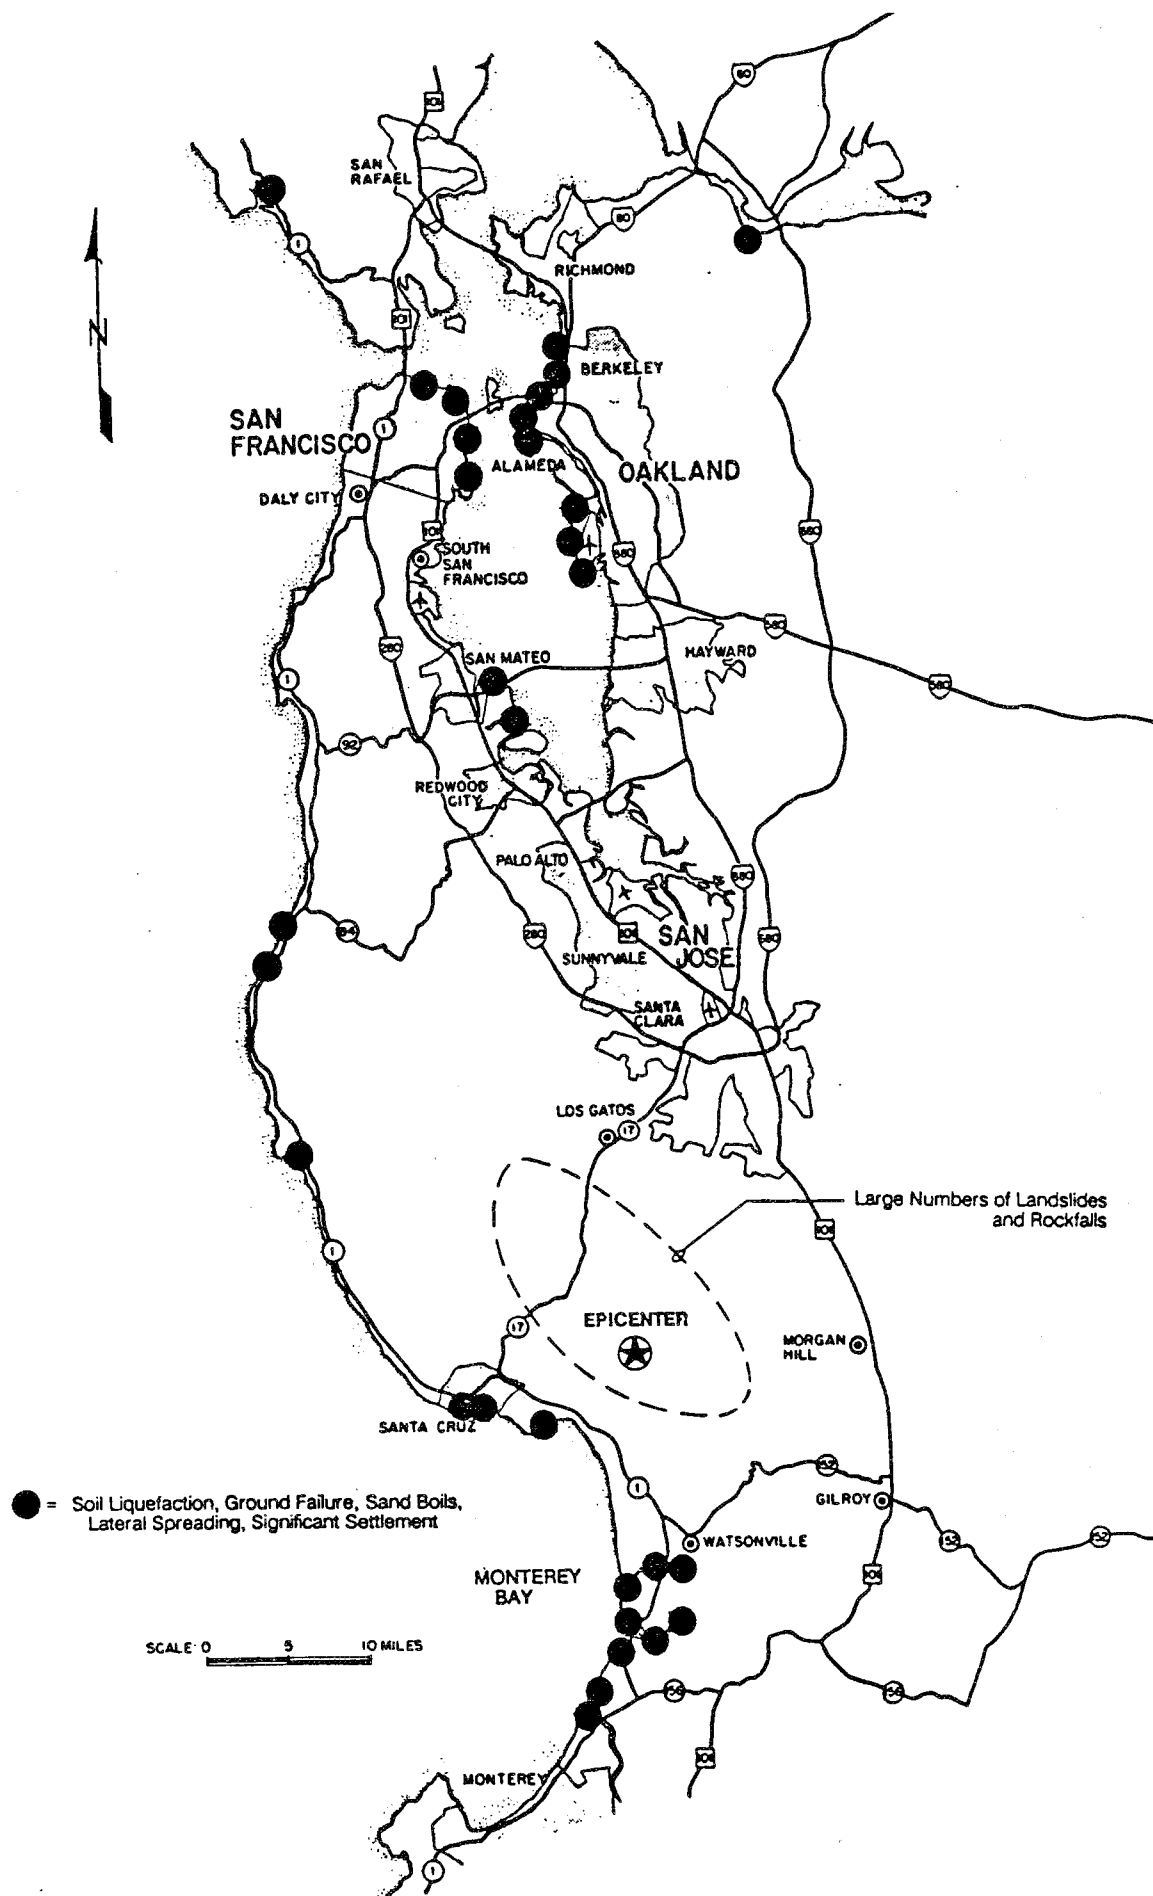
Fig. 5: Map of San Francisco Area showing Location of Soil Failures (Ref. 8)

Liquefaction failure is a process in which soft saturated granular soil is transformed to a liquid as a result of earthquake shaking or by other dynamic disturbance. When this happens the soil beneath the surface is liquefied and, under pressure from the overburden, tends to eject the water and soil mixture through the ground surface. This will result in cracking of ground, ground heave, sand boils, building collapse and differential settlement. All these phenomena were observed over an extensive area (Figure 5) ranging from very near the epicentre to more than 100 km away. Examples of liquefaction failures are shown in Figures B20 to B23 in Appendix B.

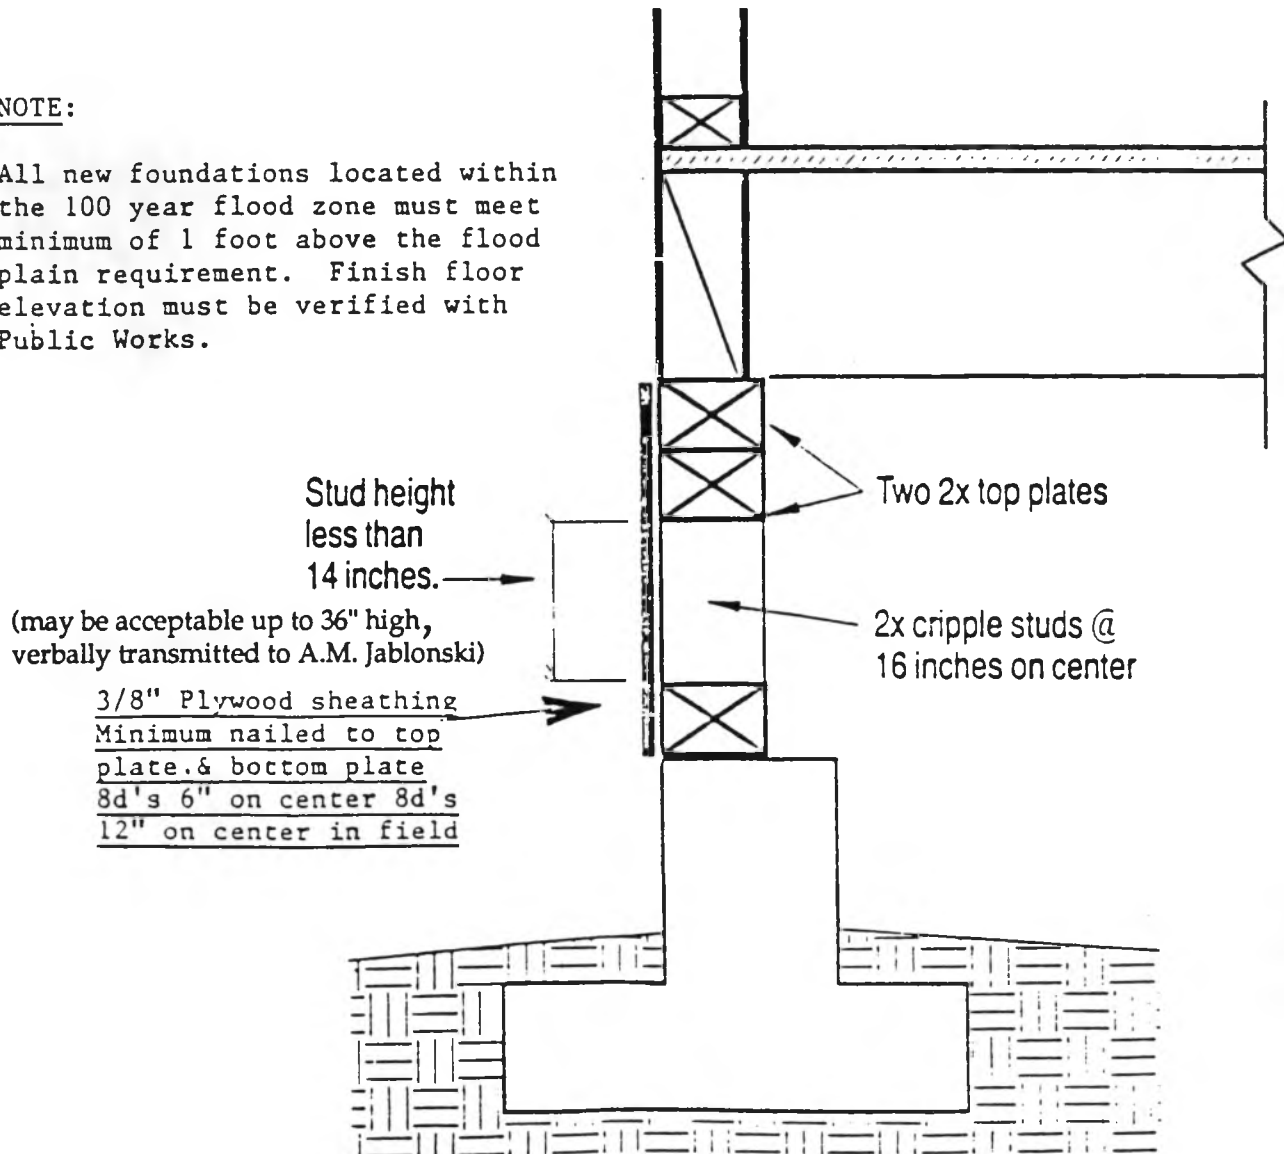
Fig. 6: Specifications for cripple walls, Earthquake requirements, City of Watsonville, CA

"Cripple" foundation walls (or "pony" walls) failed in many old wood frame houses in the epicentral area (e.g. in Watsonville and in Los Gatos) causing serious damage. Cripple walls are stud walls which form the connections between foundations (concrete or masonry) and the first floor framing (see Fig. 6). They are usually short, but in some modern wooden houses could reach a height of one full storey. Older buildings of 50 years or more appeared to not have enough lateral resistance to withstand severe shaking.

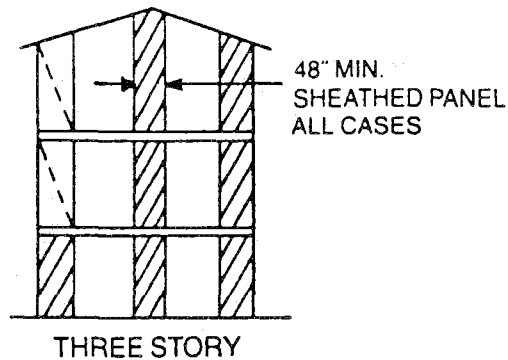
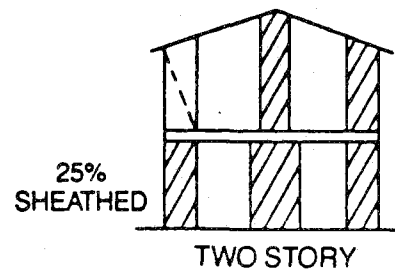
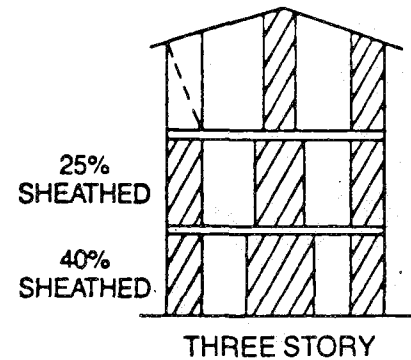
Fig. 7 : Wall Bracing Specified in 1985 Uniform Building Code (UBC) for Residential Construction (adapted from Ref. 13)

The experience of the Loma Prieta earthquake indicates that the most serious deficiency in Part 9 of the NBC is the lack of any requirements for wall bracing in wood frame construction. Ground storeys of 2 or 3 storey residential buildings containing large openings may collapse laterally, with serious consequences. This may be important for certain townhouse and apartment configurations. The UBC requirements for wall bracing are indicated in Fig. 7.
