AVIATION INVESTIGATION REPORT

A16W0092

Nose landing gear failure to extend

Beechcraft 1900D, C-GORF

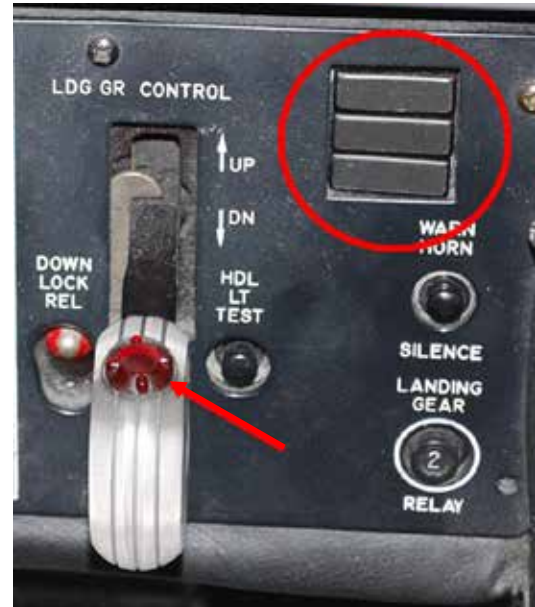
GGN7212 departed CYQL at 0531¹ and climbed to the flight-planned altitude of 11 000 feet above sea level (ASL). The flight progressed normally into CYYC until 0610, when the flight crew selected the landing gear down. When the landing gear began to extend, a grinding, banging noise was audible. When the landing gear extension sequence stopped, the flight crew observed 1 green down indicator light for each of the main landing gears, but no green indicator light for the nose landing gear. The in-transit light in the landing gear handle was extinguished (Figure 1).

Figure 1. Beechcraft 1900D gear-down indicator lights (circled in red) and landing gear control handle (arrow)
