RAILWAY INVESTIGATION REPORT

R16E0102

Main-track derailment

Canadian National Railway Company

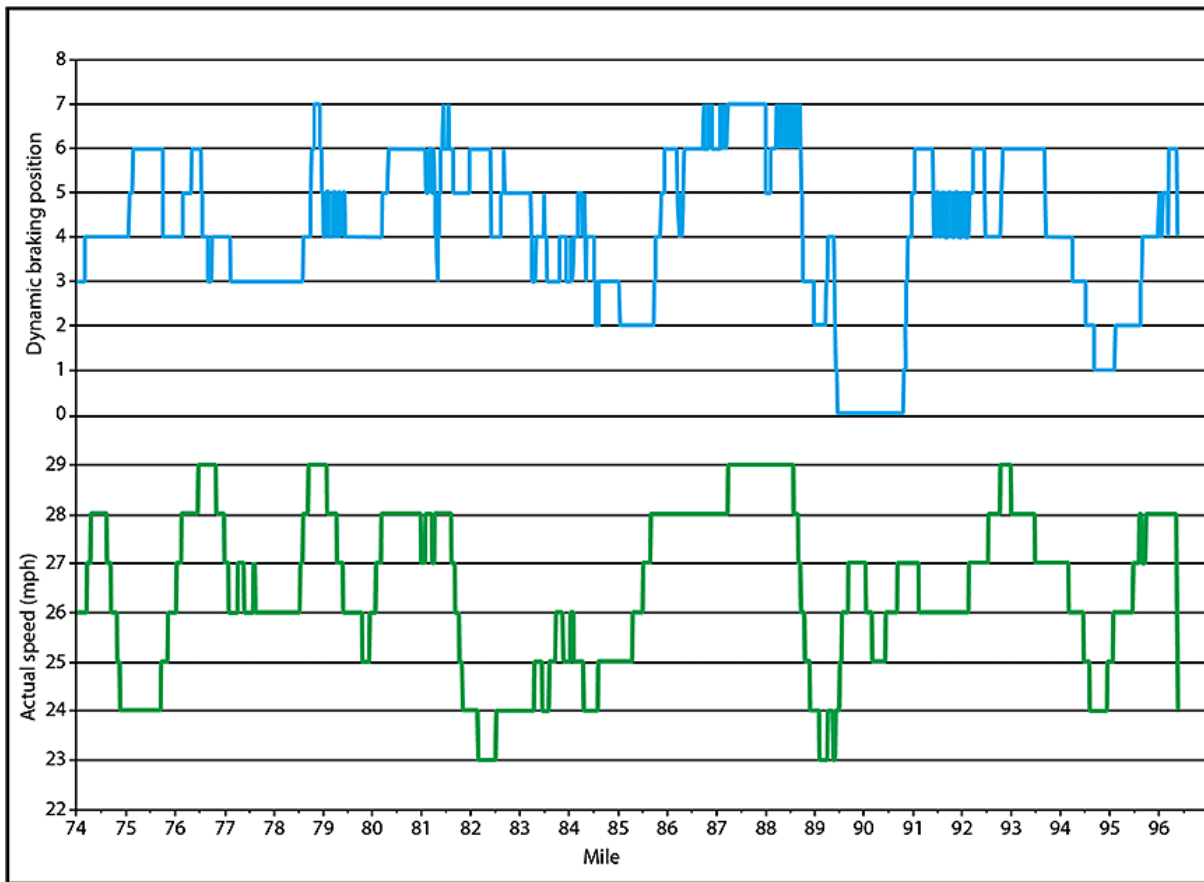
Figure 5. The occurrence train's speed profile and dynamic braking position from Mile 74 to Mile 96 (43" wheel data)

The data from the locomotive event recorder was reviewed to determine how the train was handled on the descending grade between Grey (Mile 73.0) and the point of derailment (POD) (Mile 96.38). The train speed ranged between 23 mph and 29 mph, exceeding the maximum speed of 25 mph (Figure 5). The dynamic brake (DB) was placed in position 6 and position 7 several times, exceeding the limit of DB5 (Figure 5).¹²

¹² CN 8960 G 2.13 (1) limits operative DB axles to 12 in any consist with 1 or more AC locomotives. CN 8960 G 2.13(2i) restricts the DB handle position to 5 or less when the train is operating between 5 and 30 mph.
