MARINE INVESTIGATION REPORT M17P0052

Capsizing and sinking with loss of life

Fishing vessel *Miss Cory*

06 March 2017

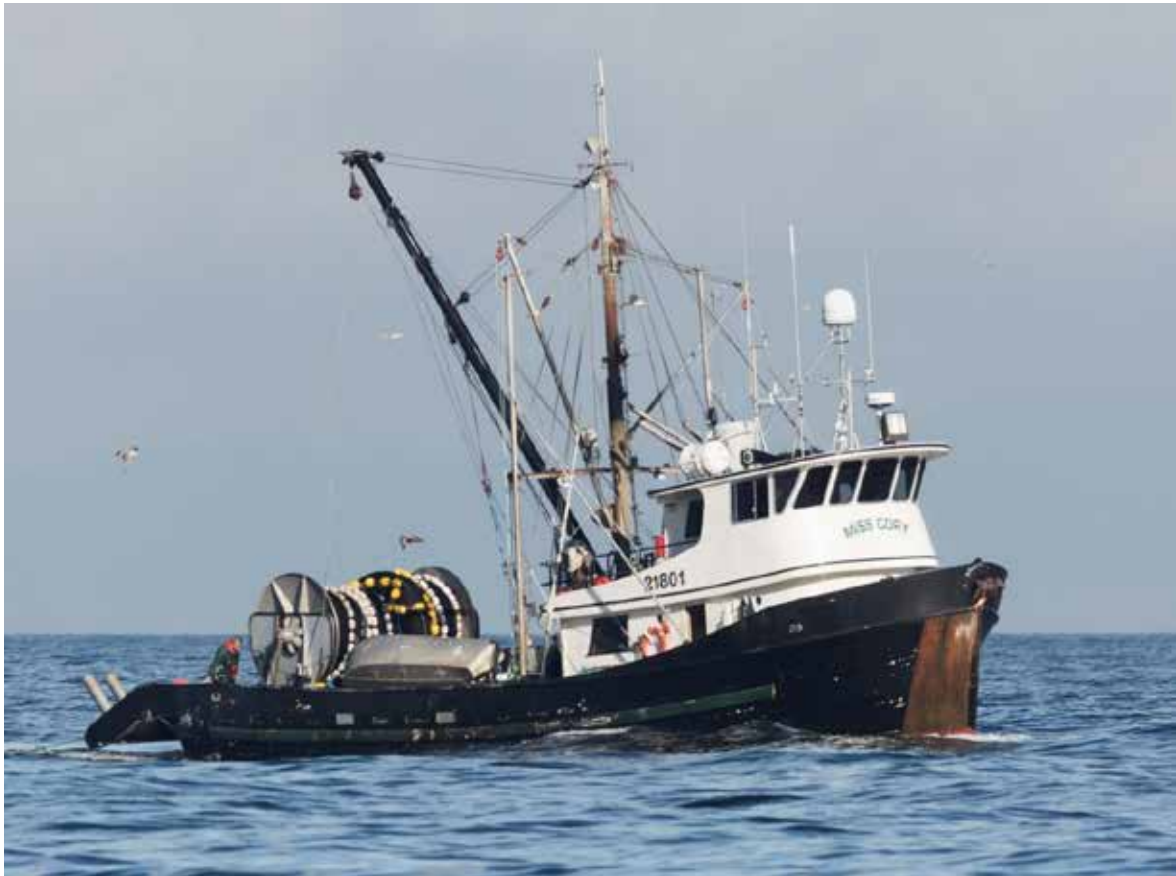
The *Miss Cory* was a fishing vessel with a raked stem, a rounded bilge to a full wood keel, and a transom stern (Figure 1). The hull below the main deck was subdivided by transverse bulkheads, enclosing from forward: the forepeak, engine room, 3 foamed/fibreglassed fish holds (2 forward and 1 aft), and a lazarette in which the hydraulic steering was located. The fish holds each had 1 access hatch and 2 manholes at deck level.¹

Figure 1. The *Miss Cory* in November 2016, outfitted for salmon purse seining (Source: Randy Hall, photographer)

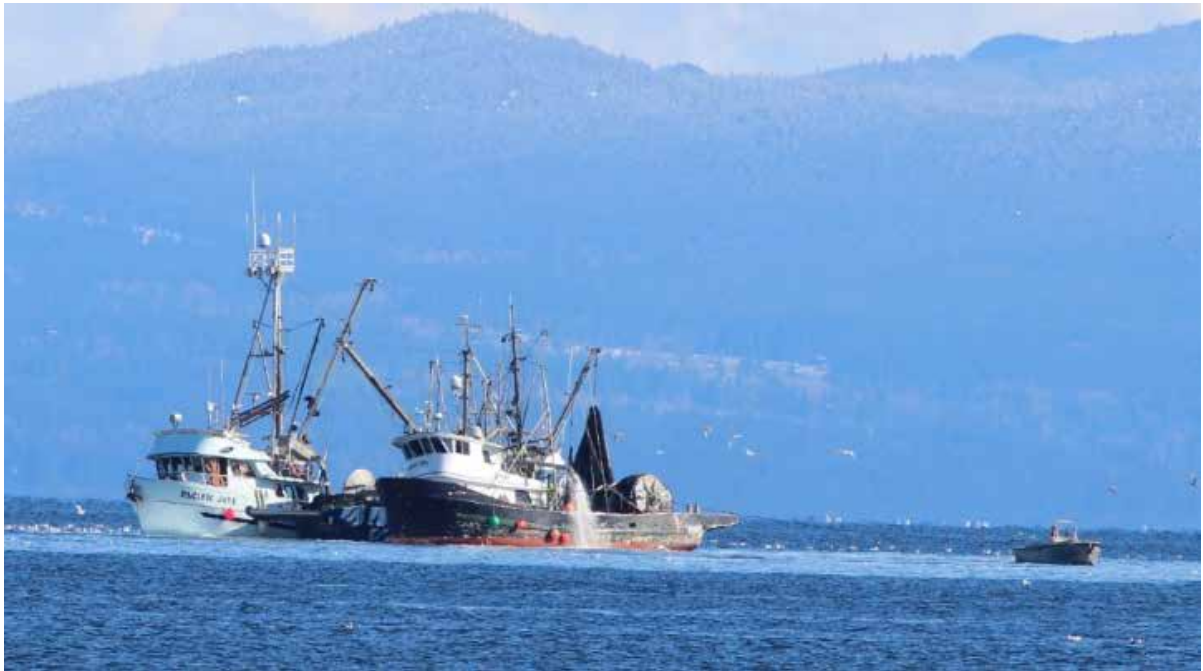
Figure 2. The *Miss Cory* (right) and the *Pacific Joye* (left), with the *Proud Venture* between them. The *Miss Cory*'s power skiff is shown at the far right. (Source: Fisheries and Oceans Canada)

The *Proud Venture* then contacted the packer *Pacific Joye*, which was in the area; the *Pacific Joye* came alongside the *Proud Venture* at approximately 1230. The *Proud Venture* used its fish pump to transfer approximately 100 tons of herring, mostly from the top of the concentrated pocket of fish in the tightly pursed seine, into the *Pacific Joye*. At approximately 1345, after the *Proud Venture* finished loading the *Pacific Joye*, the *Miss Cory* developed a noticeable starboard list from the weight of the fish in the seine. To stabilize the vessel and reduce the list, approximately 40 tons of fish were loaded into the forward holds of the vessel, which submerged the vessel's rubbing strake (Figure 3). No other packing vessels were immediately available to assist the *Miss Cory*. At approximately 1500, the crew started transferring fish into the *Proud Venture*. By this time, the fish had settled to the bottom of the purse.⁹ A section of hose was added to the pump and lowered to the bottom of the purse to access the fish.

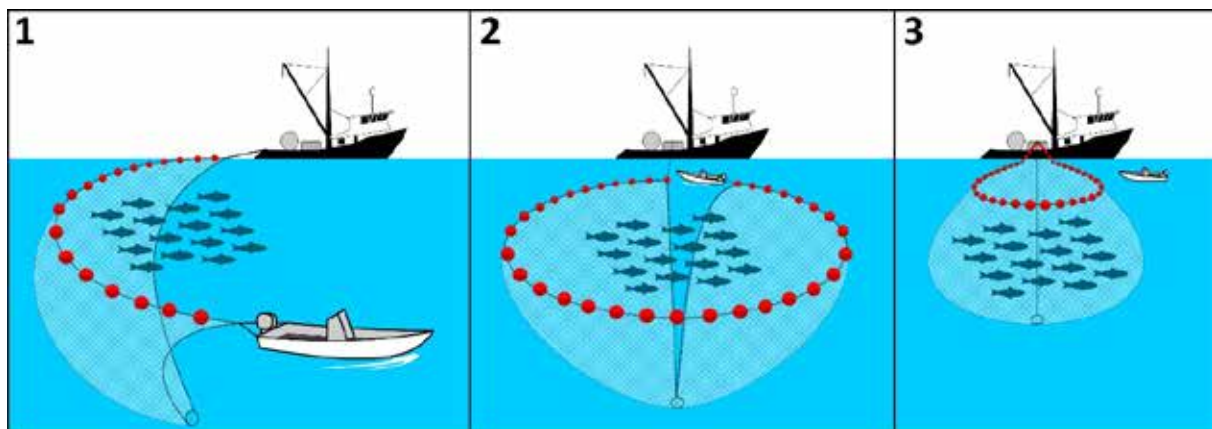
Purse seining is a method used to catch schooling fish near the ocean's surface by encircling them with a seine (net). Once the fish are encircled, a rope (purse line) running through a series of metal rings, which are attached to the bottom of the net, is winched tight to "close the purse" (Figure A1).

Figure A1. How purse seining works

- 1 A power skiff sets the net and encircles the school of fish.
- 2 The bottom of the net is closed from the fishing vessel, creating the "purse" and trapping the fish.
- 3 The portion of the net still in the water is drummed up to the fishing vessel. The fish are concentrated in a pocket and dried up so that they can be pumped into the vessel's fish holds.
