## MARINE INVESTIGATION REPORT M17P0098

### **Partial sinking with loss of life**

Commercial sport fishing vessel BC1329967  
(*Catatonic*)

30 April 2017

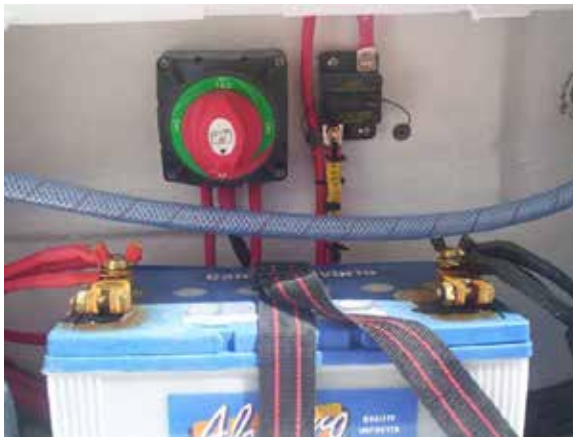
Figure 2. Builder-approved and standard battery bank arrangement in both battery compartments (Source: LeisureCAT Australia, *LeisureCat 8000 Sportsfisher Owners Manual*)

The *Catatonic's* original construction included 2 separate battery compartments. Each battery compartment contained an independent 12 V battery and a 4-way battery switch that could be set to Battery 1, Battery 2, Both, or Off (Figure 2). According to the owner's manual, to supply house power<sup>30</sup> or to start the engines, the operator had to set the 4-way battery switch to select the battery bank from which to draw power.<sup>31</sup>

As per the original design, the operator would select Battery 1 to power the port engine, and Battery 2 to power the starboard engine (Appendix F).<sup>32</sup> The design provided a safety feature that ensured that the operator could not drain both batteries simultaneously and that there would always be a backup power source.

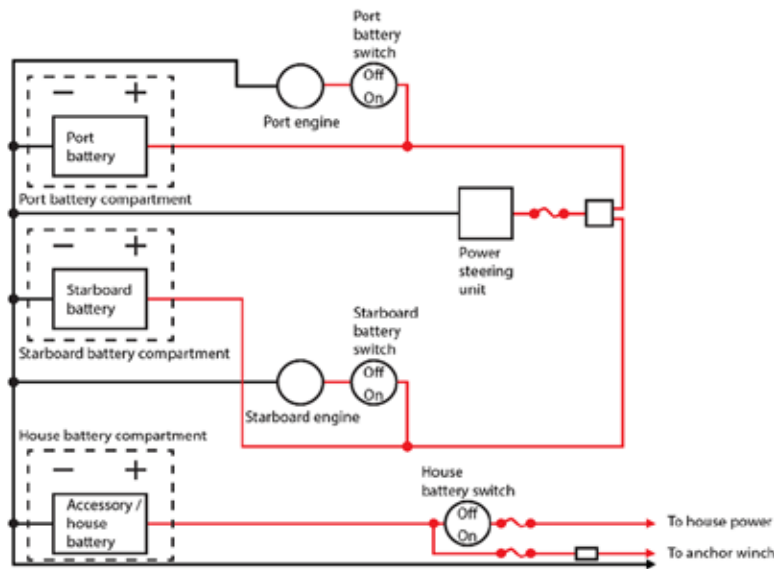
Figure 5. Engine manufacturer's recommended battery arrangement for dual Mercury 225 hp outboards

The outboard engine manufacturer's recommended design<sup>33</sup> for the installation of 2 of its outboard motors indicates that the vessel should be fitted with

- 3 batteries and 3 selector switches with ON or OFF options;
- 1 battery and 1 selector switch for each engine; and
- a separate third battery and selector switch for the house power (Figure 5).
