The Effect of Coating Propellers: the Impact on the Integrity of Nickel Aluminum Bronze as a Function of Cathodic Protection

Trisha Huber
Brad Noren, Vincent Drover, Heather Smiley
DRDC – Atlantic Research Centre

Scientific Report
DRDC-RDDC-2018-R154
August 2018

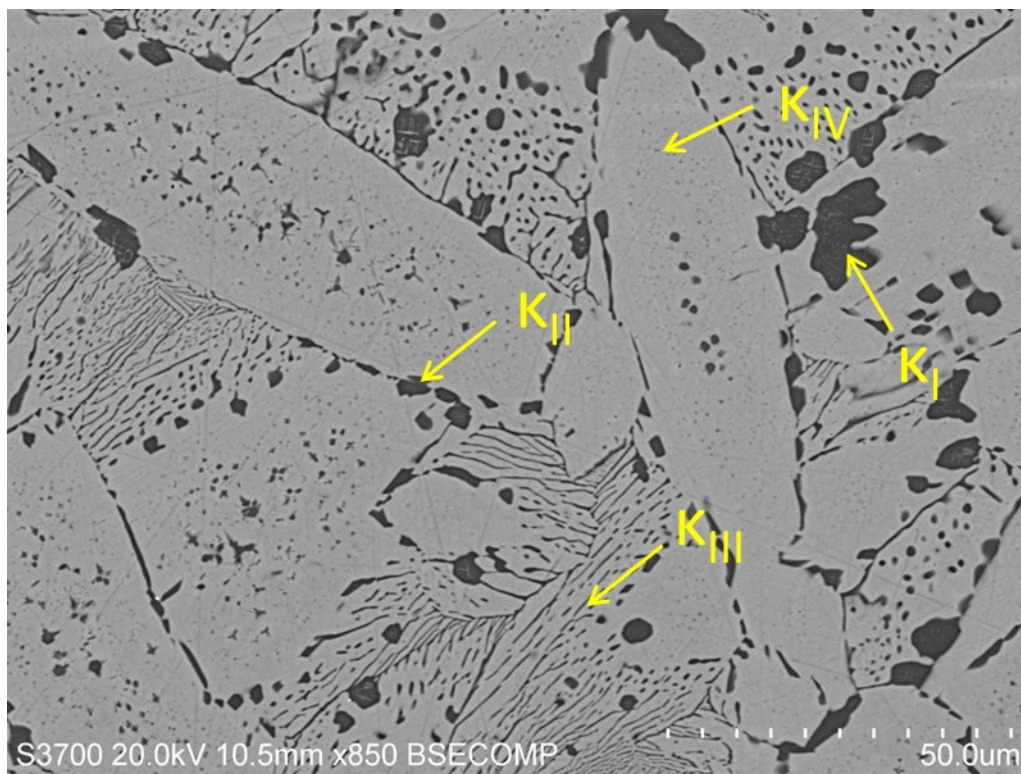
Figure 1 shows a scanning electron microscope image of NAB, denoting various phases. The α -phase is comprised mostly of copper and aluminum, and appears light in colour. The intermetallic κ -phases are rich in Ni, Al, and Fe (Table 1), and appear darker. The κ_I -phase is typically the large irregular-shaped globules (reported to be based on Fe_3Al [2]), and the κ_{II} -phase is typically the smaller irregular-shaped globules, or rosettes. The κ_{III} -phase exists as lamellar-shaped, or globular (degraded lamellar) precipitates in the eutectoid region, and the κ_{IV} -phase exists as small particles distributed throughout the α -phase [1, 2].

Figure 1: Scanning electron microscope image of NAB showing the Cu-rich α -phase and the different intermetallic κ -phases, denoted by yellow arrows.¹

¹ Although NAB having a greater proportion of Ni relative to Fe, typically does not exhibit the presence of κ_I -phase, in this work, elemental analysis of the large, globular phases shown in Figure 1 suggest that these are κ_I - not κ_{II} -phase.

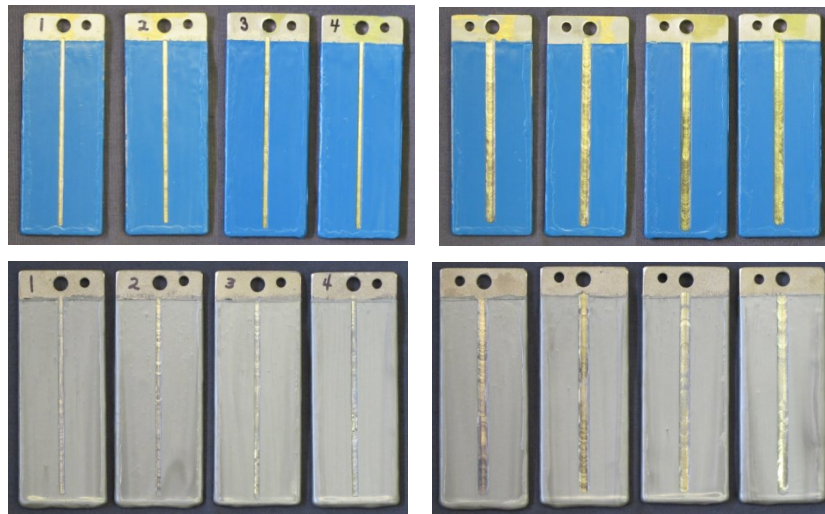
Once the coating had fully dried (antifouling) or cured (epoxy), an intentional breach in the coating was introduced by milling a lengthwise slot on each side of the specimen, completely through to the NAB surface. On one side, arbitrarily designated the front, the slot was two mm wide. On the back, the slot was five mm wide. Both front and back of each specimen was milled in order to allow for additional crevice locations; the slot widths were varied for differing exposed regions of NAB, to ascertain whether there was an effect. Figure 3 shows the front and back of the both sets of specimens after milling.

Figure 3: Front and back of antifouling-coated (top) and epoxy-coated (bottom) specimens after intentional defect had been milled on both sides: two mm on front, and five mm on back.

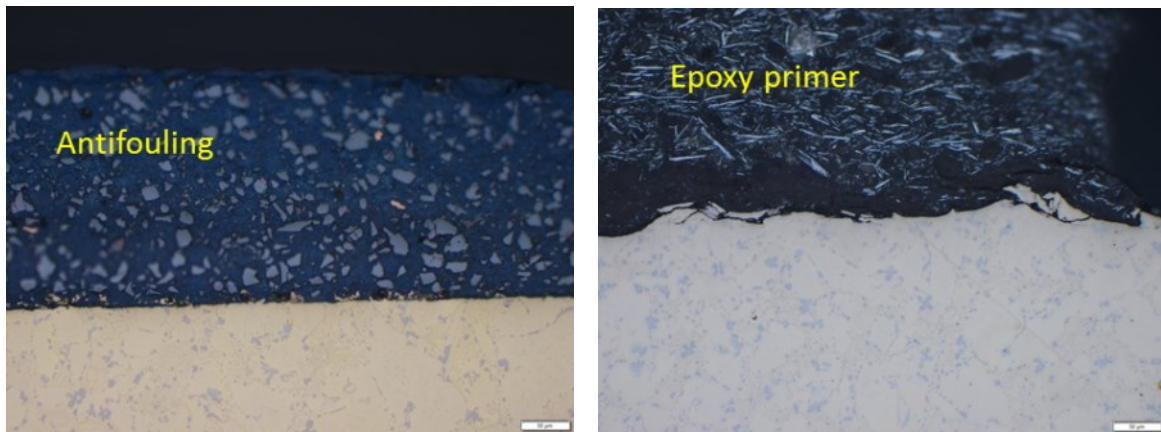
As use of the copper ablative is to temporarily mitigate biofouling, and is not intended for long-term use, coating adhesion is less important. Hence these specimens had minimal surface preparation (light sanding), ensuring a smooth surface and avoiding any mechanical damage to the NAB (Figure 7).

Figure 7: Note the smooth surface of the antifouling specimen (left), in contrast to the rough epoxy specimen (right) resulting from the grit blasting. Scale bars are 50 μm .

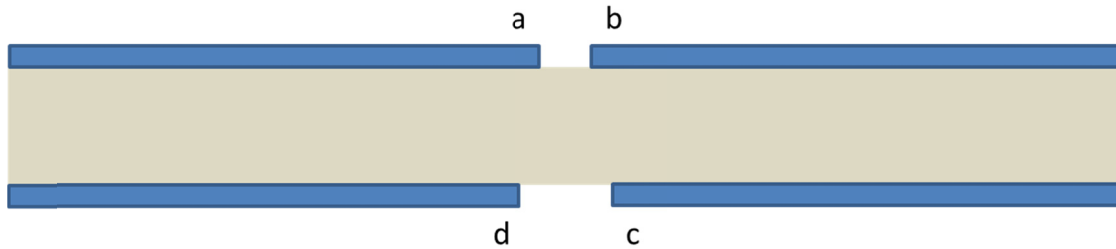
Crevice locations were defined relative to the thin and thick milled slots as shown in Figure 13. All four crevice locations on each unprotected epoxy-coated specimen were examined, and the extent of SPC under the coating was measured, in millimetres (mm) (Table 2).

In general, the extent of crevice corrosion increased with time (Table 2), both in number of affected crevices, as well as extent of undercutting in a given crevice. Although it is interesting to note that crevice corrosion developed at an inconsistent rate at the various crevice locations, even within the same sample. Specimen 1 showed a large variation in rate of undercutting progression, whereas specimen 2 exhibited crevice corrosion at only one location. This supports the notion that the geometry of the crevice impacts crevice corrosion. It is important to recall that these measurements were made on different samples cut

Figure 13: Diagram showing labelled crevices.
