**PERFORMANCE MONITORING OF A
BRICK VENEER/STEEL STUD
WALL SYSTEM
- PHASE 2 RESULTS -**

- PHASE 2 RESULTS -

SUBMITTED BY: KELLER ENGINEERING ASSOCIATES INC.
1390 PRINCE OF WALES DRIVE, SUITE 107
OTTAWA, ONTARIO
K2C 3N6

REPORT DATE: 1995 02 17

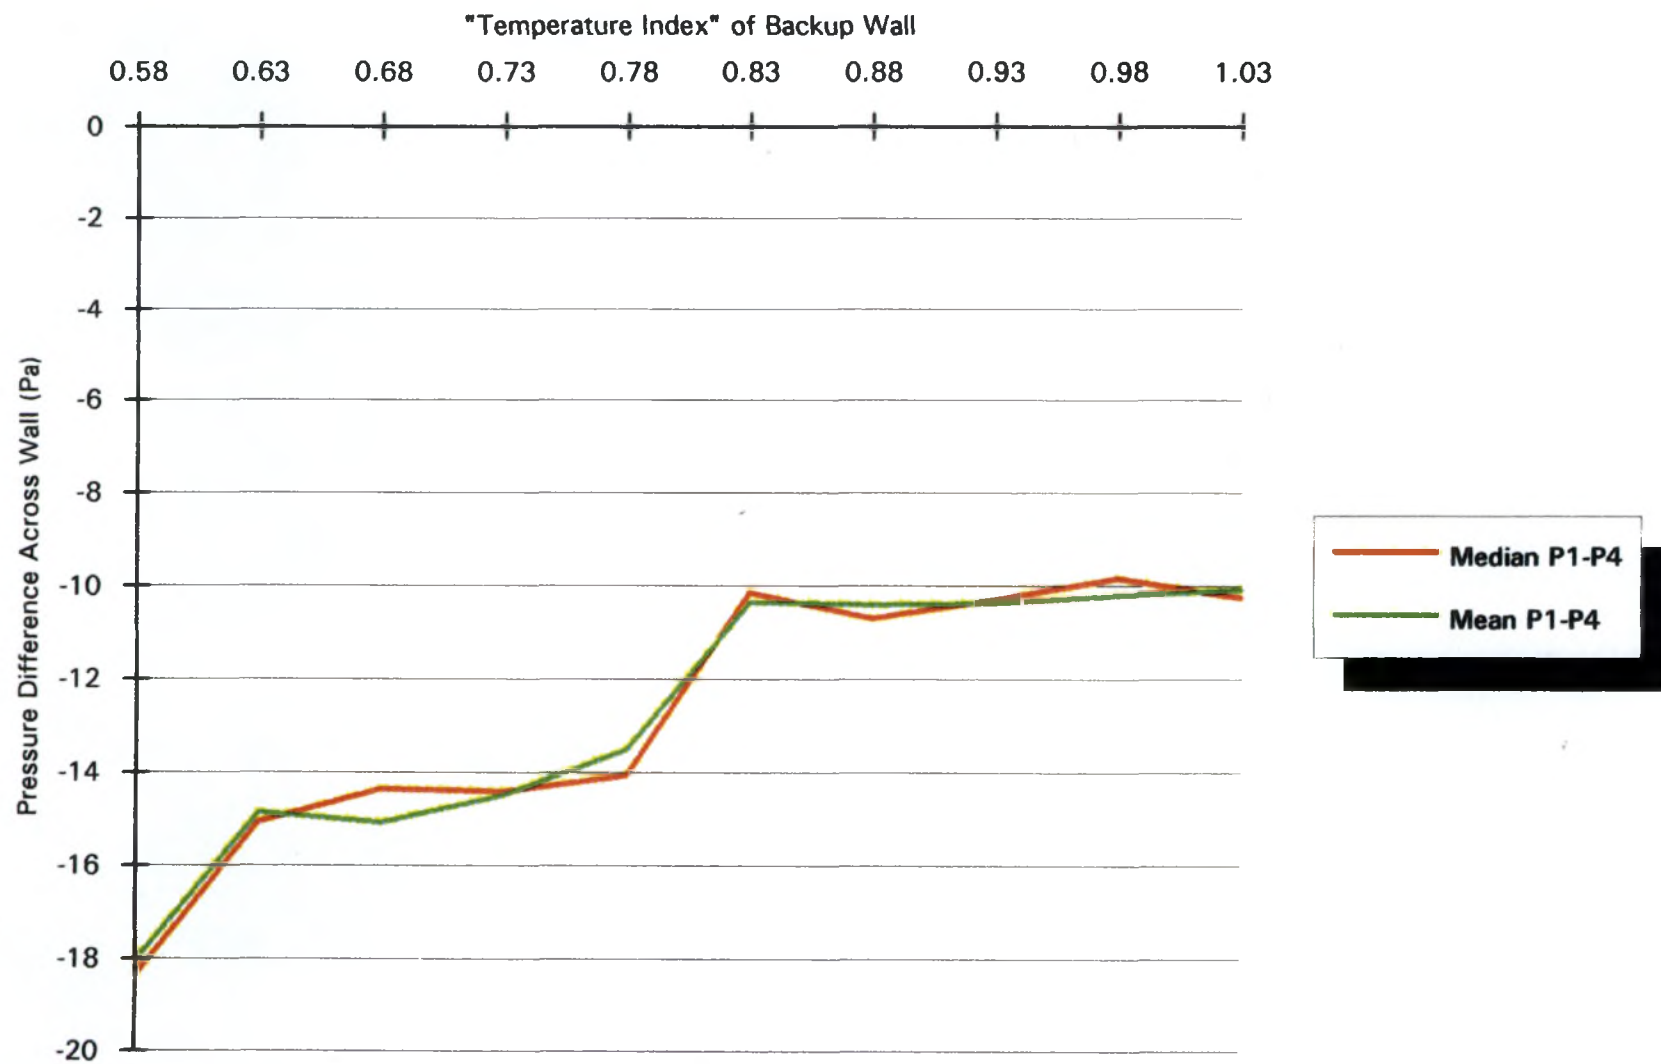
Fig. 11 Hourly Average Pressure Differences Across Test Wall

High pressure differences across the test wall were experienced most frequently during the first three monitoring periods but the January 16 - 29 pressure data best illustrates the typical trends that occur (Fig. 11 and Fig. 12). Therefore, this data set provided the most useful information regarding air pressure differences. Figs. 11 and 12 demonstrate that the test wall generally performs in a satisfactory manner since the wall meets most of the criteria outlined above. Note that, in both graphs, P1-P2 is represented by the distance between the curves of P1-P4 and P2-P4. Similarly, P2-P3 is represented by the distance between the curves of P2-P4 and P3-P4. Fig. 11 illustrates the hourly average pressure differences while Fig. 12 illustrates the daily average pressure differences.

The hourly average of P1-P4 varied between about 6.0 and 21.5 Pa during the monitoring period while the daily average of P1-P4 varied between about 8.0 and 16.5 Pa. This data demonstrates that, as expected, the wall system is effective at isolating the exterior air from the interior air. Note that smaller values for P1-P4 are generally recorded when P1 increases due to the test wall being exposed to winds from the easterly direction. (eg. Day 7 of Figs. 11 and 12).

As was found from the 1991/92 data, Figs. 11 and 13 illustrate that there is a simultaneous increase in pressure on the exterior and within the cavity, indicating that pressure equalization does occur to some degree. However, the graphs also illustrate that when wind speeds and wind directions change, there is a greater change in P1-P4 than in P2-P4. Since the changes in the pressure difference between the interior and exterior air tend to be greater than changes in the pressure difference between the cavity air and the interior air, pressure equalization is not fully effective. Therefore, this data also indicates that a certain portion of the wind load is carried by the brick veneer rather than solely by the steel stud backup wall.
