**ENVIRONMENTAL CONCERNS AND RECOMMENDATIONS:
ALASKA HIGHWAY RECONSTRUCTION AND MAINTENANCE
KILOMETRE 1008-1635**

Robert Baker
Federal Activities Branch - EICD
Environmental Protection Service
Environment Canada

EPS 8-PR-80-1

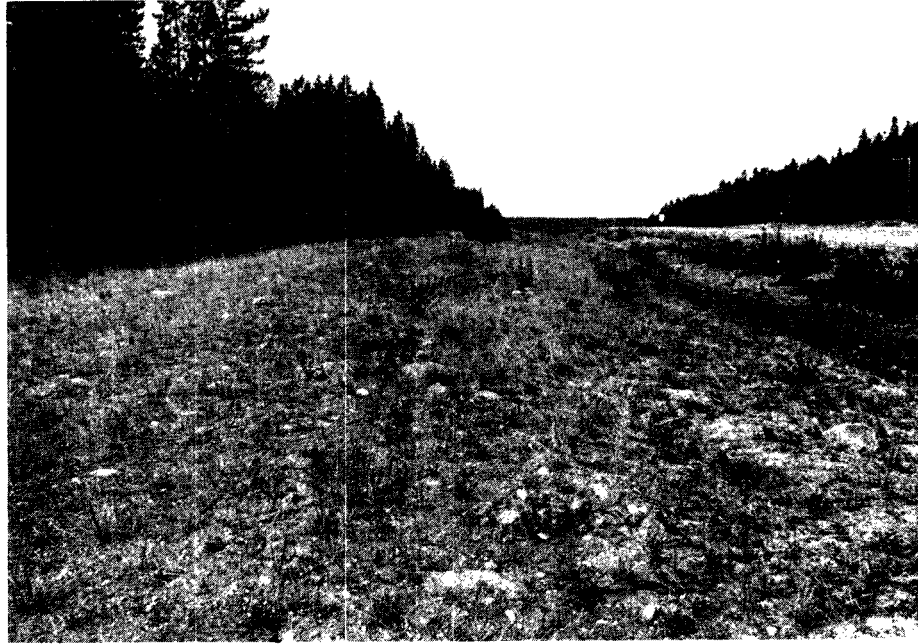
PLATE 1 Cleared right-of-way, reconstructed section of Alaska Highway, km 1022, sparsely vegetated.

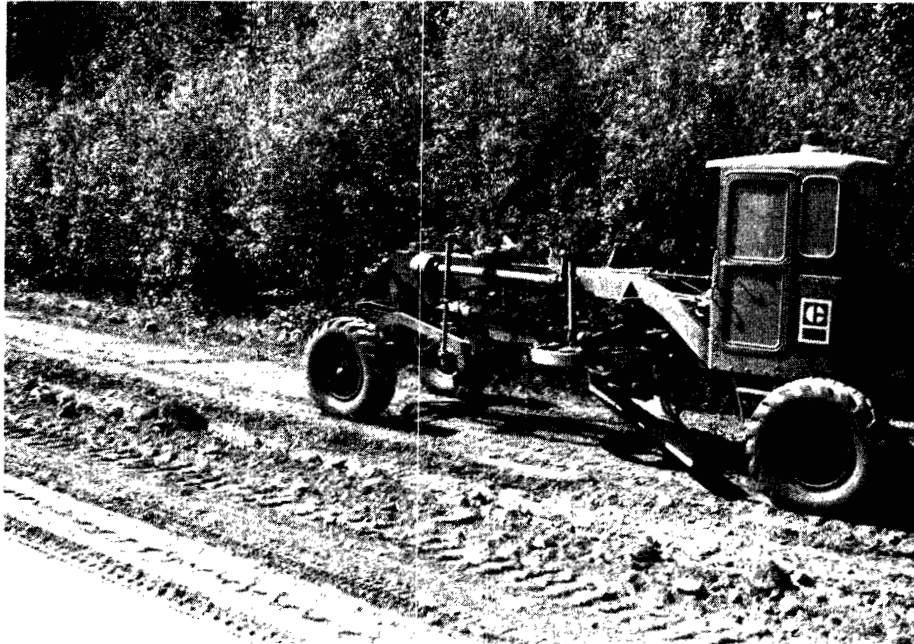
PLATE 6 Road grader clears a 4 m swath of vegetation. Cleared area in this picture is approximately 8 m wide, but it approaches 12 m wide in other sections of this highway. Robert Campbell Highway, km 56.

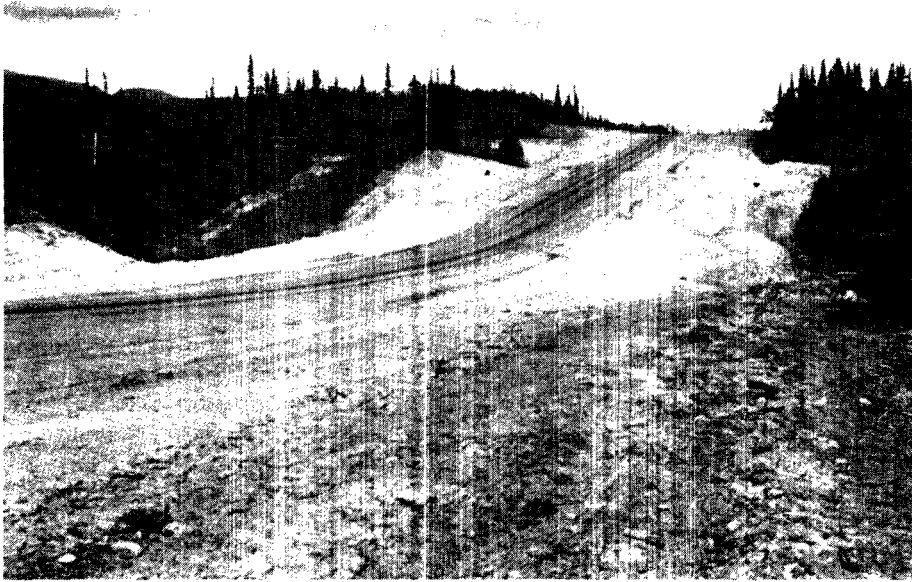
PLATE 7 Road graders are used here to keep the rights-of-way cleared of vegetation and to remove slash. The slash was left at the edges of the cleared rights-of-way when the highway was first built in the early 1940s. Rain-fall in this area is low and soils are high in silt and sand, hence erosion problems are likely. Alaska Highway, km 1628, to be reconstructed.

xiii) As well, road graders should not be used to remove old slash in erosion-prone areas. An environmentally appropriate way to resolve the aesthetic problem of old roadside slash would be to leave the slash where it is and follow recommendation vii. Within five or ten years, an aesthetically acceptable screen would develop to hide the slash from view (Plate 20).

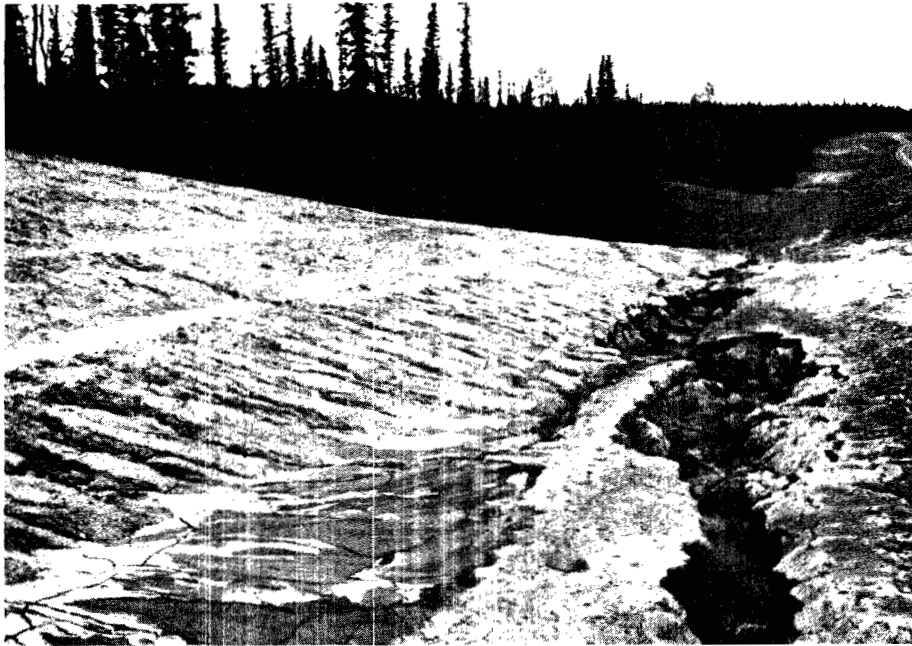
PLATE 8

Gully erosion can result when silty soils are not allowed to revegetate. The most vulnerable areas are at the bottoms of ditches. Alaska Highway, km 1628, reconstructed section.

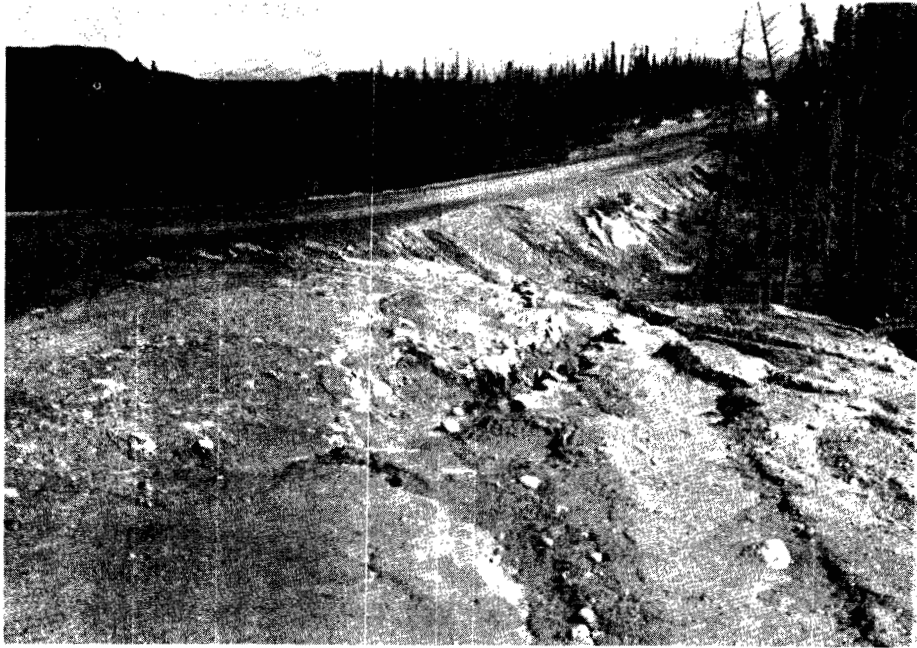
PLATE 10 Gully erosion silty, soil. Robert Campbell Highway, km 100.

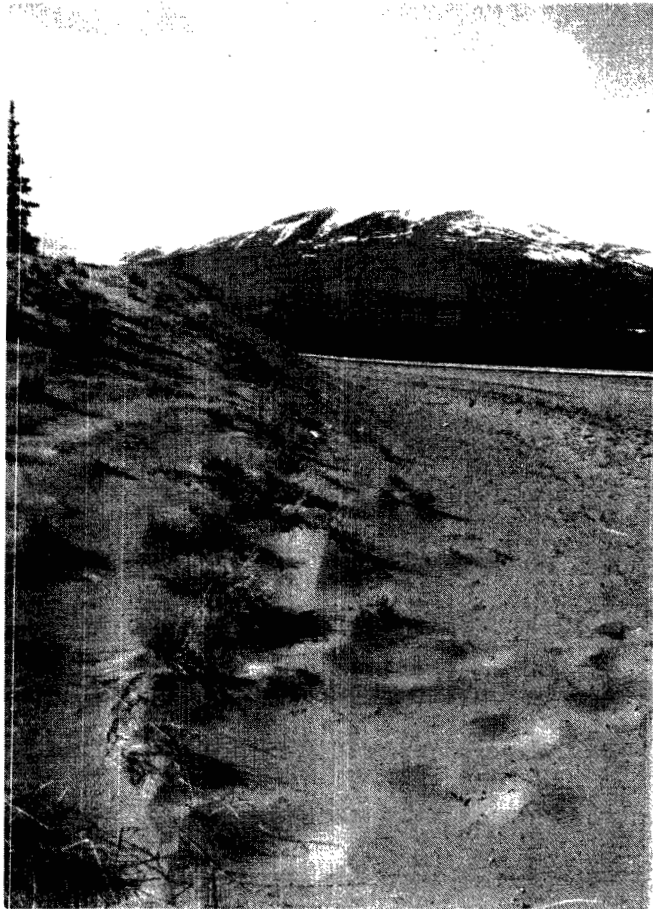
PLATE 11

Sparsely vegetated sand dune is in low rainfall area. Alaska Highway, km 1568, highway to be reconstructed.

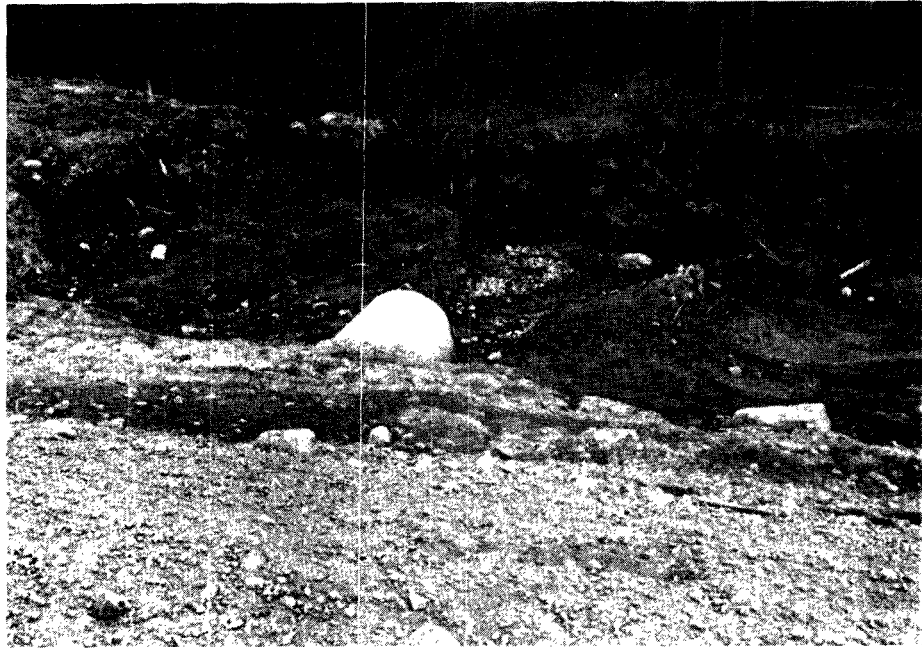
PLATE 12 Shorelands at minor stream crossing cleared of soil and vegetation. Erosion and aesthetic problems have resulted. Alaska Highway, km 1415, reconstructed section.

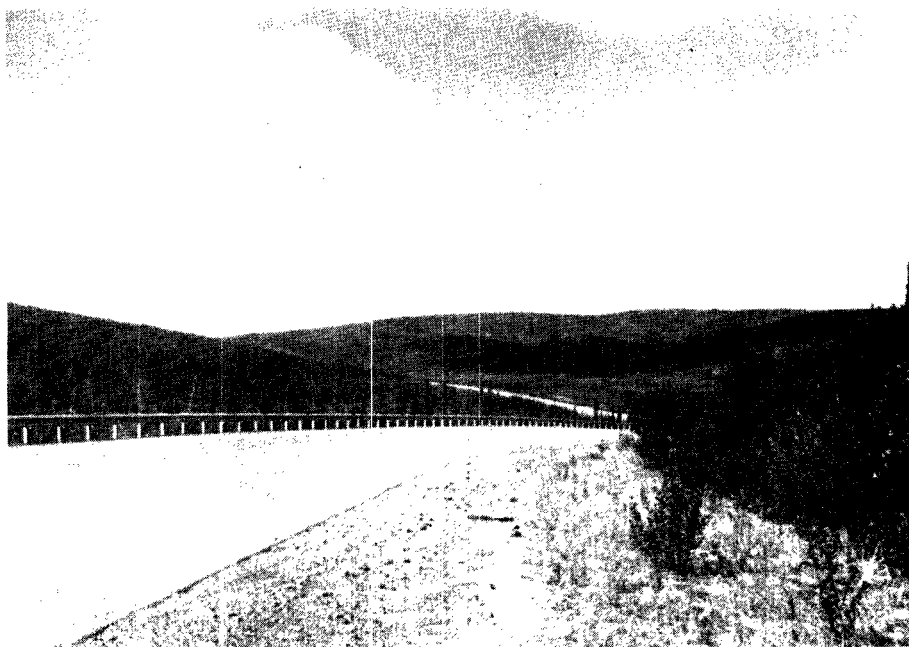
PLATE 14

Right-of-way cleared with a vegetation cutter. The cutter clears a 4 m swath on each side of the highway. One cutter clears approximately 640 km of highway per year. Soils are sandy and hence erosion-prone. Alaska Highway in State of Alaska, vicinity of Tok.

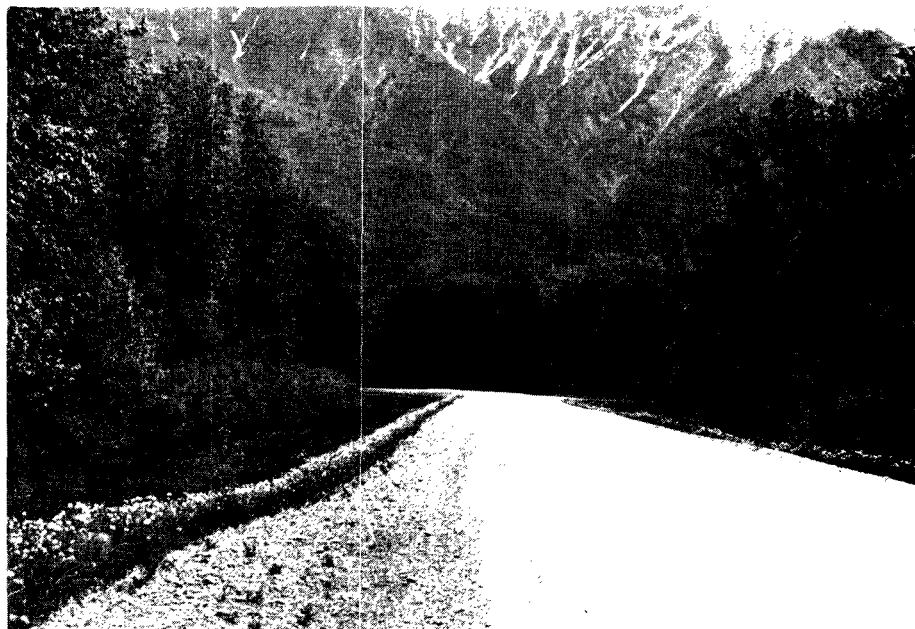
PLATE 17 Narrow, naturally vegetated cleared right-of-way. A vegetation cutter is used to clear a swath on either side of the highway. Haines Road, Alaska.

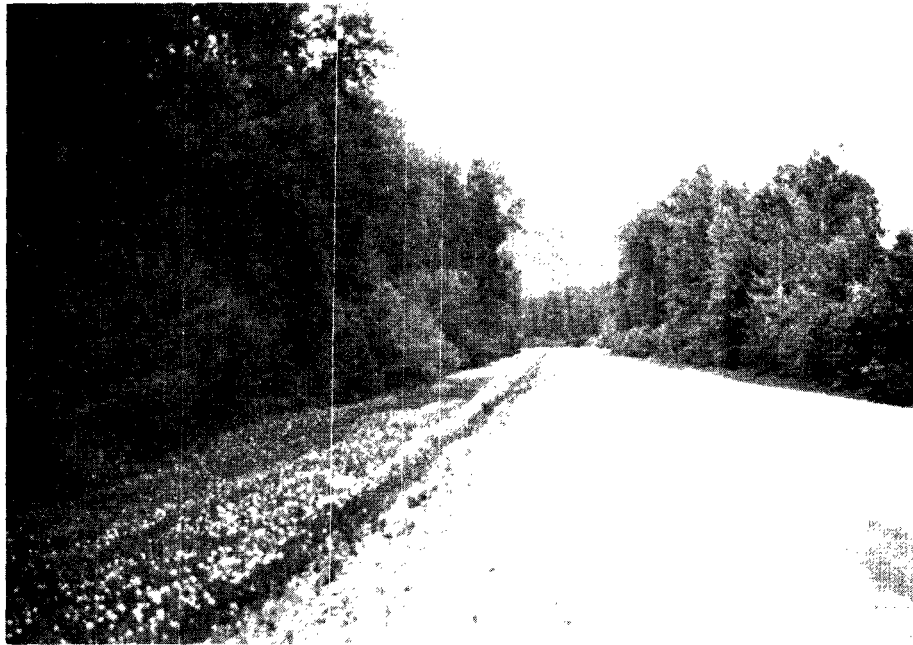
PLATE 18 Description as for Plate 17. Haines Road, Alaska.

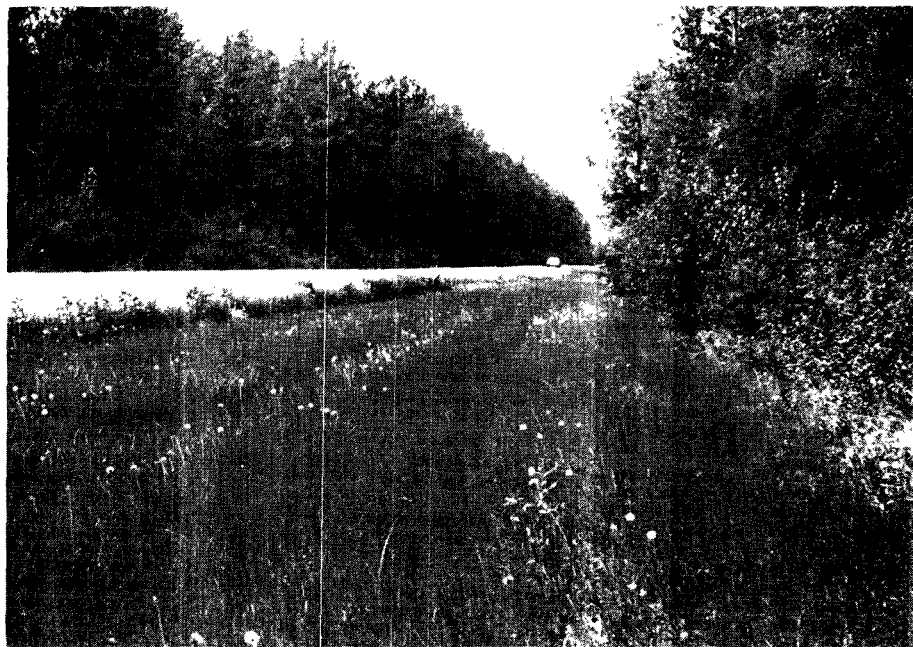
PLATE 19 Wide, naturally vegetated rights-of-way on curves. Haines Road, Alaska.

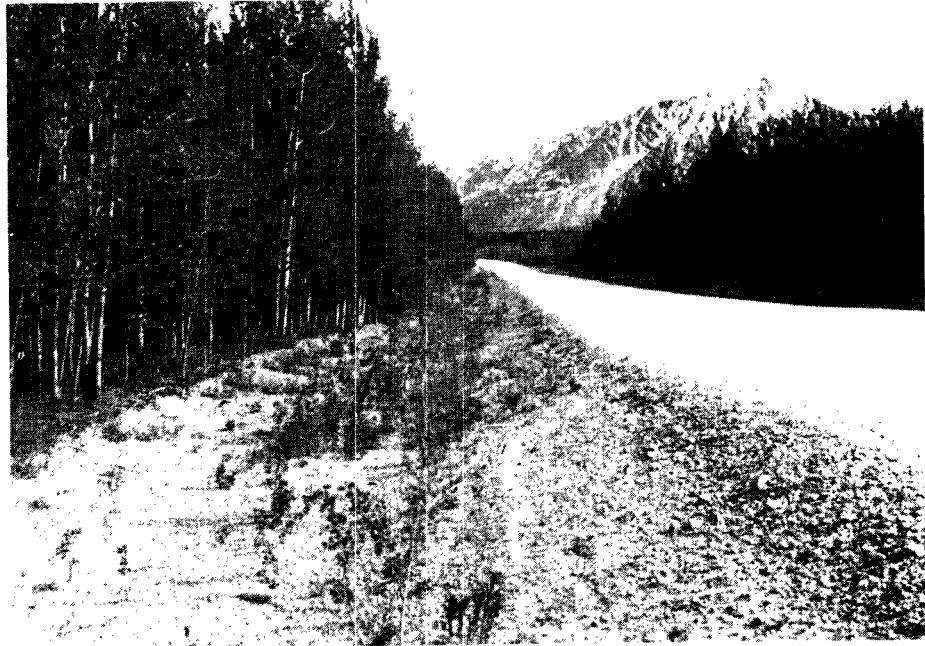
PLATE 20

Narrow cleared right-of-way. A road grader was used to cut a 4 m swath on either side of the road. Additional widening is prevented by slash left from original road construction operations. The slash is hidden by bush at left and right in picture. Haines Road, km 242, Yukon.

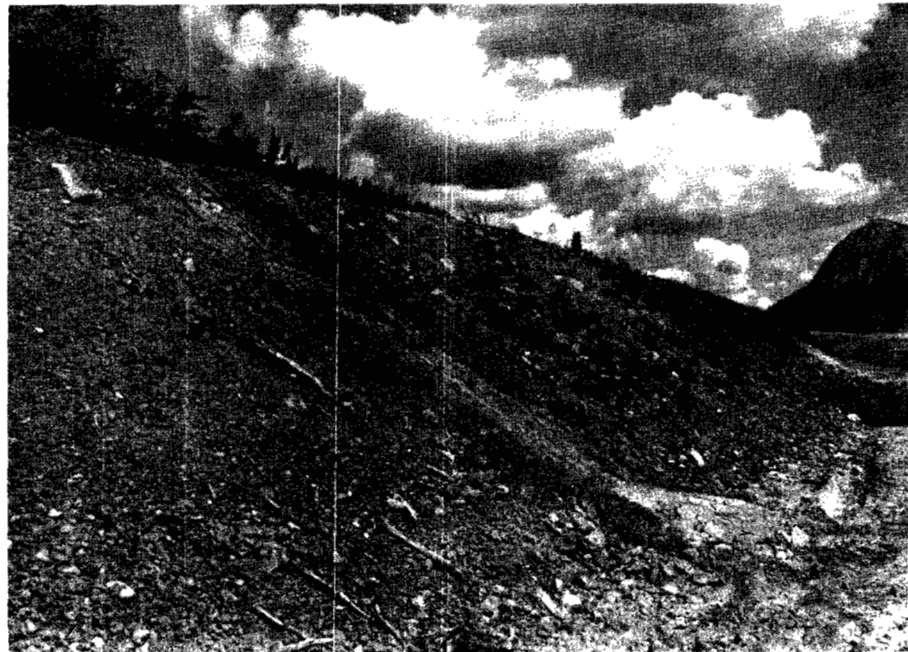
PLATE 25

Backslope nearly vertical, silty soil, extensive slumping. Robert Campbell Highway, km 85.

- i) Backslopes should not be cut at angles greater than 30 degrees (approximate). Geotechnical tables would have to be consulted for precise information on natural angles of repose for specific soil types. For example, see Hardy Assoc. 1979. Shakwak Highway Project Reclamation Program Formulation. Project No. 010417. Vol. I and II.
- ii) A horizontal hydro-seeded space 4 m wide should be provided between the edge of the highway and the base of the backslope. Such an area provides a place for slope revegetation to start (Plate 29).
- iii) When backslopes are higher than 8 m, a bench should be provided part-way up the slope; this would provide a place for slope revegetation to begin (analogous to the flat,

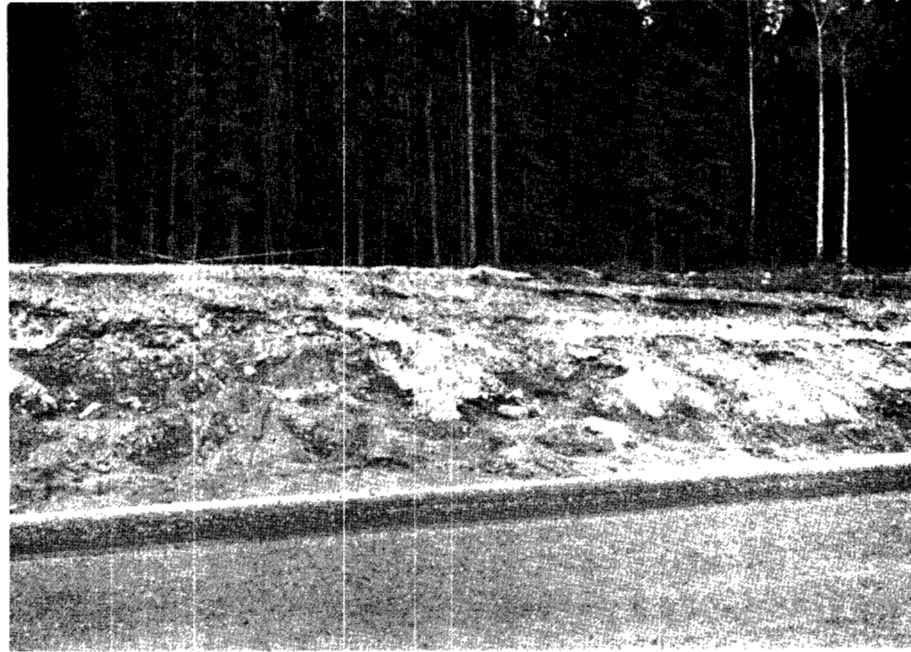
PLATE 26

Backslope at 45°, silty soil, top of slope has slumped (upper left to lower right in picture). Alaska Highway, km 1390, reconstructed section. Other backslopes on this section are also cut at angles well in excess of 30 degrees as are backslopes at km 1100 (reconstructed section), km 1180 (reconstructed section), km 1345 (to be reconstructed).

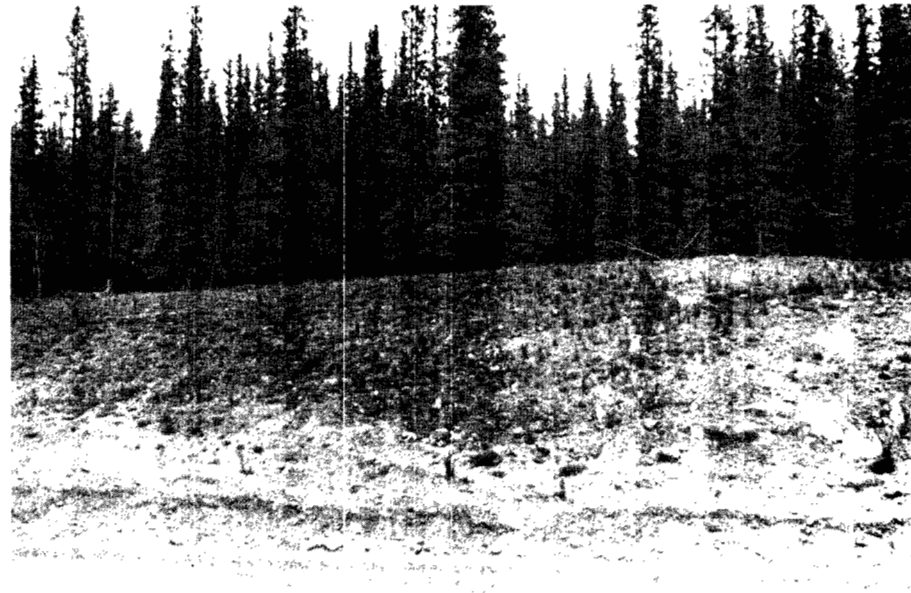
PLATE 27

Small steep cut in sandy, silty soil. Contrast the revegetation and soil stability problems here with successful revegetation efforts nearby (see next plate). Alaska Highway, km 1398.

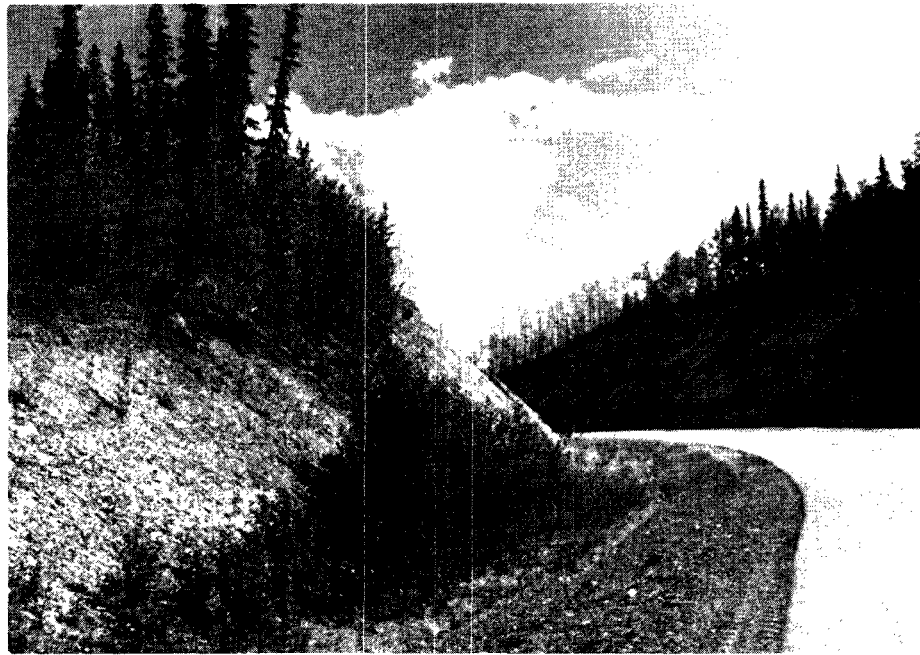
PLATE 28

Location as for Plate 27, well vegetated 30° backslope.

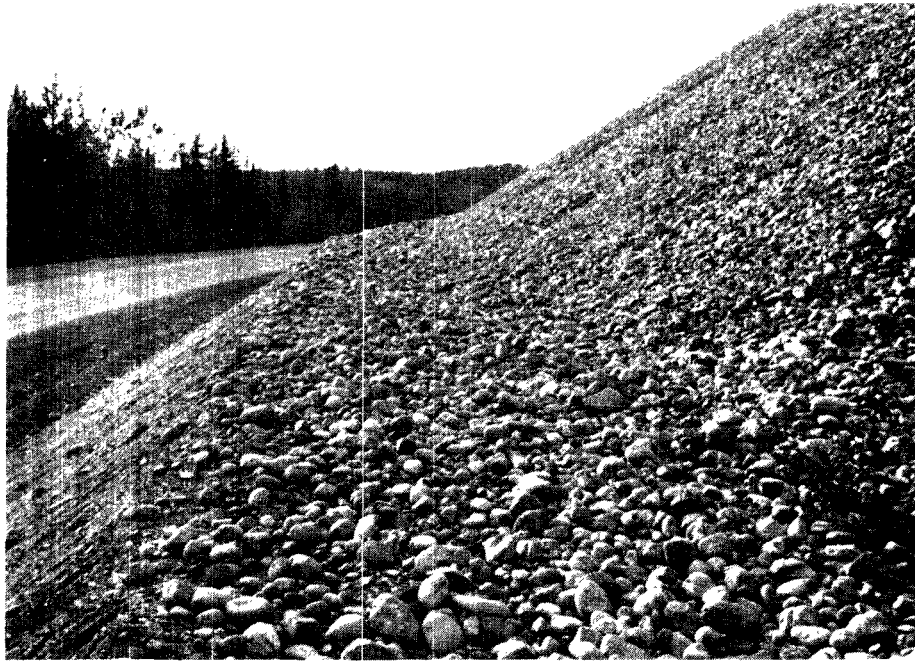
PLATE 30

Bench cut in 30° backslope prevents stones and gravel from collecting at base. Revegetation starts on bench and eventually provides a seed source for the revegetation of adjacent areas. Klondike Highway.

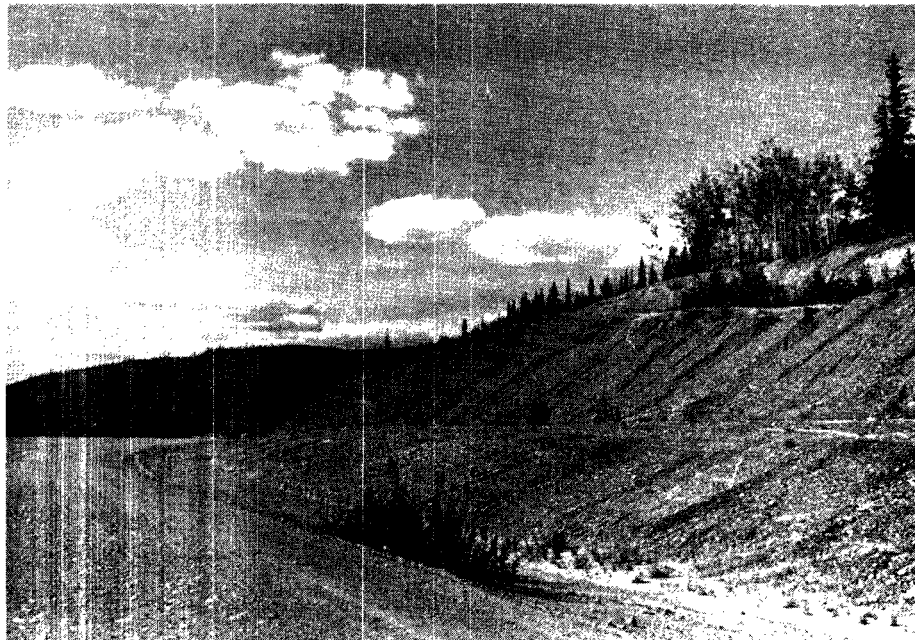
PLATE 31

Benches cut in 30° backslope, sandy soils. Benches beginning to vegetate. They were likely cut to meet additional fill requirements during reconstruction operations. Klondike Highway.

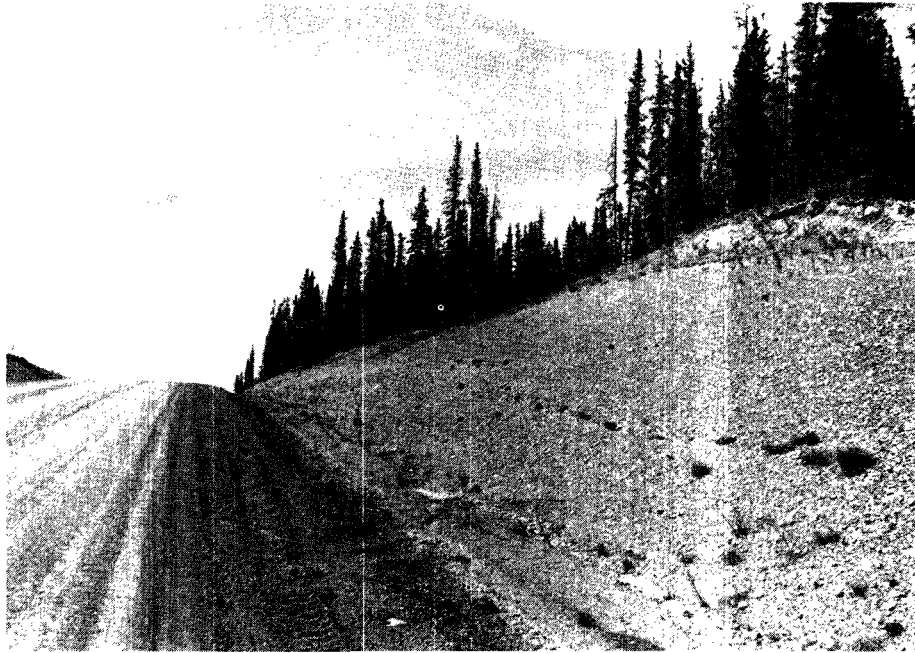
PLATE 32

Backslope at 35°, sandy soil, covered with a layer of gravel. It is likely that sandy gravel originally covered the slope surface. Eventually the sand eroded away leaving pure gravel. Robert Campbell Highway, km 345.

iv) If backslopes are cut in silty or sandy soils and do not revegetate despite repeated efforts, then the slopes should be covered with a layer of gravel 0.3 m thick (Plates 32 and 33).

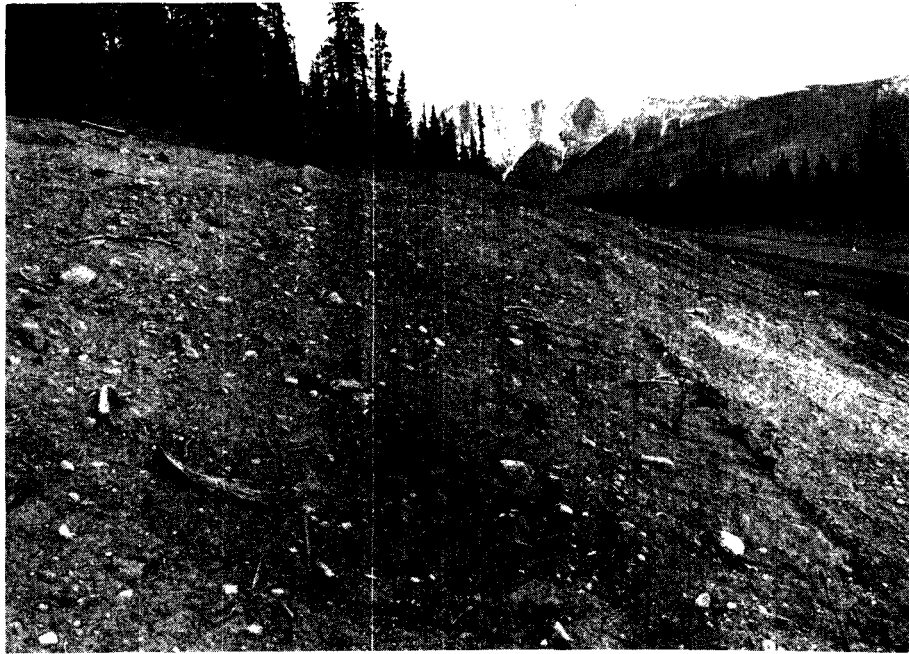
PLATE 34

Rounded off backslope in silty soil increases stability in the most slump-prone part of the slope and facilitates the spread of vegetation from areas at left of picture downslope. An abrupt change in slope gradient would have been less effective.

v) The tops of backslopes should be rounded-off to facilitate revegetation and prevent slumping (Plates 29 and 34).

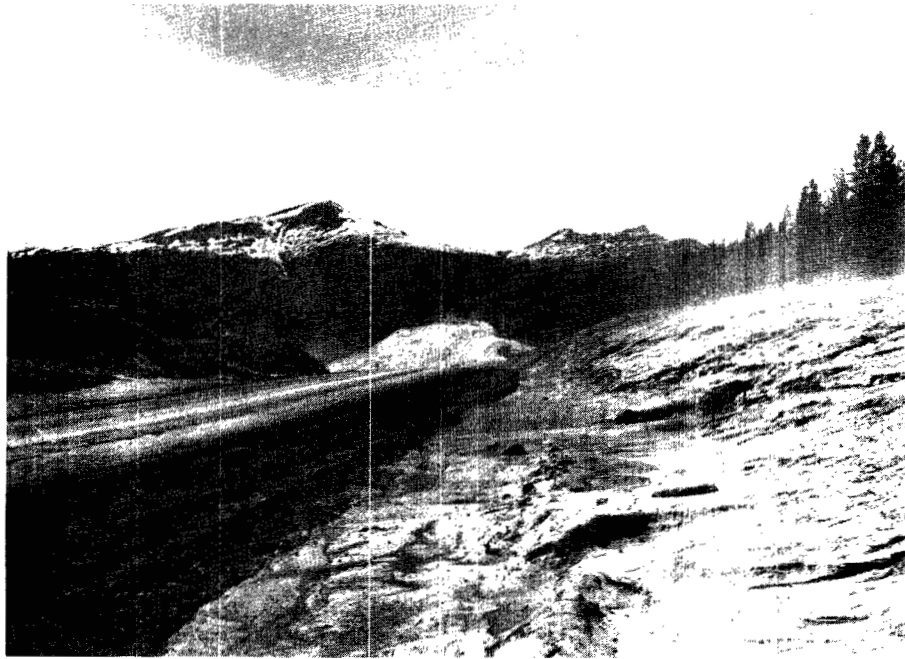
PLATE 35

Right-of-way approaching Seagull Creek, 60 m wide. Wind and water erosion problems are evident. No ditches or checks have been provided. No rip-rap or other means have been used to stabilize the area. Alaska Highway, km 1180. Reconstructed section.

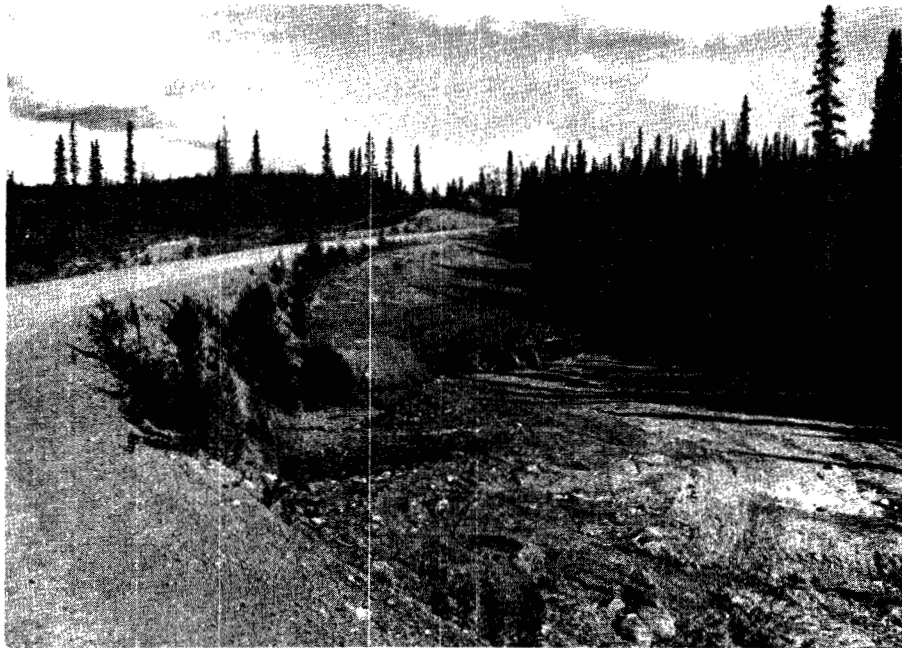
PLATE 36

Wide right-of-way cleared for reconstruction purposes at stream crossing. The area cannot revegetate because highway maintenance staff periodically plow it up with road graders. Robert Campbell Highway, km 397.

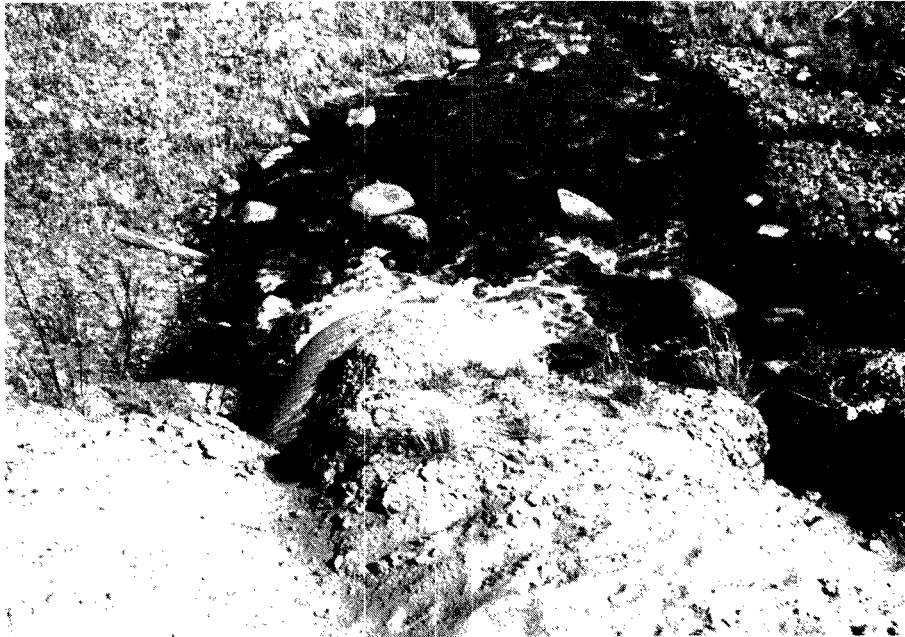
PLATE 41

Sand used for fill aggravates problem (see plate 40). Gravel should always be used to stabilize foreslopes at culvert entrances and exits. Serious erosion problems evident after reconstruction should be resolved by highway maintenance staff through addition of rip-rap. Cowley Creek, Alaska Highway, km 1459. Reconstructed section.

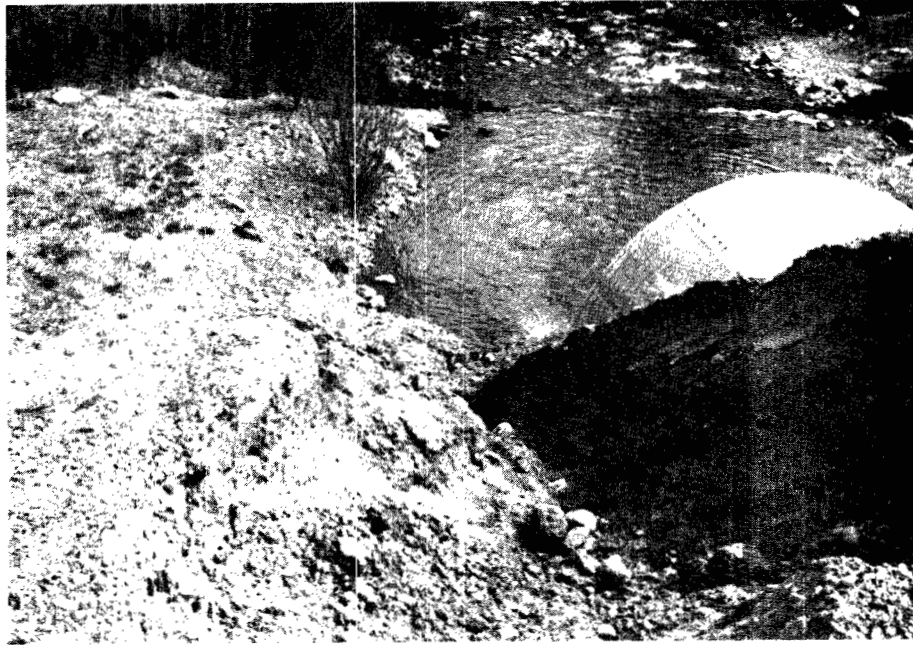
PLATE 42

For problem description, see Plate 41. Fill has high sand content. Wolf Creek, Alaska Highway, km 1459. Reconstructed section.

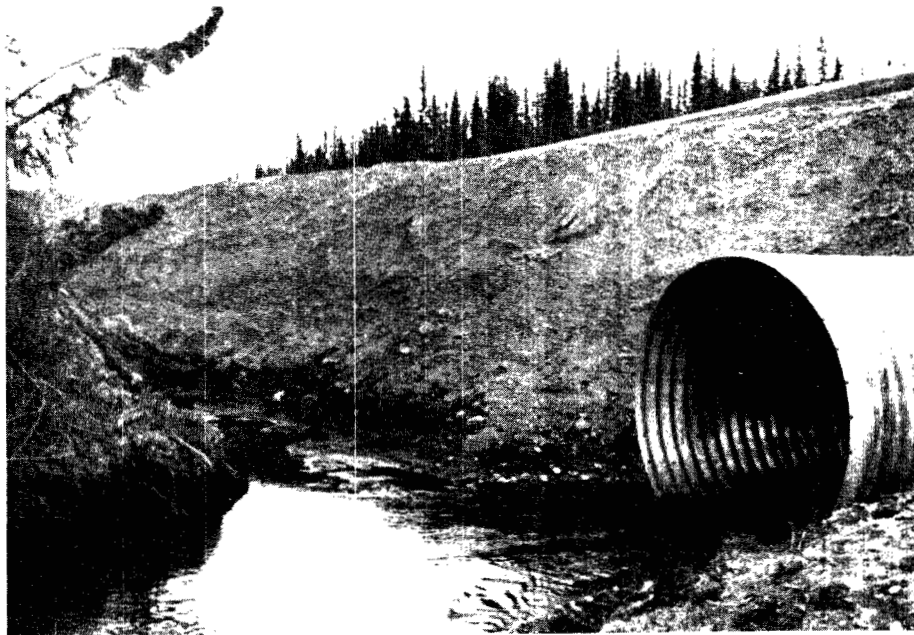
PLATE 43

Fill with high silt content and foreslope well in excess of 30° . Much of this material will end up in the stream and in the ditch; it will not stabilize or vegetate and is highly sensitive to erosion from highway runoff. Alaska Highway, km 1411. Reconstructed section.

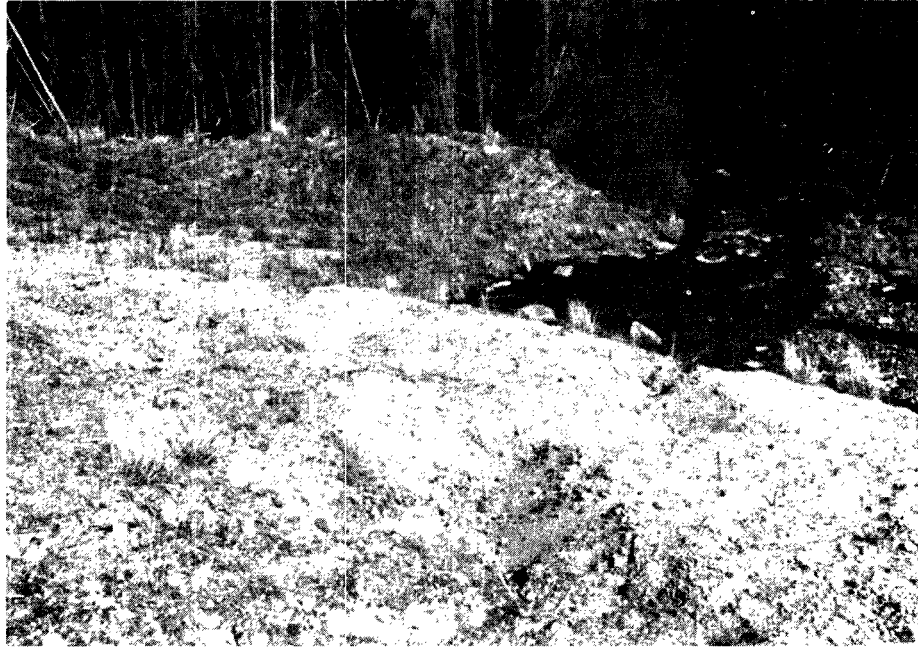
PLATE 44 When substantial fills are required at streams and in the approaches to streams, some of the fill ends up in shoreland areas on either side of crossing structures. Cowley Creek, Alaska Highway, km 1457. Reconstructed section.

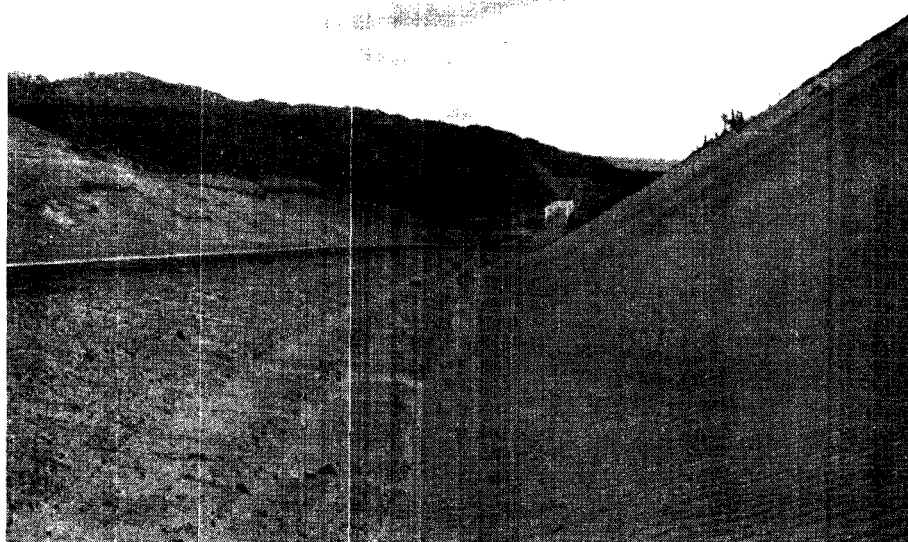
PLATE 48

Lack of rip-rap in ditch, approach to Yukon River, large silty sand backslopes. Alaska Highway, km 1444. Reconstructed section.

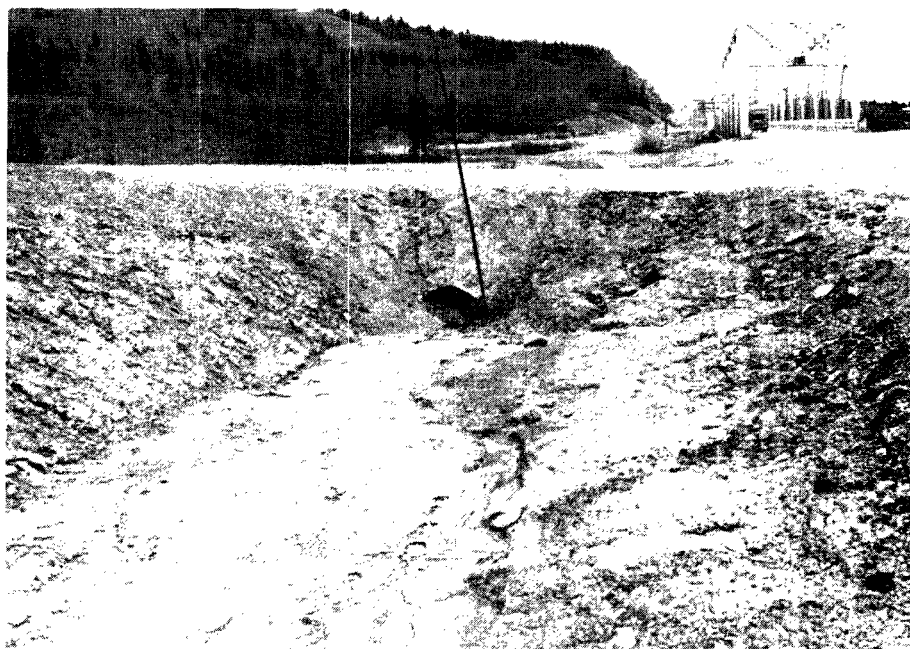
PLATE 49

Lack of rip-rap and under-sized, poorly maintained culvert in approach to Yukon River, Alaska Highway, km 1444. Reconstructed section.

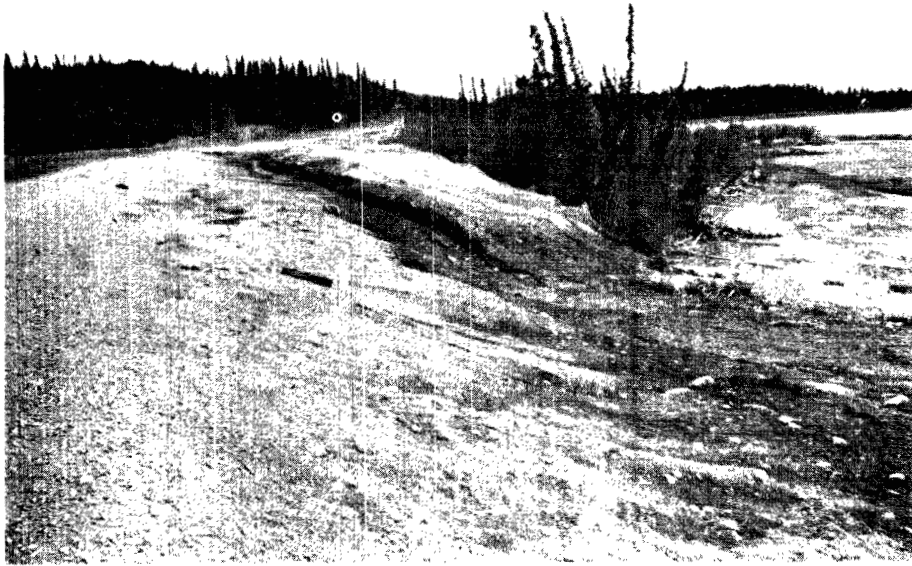
PLATE 51

Ditch in silty soil lacks rip-rap. Approach to bridge at Nisutlin Bay inlet, Alaska Highway, km 1291. Reconstructed section.

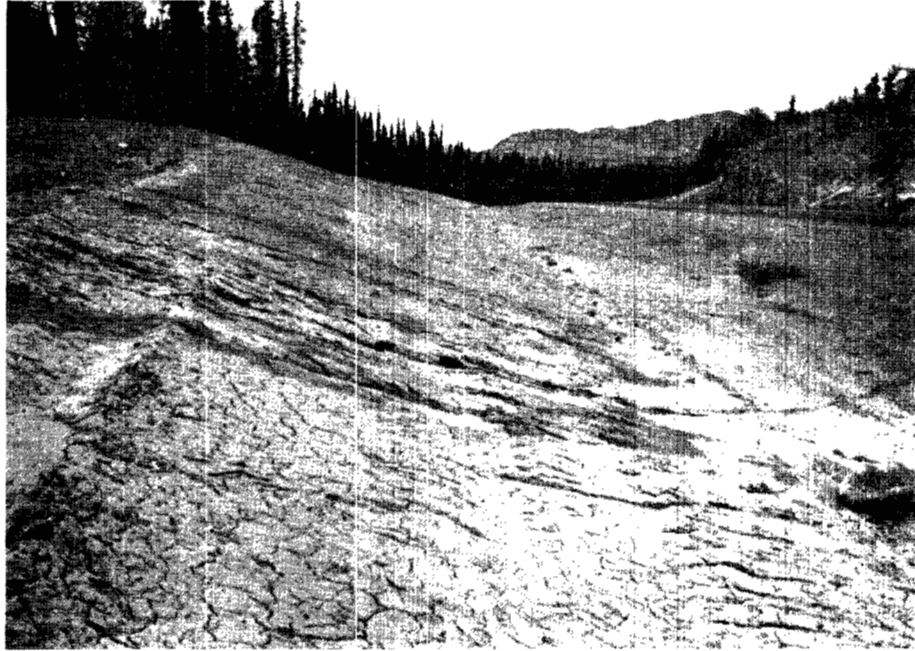
PLATE 53

Ditch lacks rip-rap. Sediment in run-off may clog minor drainage culverts (one is located at bottom of hill), erosion-prone silty soils. Alaska Highway, km 1415. Reconstructed section.

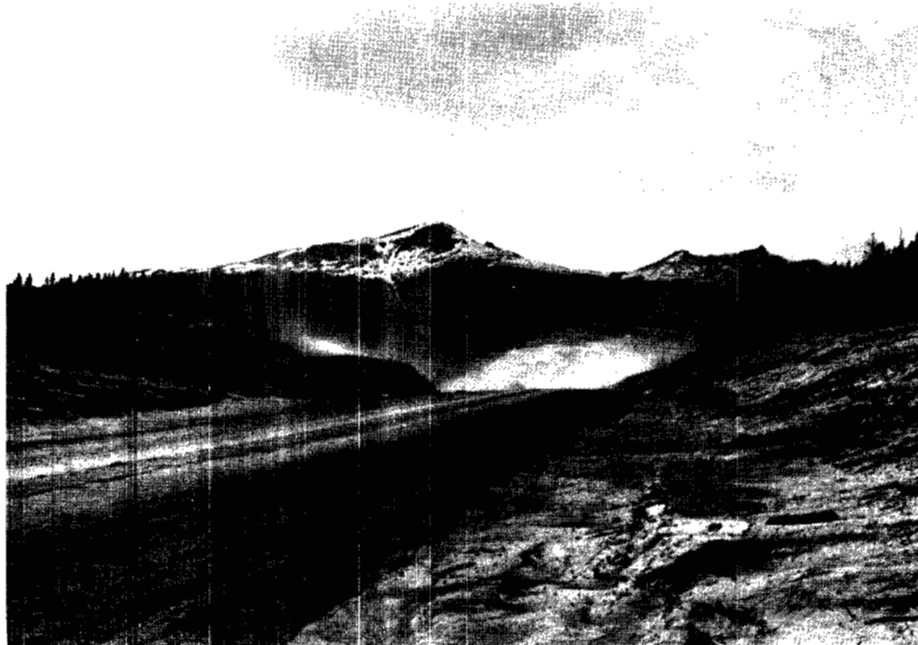
PLATE 54

For problem description, see Plate 53. Alaska Highway, km 1416. Reconstructed section.

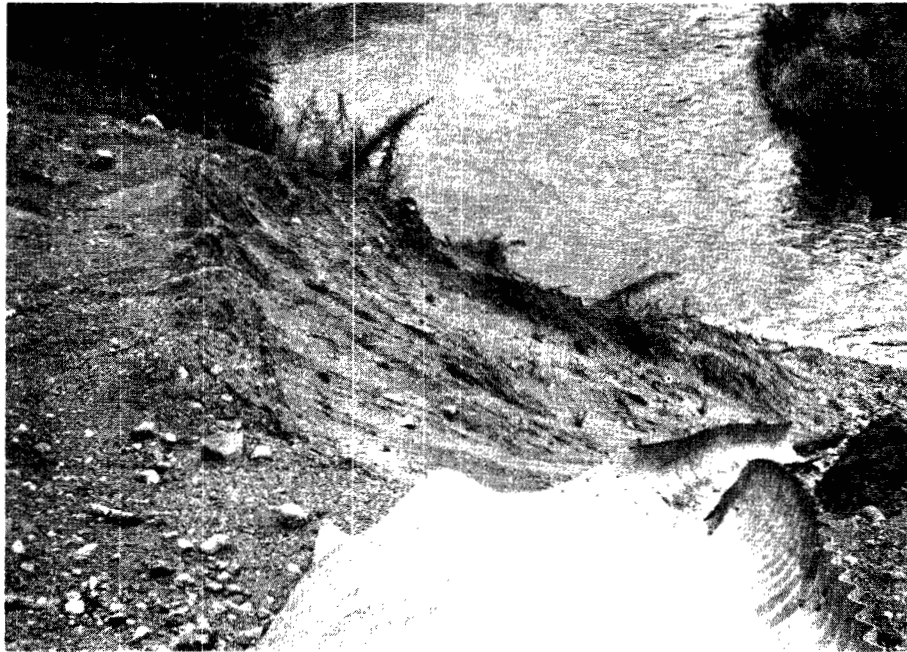
PLATE 55

Backslopes are usually constructed at angles well in excess of 30 degrees. Such slopes are unstable and will not vegetate. The problem is greatest in areas having soils with a high silt or sand content (Plate 55). Other techniques are available for stabilizing backslopes (benches, rip-rap) but are never used in the Yukon.

Steep, sandy-silt backslopes in approach to Seagull Creek. Alaska Highway, km 1180. Reconstructed section.

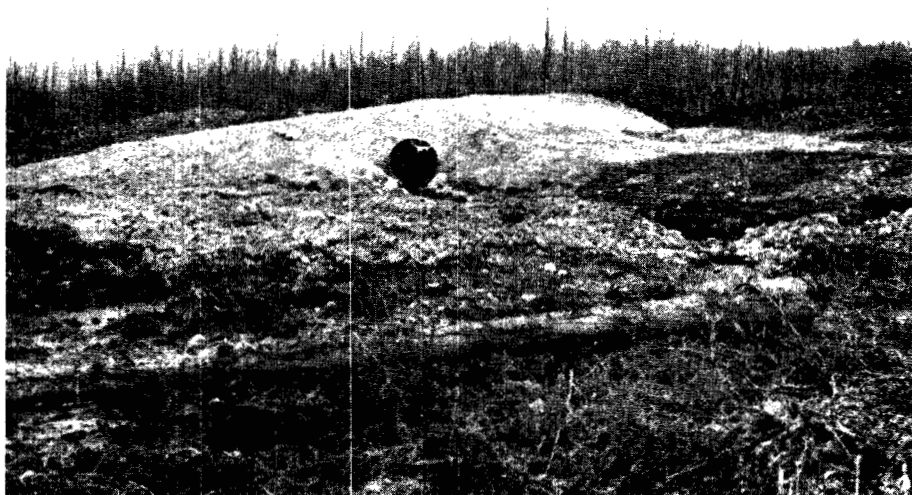
PLATE 57 Minor stream crossing, note extensive destruction of shorelands. Alaska Highway, km 1501. Section being reconstructed.

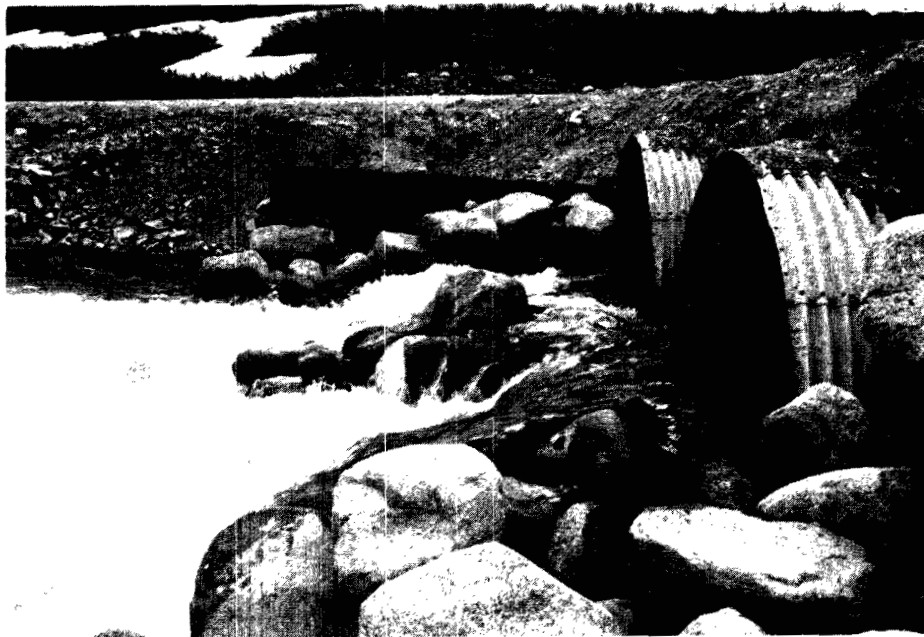
PLATE 62

Stream cross-sections inside most culverts were found to be noticeably smaller than natural stream cross-sections. Observations were made in early June when stream flows are high (Plates 61 and 62).

Description as for Plate 61.
Carcross Highway.

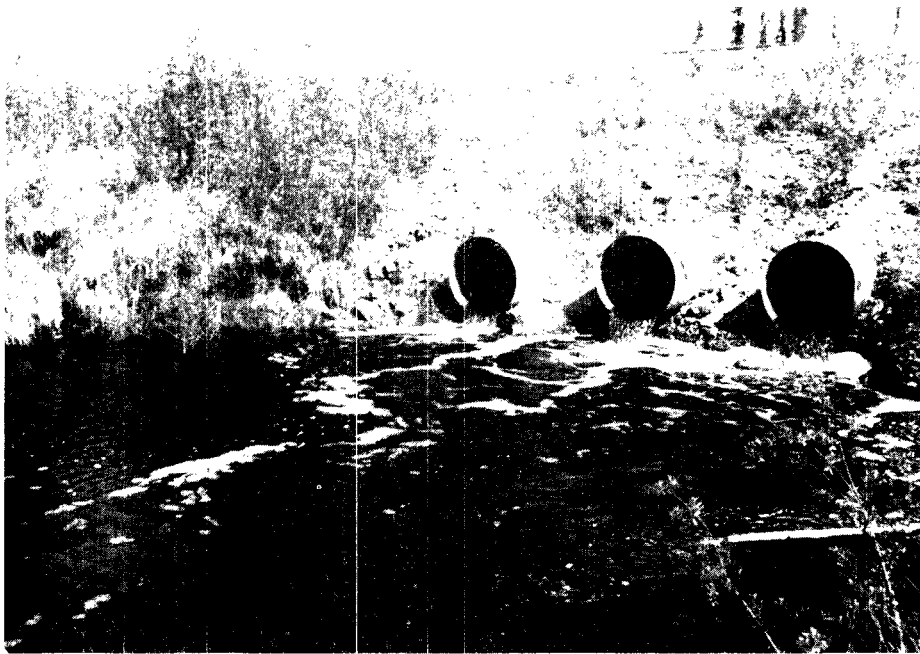
PLATE 63

Culvert installed in a nearly horizontal position. Stream drops steeply as it leaves the culvert. Haines Road, km 81.

- xiii) All culverts should be installed on the stream gradient.
- xiv) Culvert inverts should be installed below the natural stream bottom. More sophisticated criteria are clearly required here; ones which relate culvert diameter to the optimum depth for installation of inverts (Plates 85, 87 and 89).
