**ENVIRONMENTAL CONCERNS AND RECOMMENDATIONS:
ALASKA HIGHWAY RECONSTRUCTION AND MAINTENANCE
KILOMETRE 1008-1635**

Robert Baker
Federal Activities Branch - EICD
Environmental Protection Service
Environment Canada

EPS 8-PR-80-1

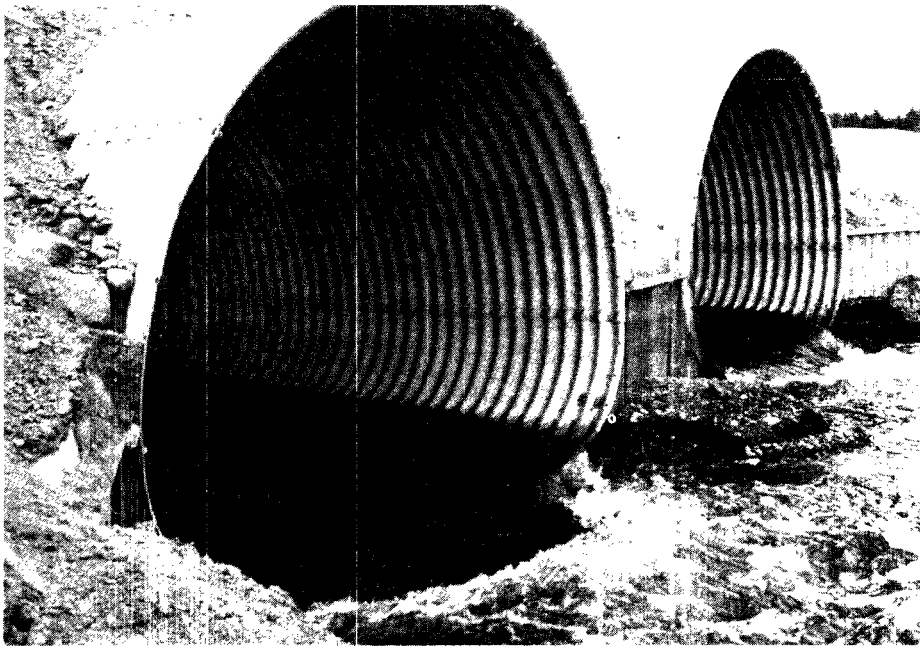
PLATE 64

Description as for Plate 63. Alaska Highway, reconstructed section near Tok, Alaska.

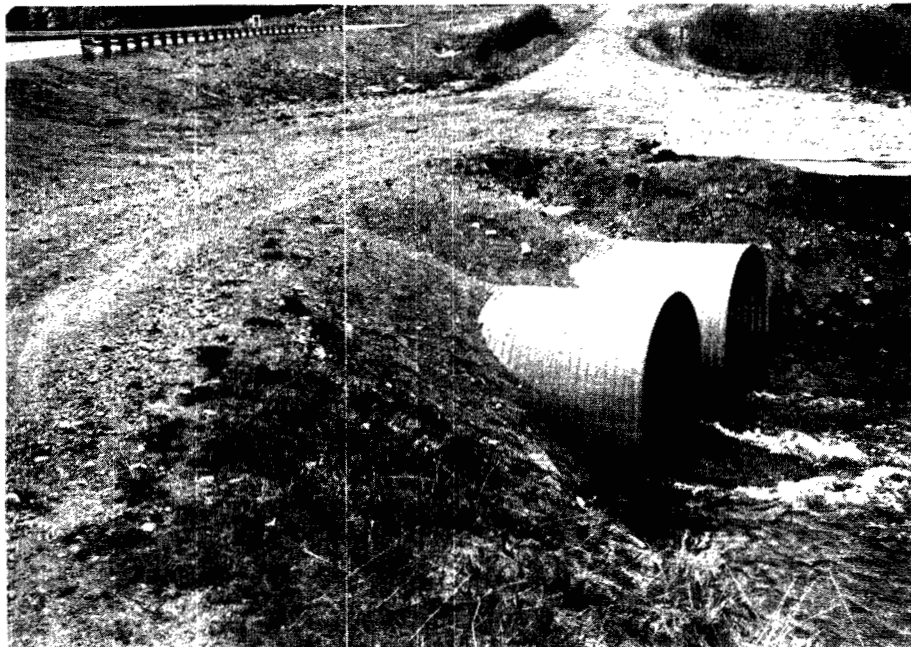
PLATE 66

Description as for Plate 63.
Haines Road, mile post 120.

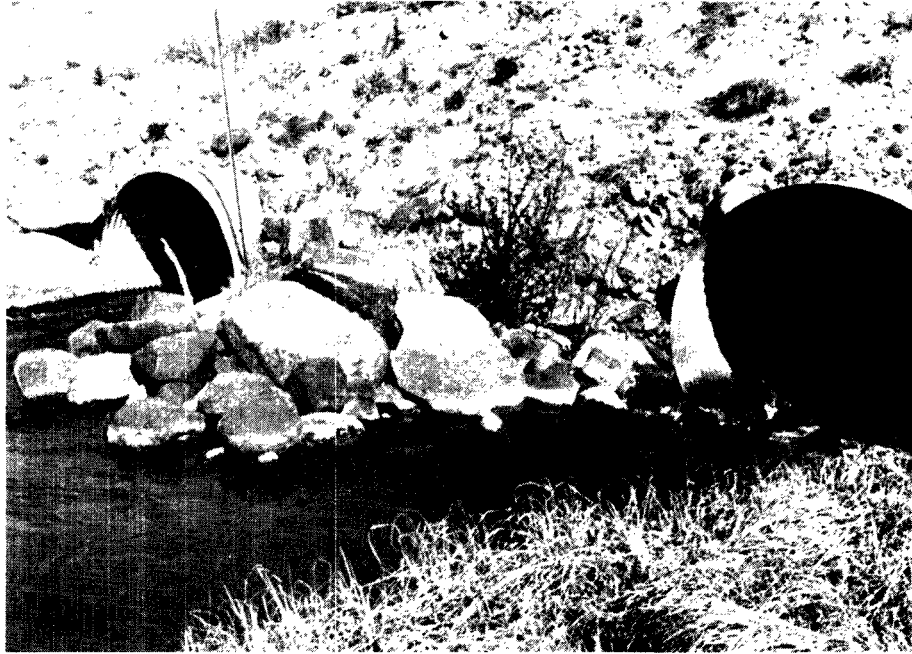
PLATE 67

Description as for Plate 63. McIntyre Creek, Alaska Highway, km 1479.
Reconstructed section.

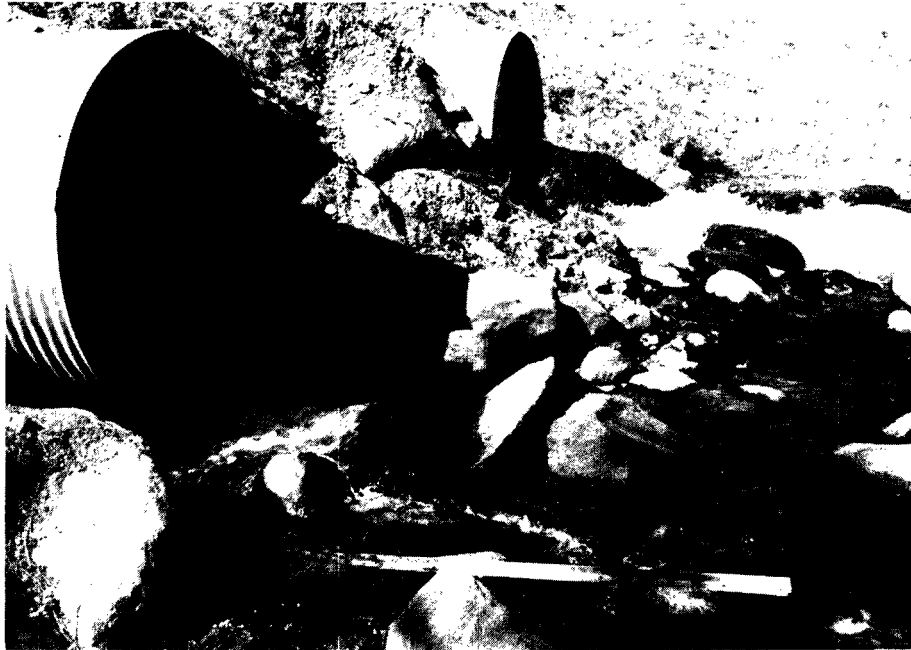
PLATE 68

Culvert installed in a nearly horizontal position, view of culvert entrance. Cowley Creek, Alaska Highway, km 1457. Reconstructed section.

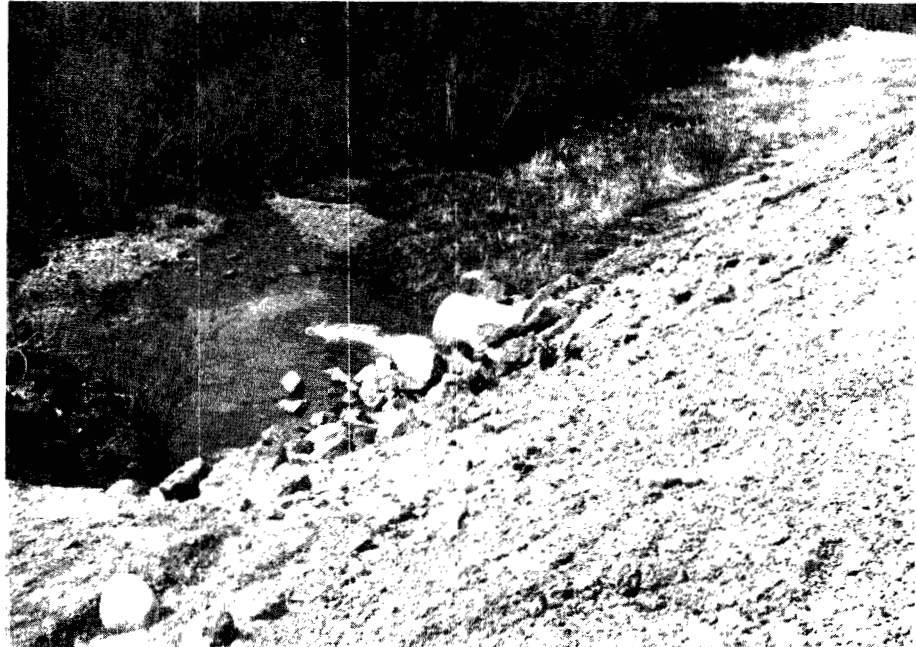
PLATE 69

Stream must drop down sharply as it leaves culvert. Cowley Creek, Alaska Highway, km 1457. Reconstructed section.

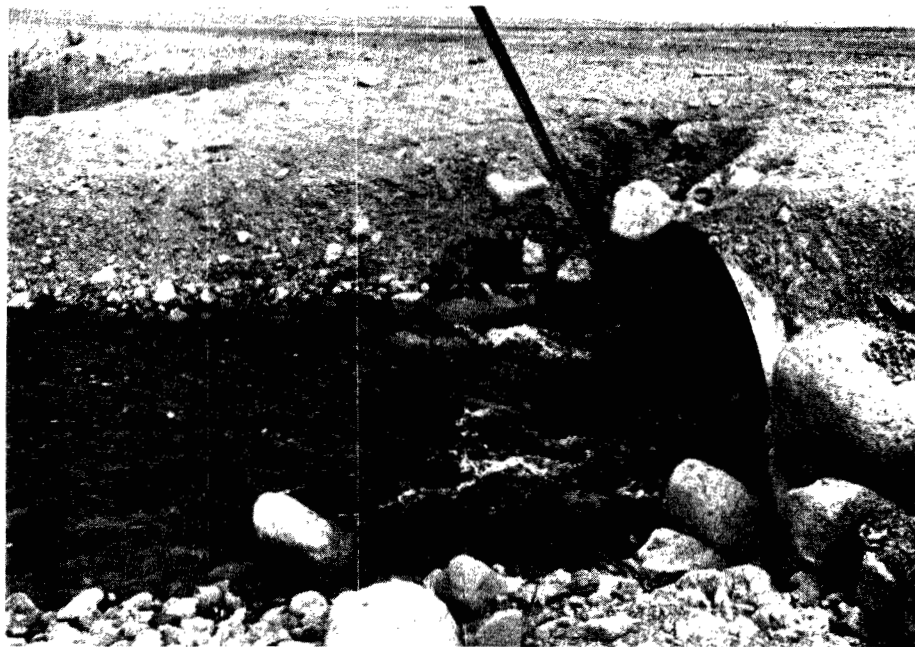
PLATE 70

Grayling stream, water must drop down sharply as it leaves culvert. Alaska Highway, km 1421.5. Reconstructed section.

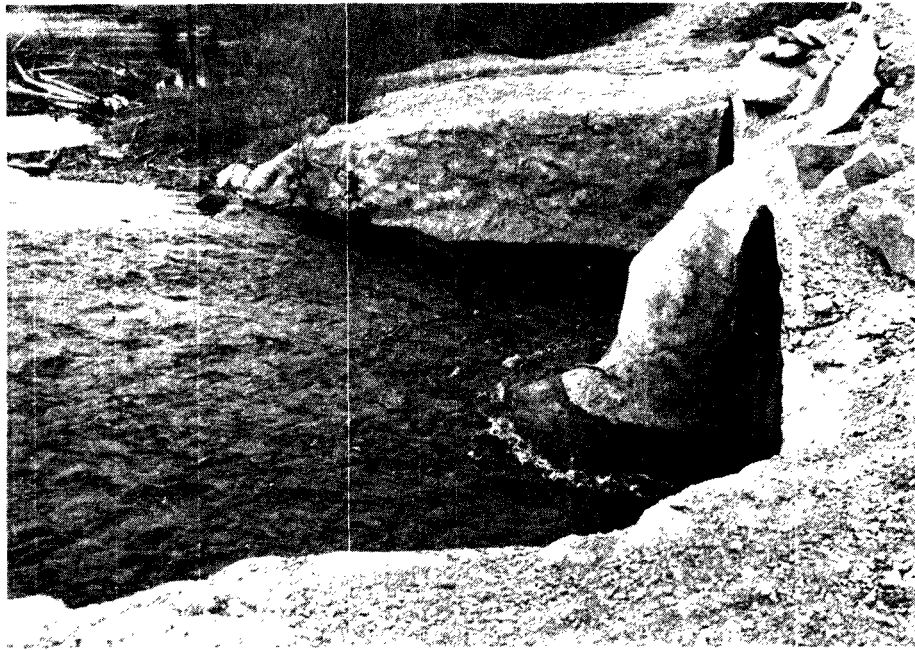
PLATE 71

Culvert installed in a nearly horizontal position, stream flow affected at culvert entrance. Alaska Highway, km 1185. Highway to be reconstructed.

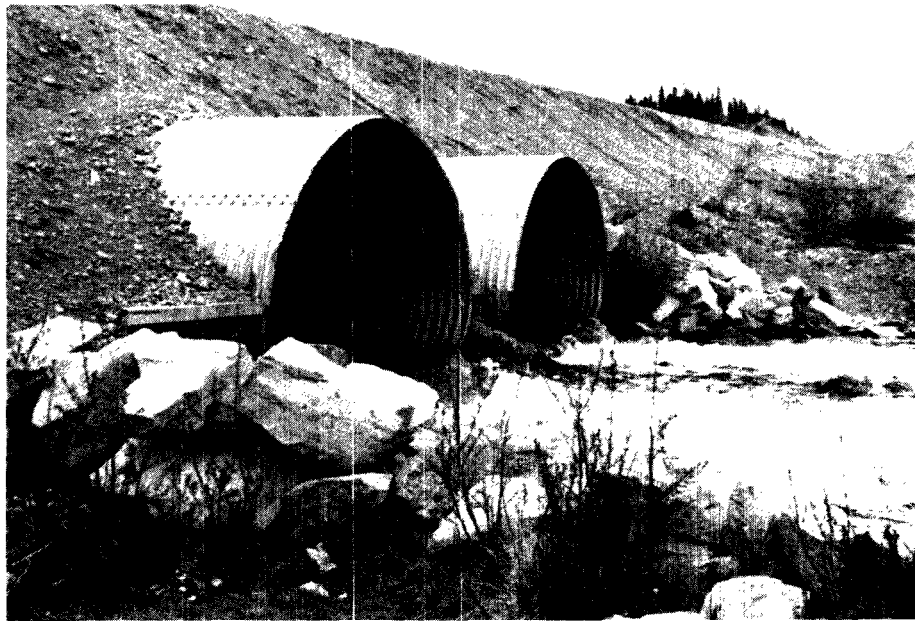
PLATE 72

Culverts installed in a nearly horizontal position, stream flow affected at culvert entrances. Marshall Creek, Alaska Highway, km 1619. Highway to be reconstructed.

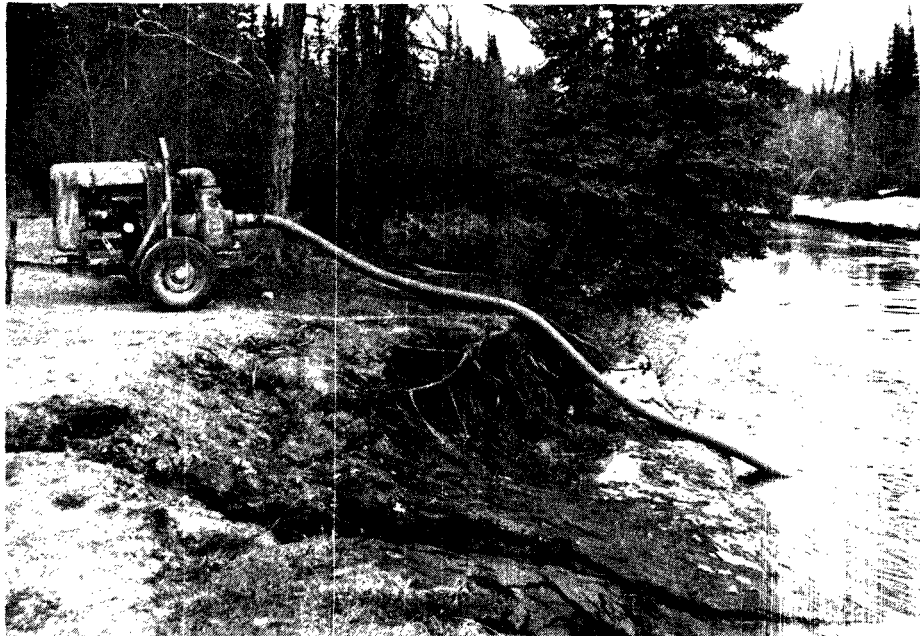
PLATE 77 No access restriction to the banks of this creek. Alaska Highway, north of Haines Junction.

- xix) Vehicular access to shorelands at stream and river crossings should be controlled. This recommendation can be met if reconstruction and maintenance practices are chosen which allow large amounts of vegetation to remain on either side of crossing structures (Plates 90-92).

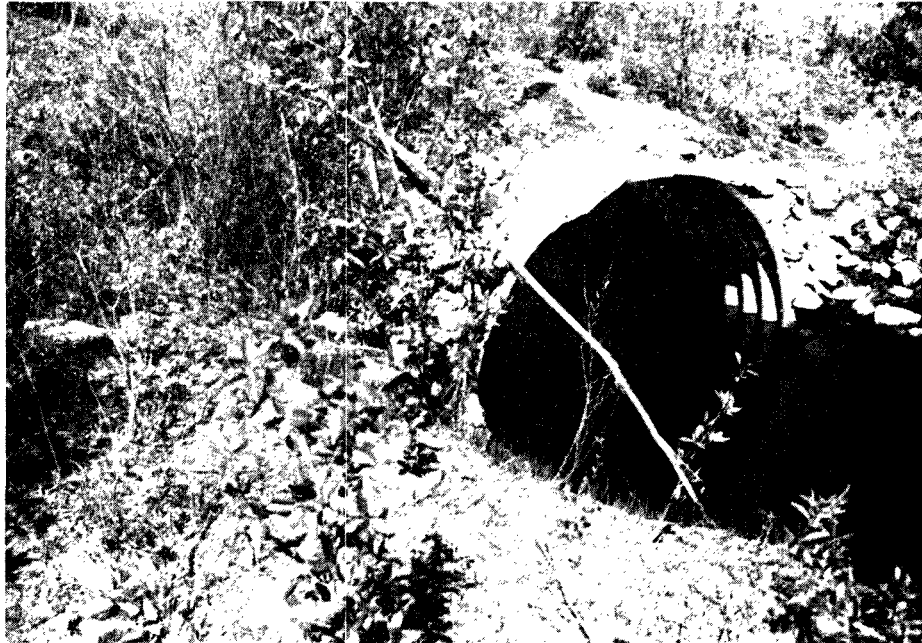
PLATE 82

Minor stream crossing, vegetation cleared at culvert exit. Location as for Plate 81.

- ii) Highway maintenance staff should not use road graders to remove vegetation in the areas defined above in i) (Plates 79-82).
- iii) Highway maintenance staff should not use vegetation mowers or cutters within 16 m of any major stream or river crossing or within 3 m of any minor stream crossing (Plates 81 and 82).

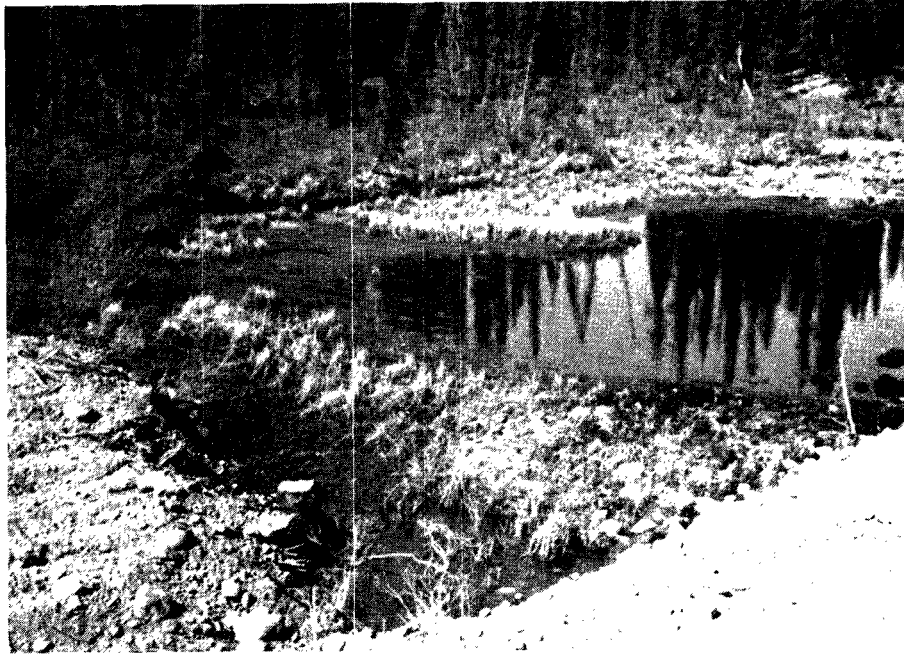
PLATE 94

Excessive use of fill, right-of-way vegetation cleared with road grader adjacent to wetland. In 1976, a 5 - 7 m aspen buffer zone separated this wetland from the highway. The wetland supports buffle heads in the spring. Alaska Highway, km 1393. Reconstructed section.

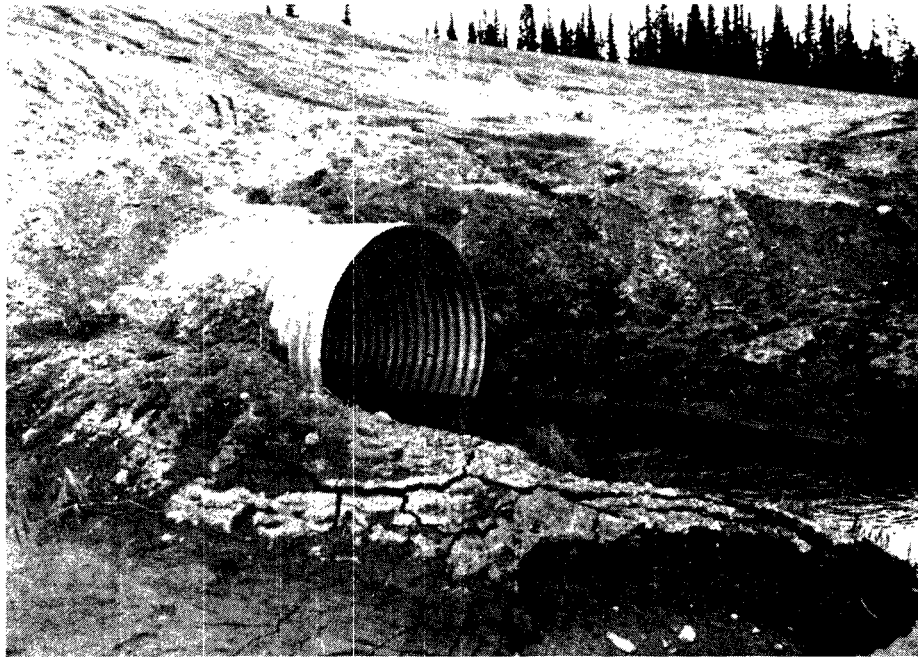
PLATE 102

Description as for Plate 101. Highway maintenance staff use road graders in shoreland areas to clear vegetation.

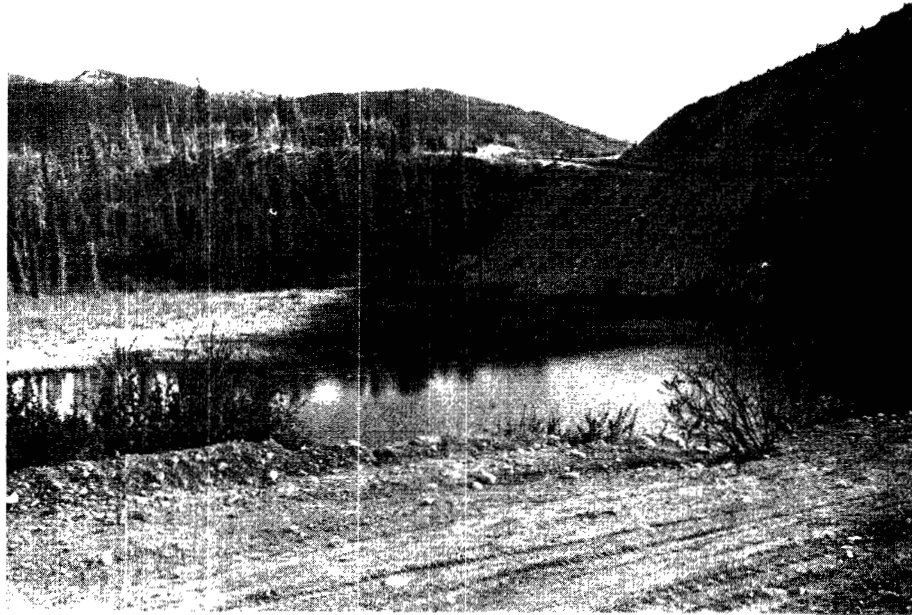
When fills are required near wetlands or streams, some of the fill inevitably ends up on those areas (Plates 101-103). The wetlands along the Rancheria River are in an area of particular concern (Plates 104 and 105); some backslopes are unstable and the spoil accumulating at their bases could be dumped into the Rancheria River or into wetlands (Plates 106 and 107).

In certain instances, as along the Rancheria River, it is possible that present plans for highway straightening and widening will result in the destruction of a number of wetlands (Plates 104 and 105).

PLATE 104 When extensive cuts are needed for highway widening and straightening adjacent to wetlands some of the cut material may end up in the wetland instead of on the highway (ordinarily cut material is used as fill on other sections of highway). Alaska Highway, km 1128.

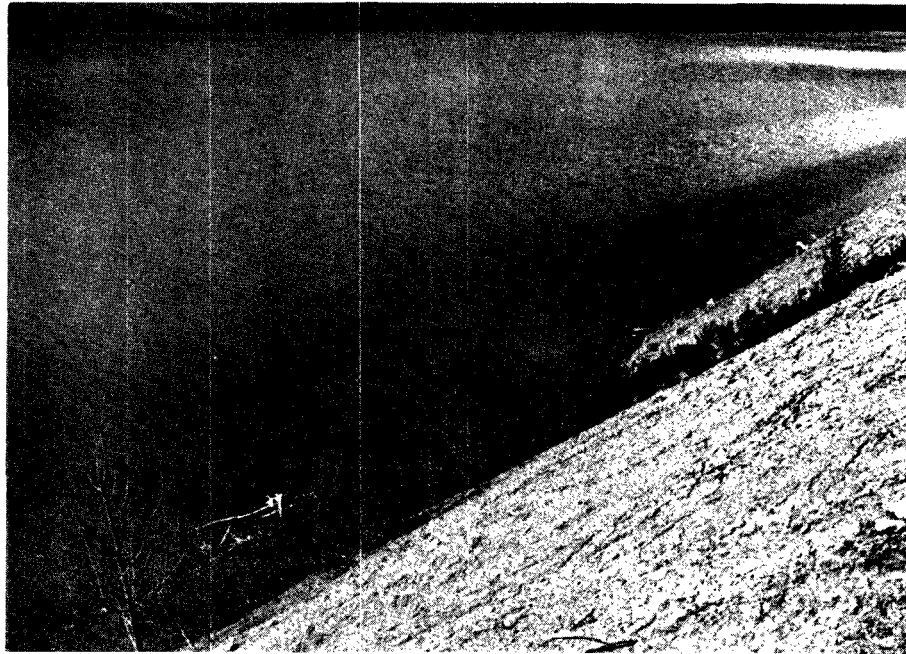
PLATE 106 Front-end loader dumping spoil from base of steep, unstable backslope into Fox Lake. Klondike Highway, km 70.

xii) Spoil removed from the base of unstable backslopes during maintenance clearing operations should not be dumped into the Rancheria River or into wetlands associated with the Rancheria River (Plate 132).

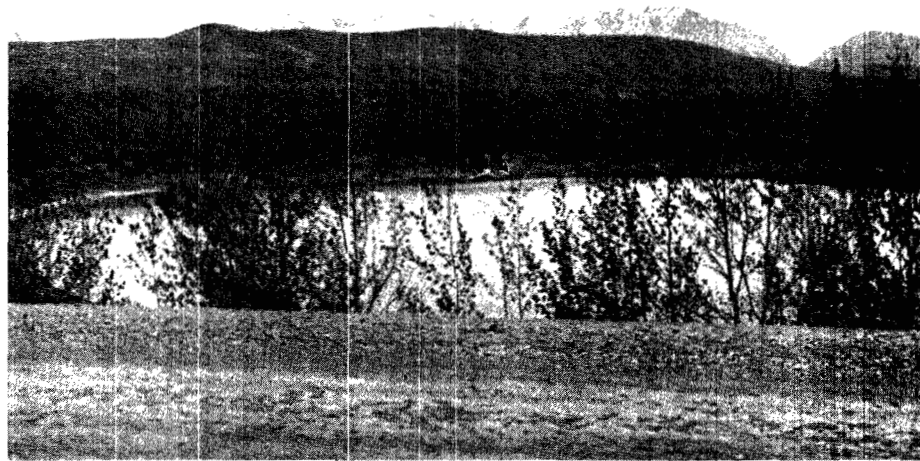
PLATE 108

Small lake showing narrow buffer zone to highway (at right) and to rest stop (foreground). Highway widening towards the lake would destroy the buffer zone. Uncontrolled movement of heavy equipment at the rest stop would destroy that buffer zone. If trees had been left standing in the buffer zone the latter problem would not likely occur. (see Plate 110). Alaska Highway, km 1155. Highway to be widened.

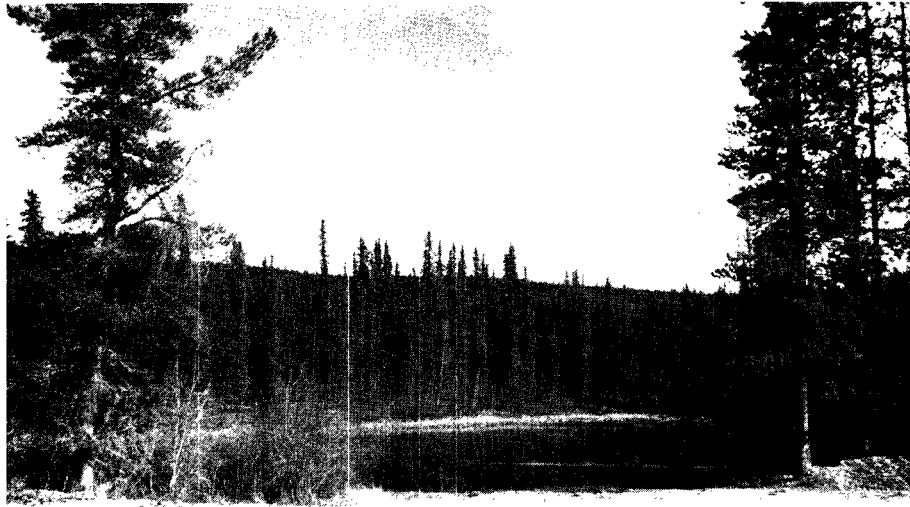
PLATE 109

Pond showing narrow buffer zone to highway. If the highway is widened toward the lake the vegetated foreslope/buffer zone will be destroyed. This is one of the few ponds between Whitehorse and Haines Junction, hence it has a high scarcity value. Alaska Highway, km 1523 - 24. Highway to be widened.

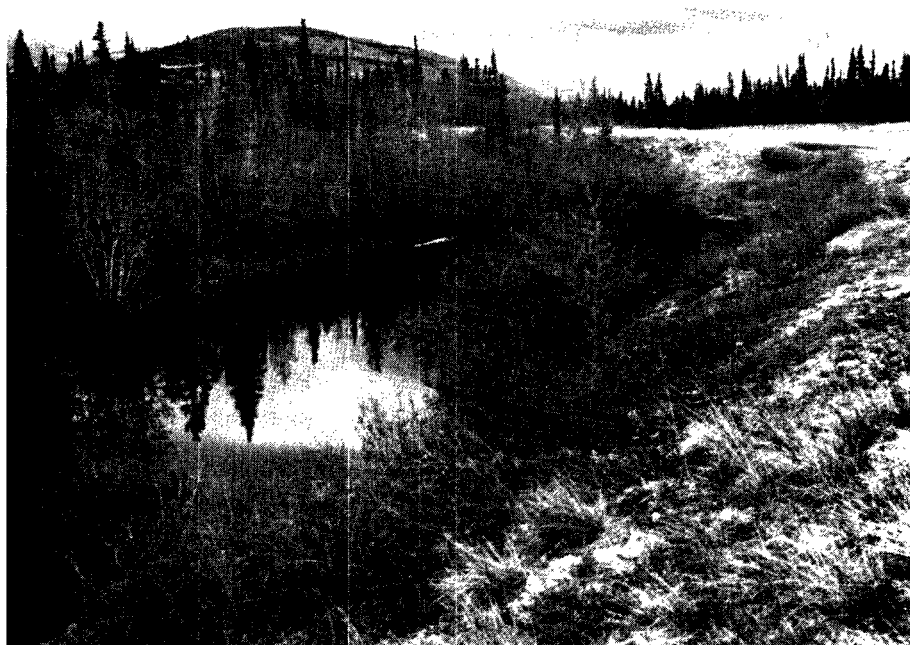
PLATE 110

Controlled vehicular access at small lake. The highway is to be widened here and heavy equipment could destroy the treed buffer zone. Alaska Highway, km 1359.

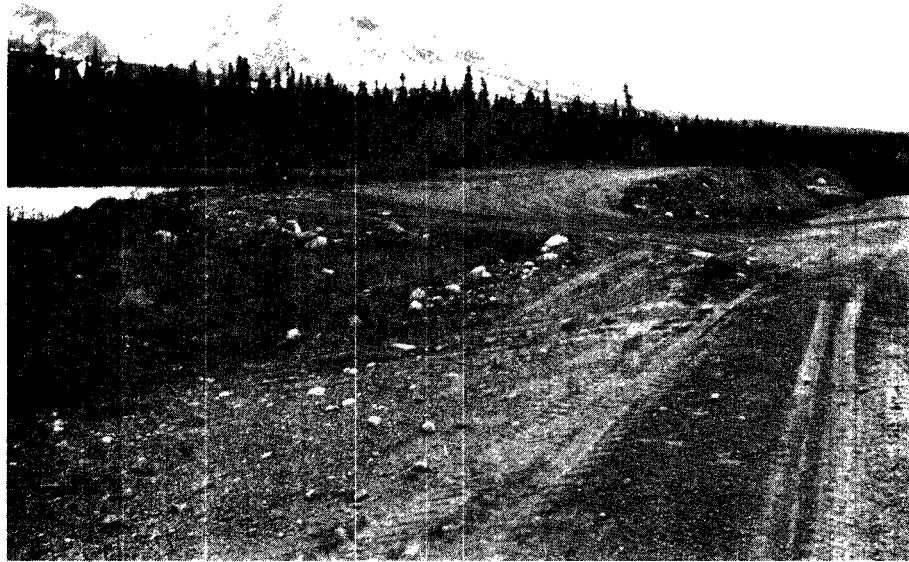
PLATE 111

One of the few ponds between Whitehorse and Haines Junction; it has a high scarcity value. The highway is to be relocated here and the new alignment may result in the partial filling in of the pond. Alaska Highway, km 1590.

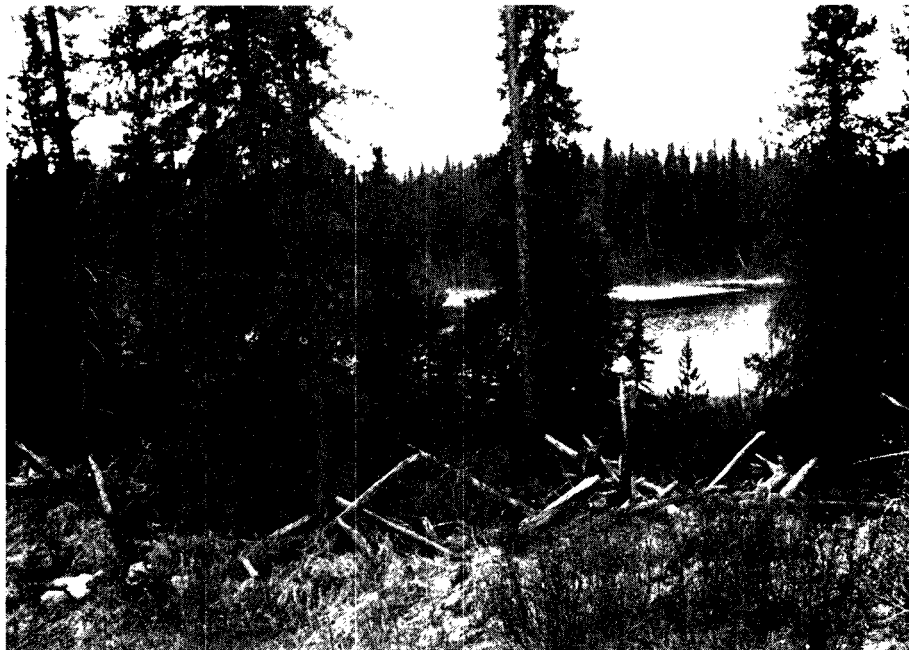
PLATE 112

Uncontrolled vehicular access to small lake results in buffer zone destruction. Haines Road, km 151.

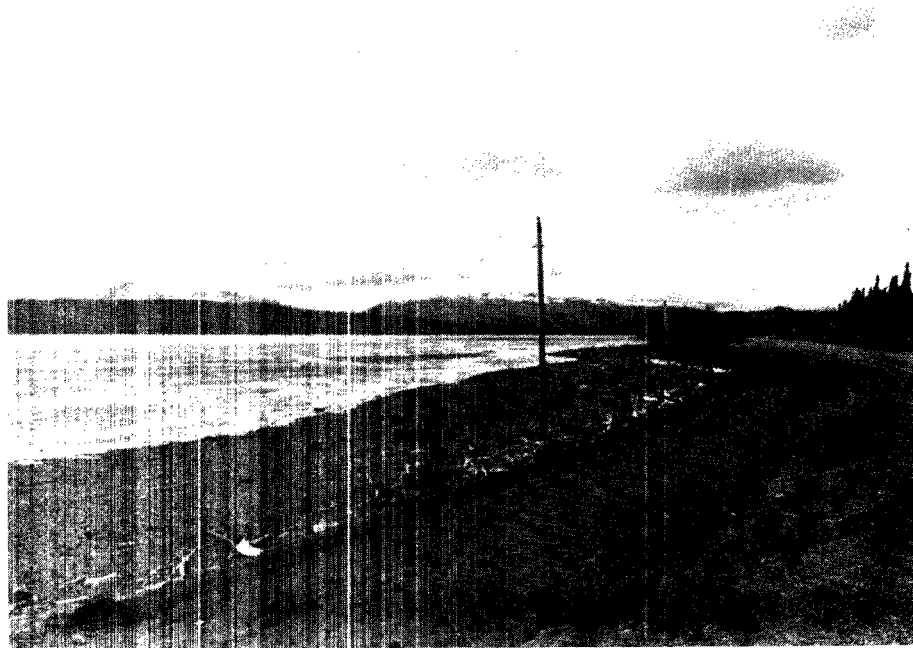
PLATE 118 Service road/right-of-way maintenance clearing between Alaska Highway and Morley River. No vegetated buffer zone.

xi) Highway maintenance staff should not use road graders to clear vegetation within 30 m of any lake, wetland or river.

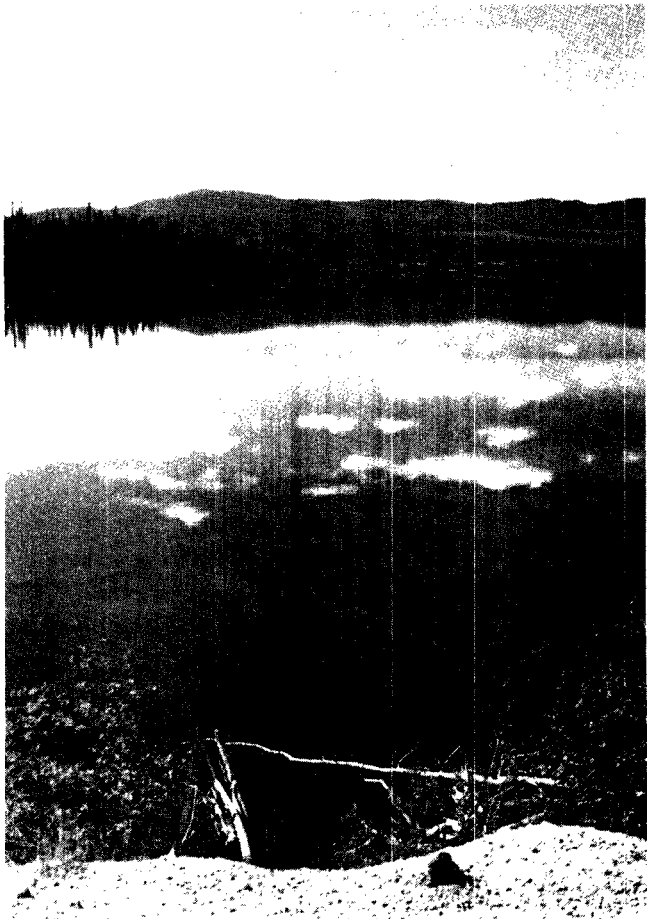
PLATE 120

Fill inadvertently dumped into
Morley River. Reconstructed
section of Alaska Highway.

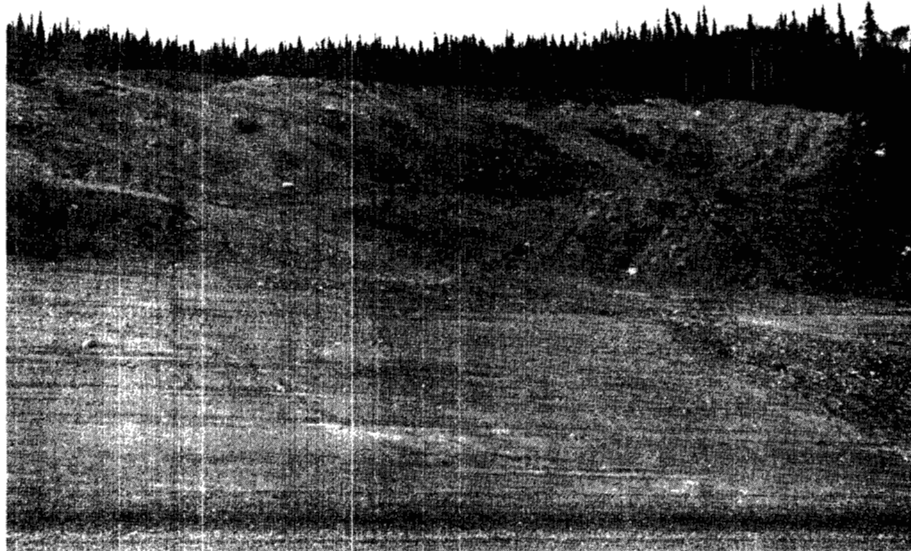
PLATE 133

Borrow pits are often situated near water bodies because gravel deposits are frequently substantial in such areas. Borrow pits located near the highway cause aesthetic problems (Plate 133). Abandoned borrow pits are rarely landscaped or seeded (Plate 133). Buffer zone space may be provided between the highway and borrow pits; however, trees and shrubs in these areas are often removed (Plate 134). Buffer zone vegetation is often prevented from developing because vehicular access at borrow pits is not restricted. Single entrances/exits at both existing and abandoned borrow pits are needed to resolve this problem, but are usually not provided (Plate 135). Road graders are used to keep wide areas of highway right-of-way cleared of vegetation in the vicinity of borrow pits. Buffer zone vegetation is removed in the process (Plates 136 and 137). Slash is sometimes not removed at borrow pits (Plate 138).

Abandoned borrow pit lacks a single entrance/exit to provide opportunity for buffer zone vegetation to develop, is not landscaped and revegetation efforts have not been taken. It is aesthetically unpleasing to tourists and others who travel the Alaska Highway, km 1392. Reconstructed section.

- iii) Berms should be used at existing and abandoned borrow pits to control access when pits are located near the Alaska Highway and whenever access is unrestricted. Berm slopes should not exceed 1.5:1 and should be hydro-seeded (Plate 139).

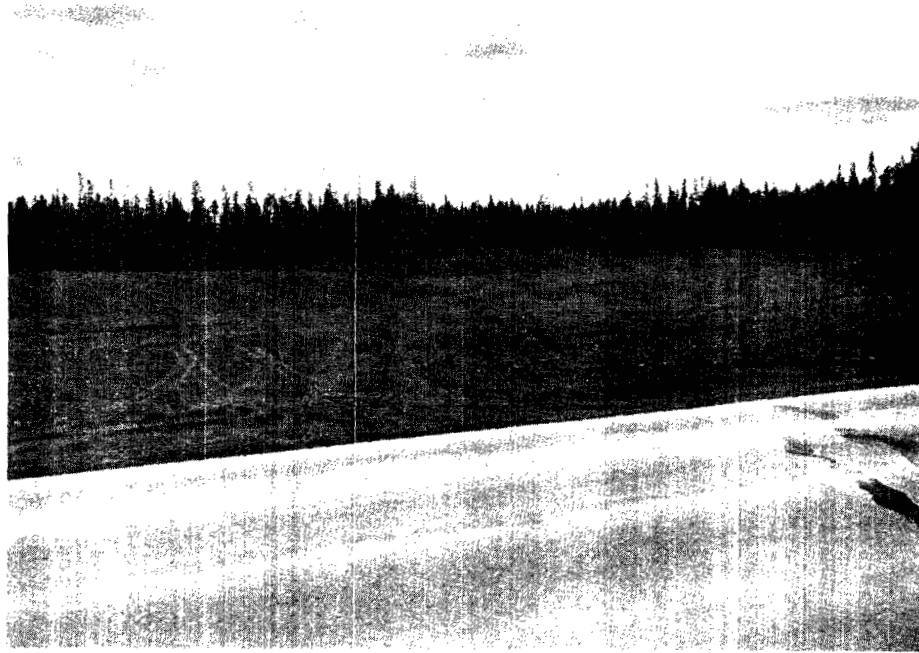
PLATE 135

Unrestricted access to borrow pit prevents buffer zone vegetation from developing, pit is abandoned and has been well landscaped. Alaska Highway, km 1026. Reconstructed section.

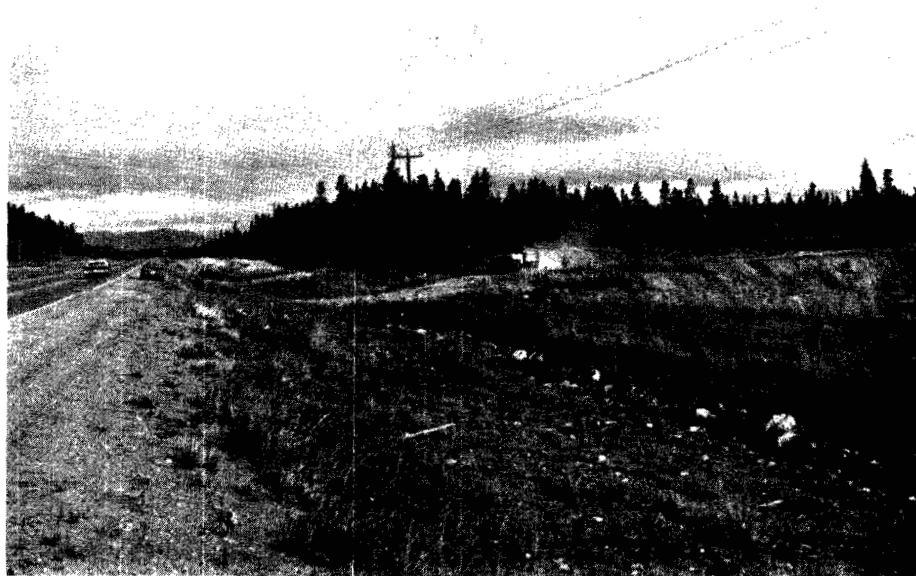
PLATE 136

Restricted access to borrow pit. Road graders periodically clear the buffer zone area to prevent trees and shrubs from growing. The next plate shows how vegetation can develop in such areas if given a chance. Alaska Highway, km 1470. Reconstructed section.

- iv) Trees and shrubs should not be removed from borrow pit buffer zones. Highway maintenance staff should not remove vegetation within 30 m of any borrow pit located on the Alaska Highway. These 30 m no-clearing zones should be clearly marked to assist equipment operators. If right-of-way clearing is essential for sighting or other purposes, then a vegetation cutter should be used to clear a swath no wider than 4 m.
