# Performance Assessment of Test Liners for Petroleum Product Storage Areas in Northern Canada

Technology Development Report

EPS 4-EC-78-6

EBA Engineering Consultants Ltd.  
Edmonton, Alberta

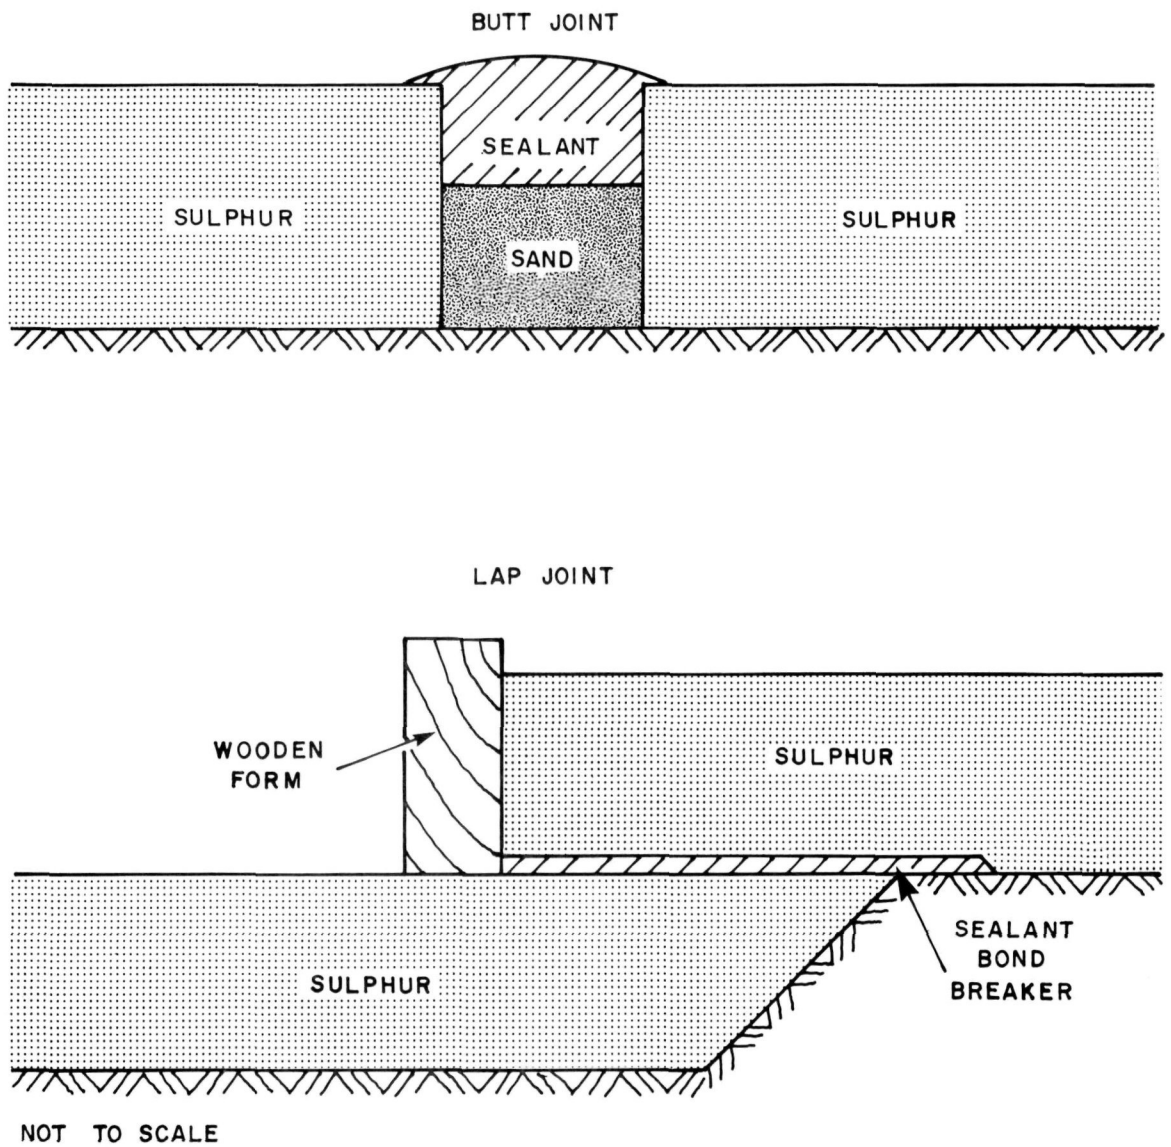
Fig.3 - SULPHUR PANEL JOINT DETAILS

Initial shrinkage upon cooling often resulted in formation of cracks along the wooden forms, as shown in Plate 10. When the panels had cooled, the wooden forms were removed, as illustrated in Plate 11; sand was poured in to within 1 cm (0.5 in) of the surface of the lining, and sealant was trowelled into the joint. Joint details are depicted in Figure 3. An asphalt-based sealant, Domtar Fibregum Plastic Cement, was used in the majority of the joints. Oil-based DAP Architectural Grade Caulking compound was used between panels 2 and 4, and DAP Butyl Gutter and Lap Sealer was used between panels 2 and 6.

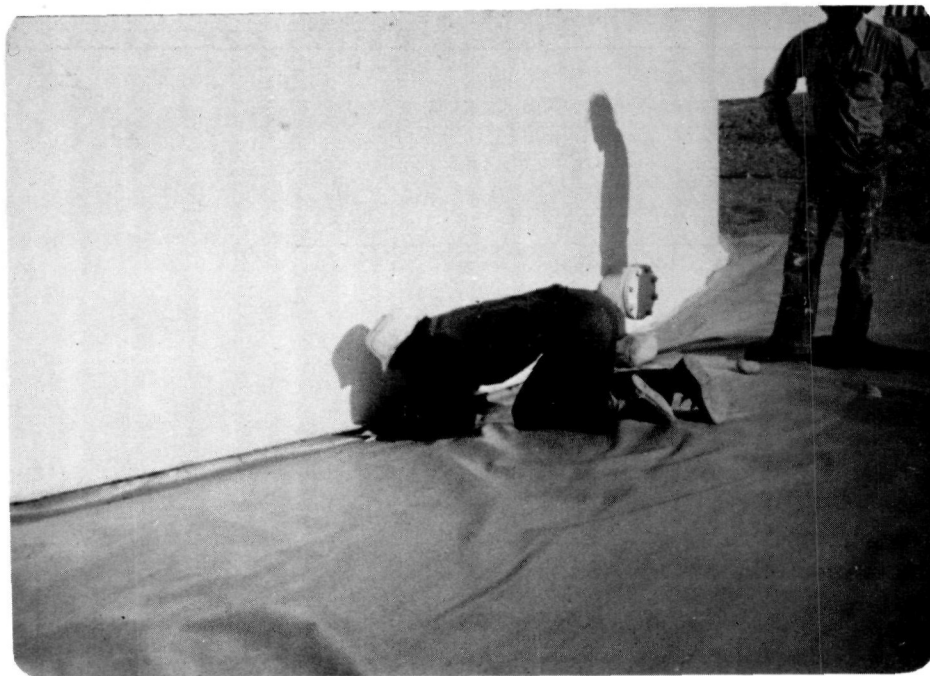
Plate 12 The Tufton backing fabric was hand-fitted around the tank: urethane foam was used to bond the fabric to the tank. The urethane coatings were applied monolithically from the base of the tank over the foam and across the Tufton.

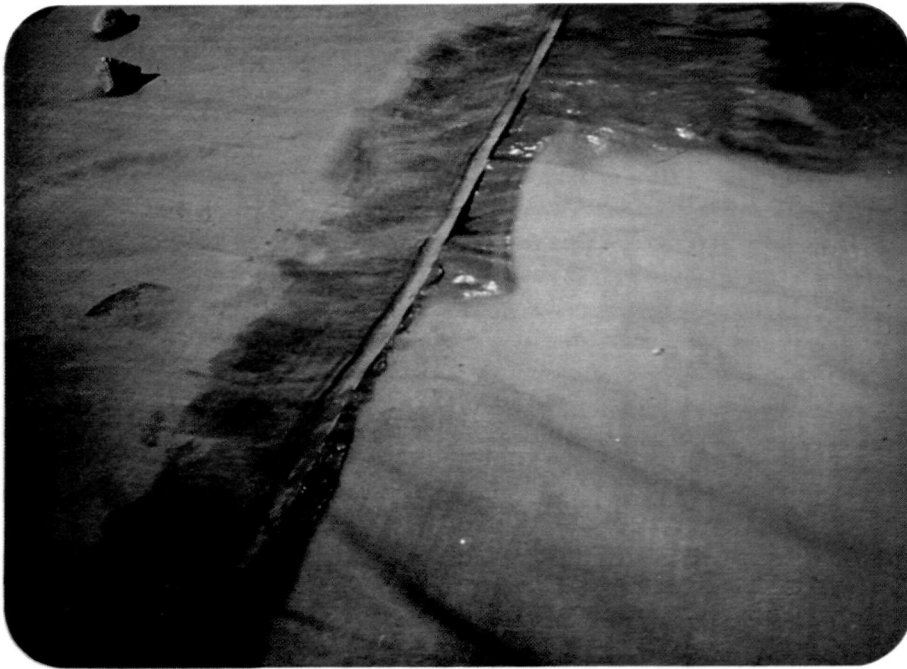
Plate 13 Joints were formed by spraying the lower piece of Tufton, then pressing the upper piece into the tacky urethane material.

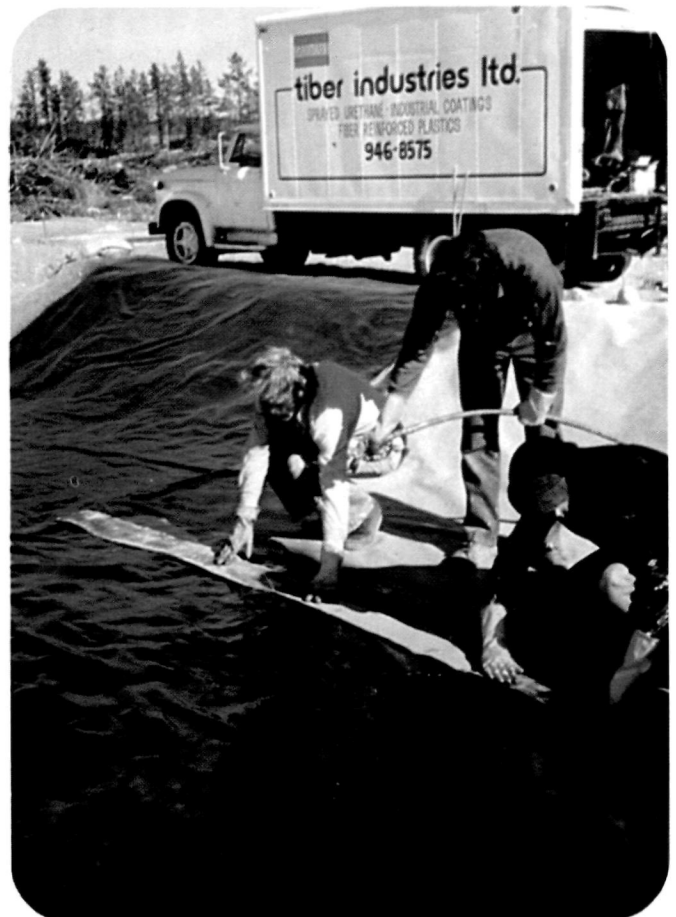
Plate 14 After the upper layer of Tufton was pressed into the tacky urethane material, an additional coat was sprayed over the entire joint. Note that Carboline is a lighter green than the Elastuff 504 in the foreground: compare with Plate 37.

Weathering caused opposite discolouration effects in the two urethane polymers. Carboline had changed from a forest green to a very dark green. Elastuff 504 changed from a dark green to a light greyish green, as is evident by comparing Plates 14 and 37. On both test sections, colouration much closer to the original was retained in areas covered by several centimetres of sand. Also, the colour of the Elastuff 504 had faded much more noticeably where the coating was thinner than average. As expected, these spots succumbed more quickly to the effects of weathering. The Tufton-backing fabric showed no signs of deterioration.

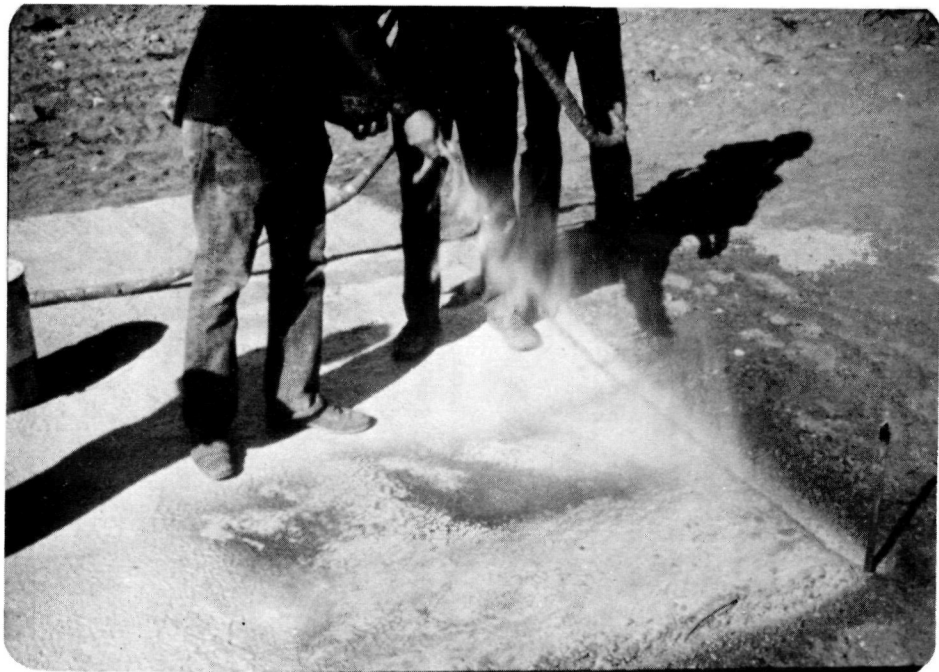
Plate 17 Sand was sprinkled into a tack coat of slow foam to form both a friction surface and an opaque coating to reduce exposure of the foam to sunlight.

An unusual problem developed. Ravens were attracted to the Carboline covering. The birds pecked several holes through the Carboline and into the foam the first night after the coating had been applied. After a few days, the uncoated sections of foam also showed evidence of damage. The sand-coated section was left untouched.

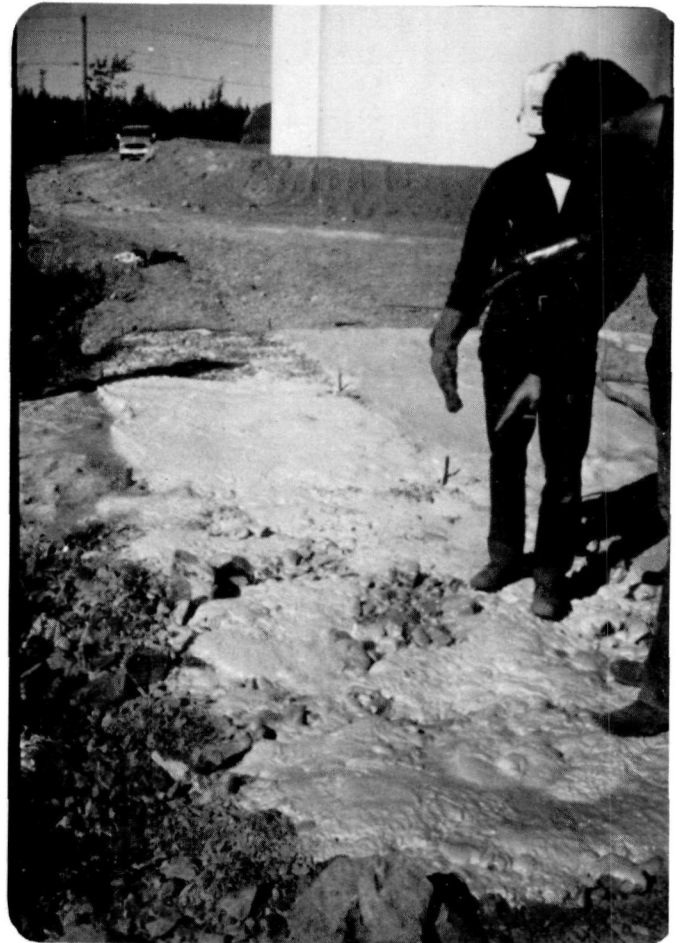
The degree of roughness of the base has a profound effect on application rates. On smooth surfaces, three layers may be applied at a rate approaching  $50 \text{ m}^2$  ( $550 \text{ ft}^2$ ) per hour. The surface roughness of the sorted, 4 cm crush gravel slowed the rate somewhat, as some spot spraying was required to fill individual voids. The extreme case was the mine muck substrate - an average application rate on this material might be as low as 15 to  $25 \text{ m}^2/\text{hr}$  ( $160$  to  $270 \text{ ft}^2/\text{hr}$ ). In addition to the extensive spot spraying required, as is evident in Plate 18, a higher degree of care is necessary on the part of the operator to ensure uniformity of coverage. Also, in the order of 50% more foam per unit area was needed to adequately cover the extremely uneven surface.

Plate 18      The rough mine-muck base required extensive spot spraying to ensure effective coverage.

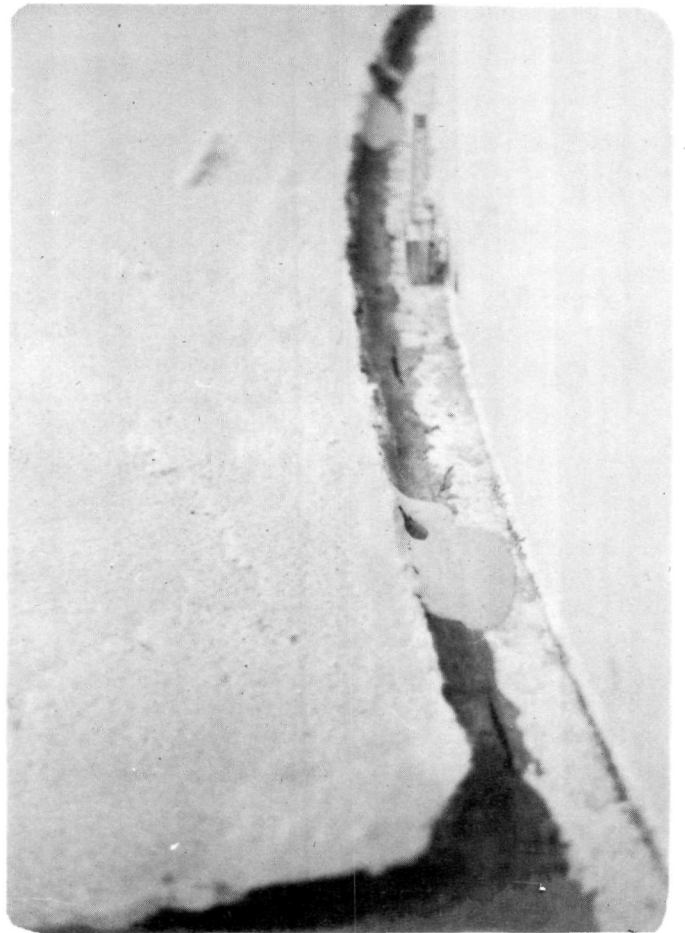
During construction of panel 2, boards were placed intermittently to form a line of weakness in the panel. It was expected that cracking would occur in a controlled direction along this quasi-joint. Although several cracks had formed in this panel, however, (one crack was within a metre and parallel to the quasi-joint) none formed along the quasi-joint itself. This indicates that thickness variations and other anomalies were more influential than the artificially induced line of weakness along the quasi-joint. Plate 35 shows such an anomaly where a sample was removed for laboratory testing.

Anomalies in panel thickness may have acted as initiation points for cracking.

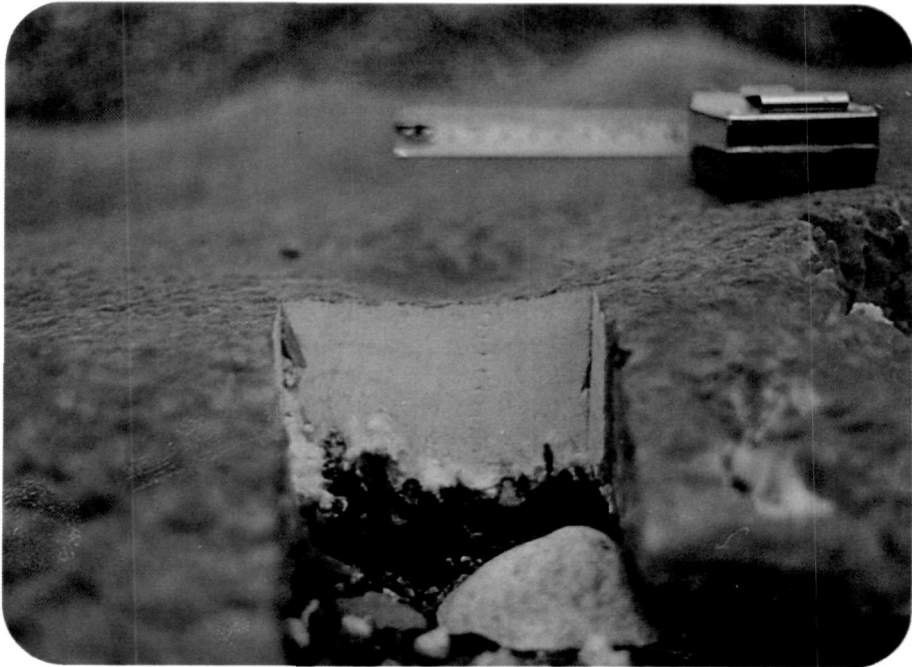
Plate 45

Weathering affected the surface of the urethane foam - exposed test sections had weathered to a deep orange colour. This discolouration was present in approximately the top 1 mm (0.05 in) as illustrated in Plate 45, except where the foam was protected by several centimetres of sand. The weathered layer was brittle and could be powdered on the normal foam by rubbing under finger pressure. More vigorous rubbing was required to abrade the denser slow foam. Once the orange powder was brushed away, there was no sign of discolouration in the foam below. As long as it was not disturbed, the top opaque layer apparently protected the foam beneath from ultraviolet light. However, the cycle of weathering-abrasion-weathering would result in high attrition rates; this could be avoided by the use of walkways in high-traffic areas. No weathering had taken place below test sections protected by the Carboline polymer coating. The bond between coating and foam was still excellent. Plate 46 shows a cross-section through the Carboline-covered foam.

There were numerous signs of both fresh and old pecking activity by ravens on the Carboline-covered section (Plate 45). More pecking damage was done to the lower density normal foam than the slow foam. In excess of 20 marks were evident, of which several were 2 to 3 cm (1 in) deep. At least one peck hole penetrated entirely through the liner. One or two peck marks were evident on the foam with no coating, but the sand tack coat on the remainder of the test sections apparently discouraged the curiosity of the ravens.

Foam had weathered to an orange colour, but only to a depth of 1 mm (0.05 in). Note recent raven peck marks in lower right corner of picture and old peck marks by the tape measure.

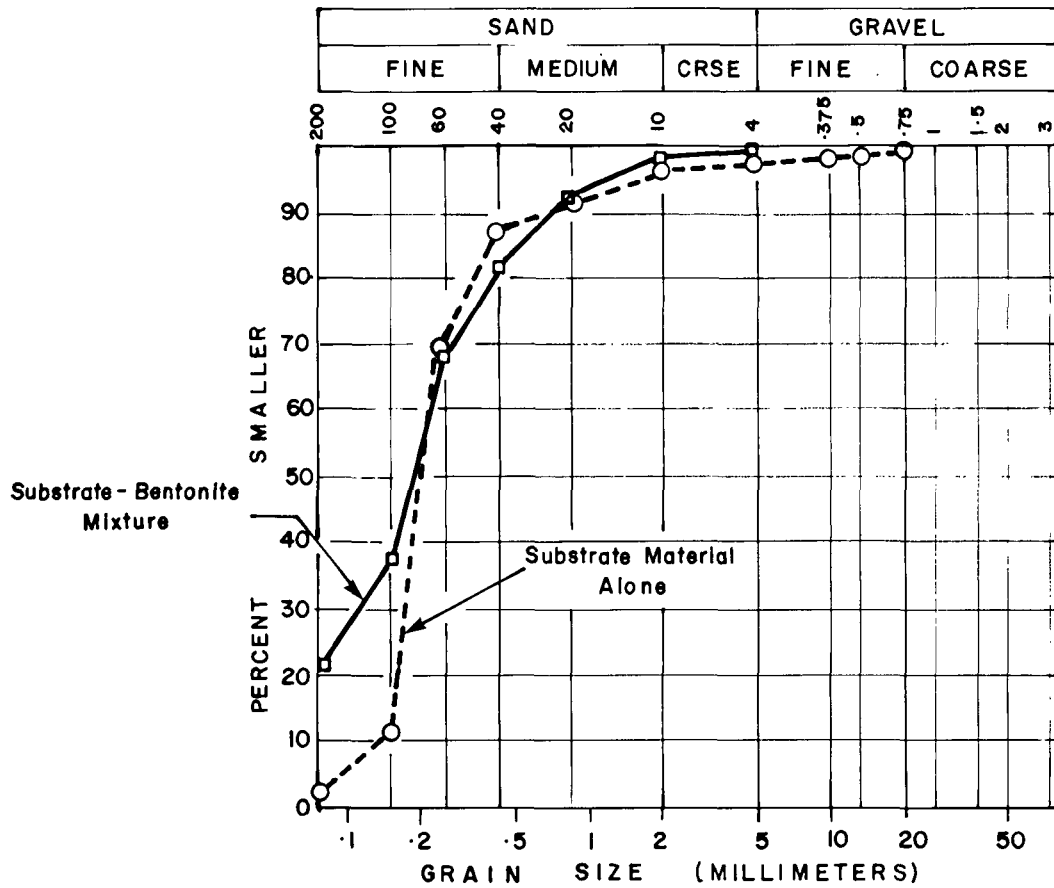
Fig.7 - Grain Size Distribution—Beach Sand

**3.7.1 Processed Bentonite.** Grain size analyses were performed on samples from the three bentonite test cells. Comparison of particle size distributions from these samples and blank samples of substrate soils indicate that beach sand and 2 cm crush contain approximately 18% bentonite, while the 4 cm crush contains 24% bentonite. Comparative grain size distribution curves are shown in Figures 7 to 9.
