ARCHAEOLOGICAL INVESTIGATIONS AT

LOWER FORT GARRY, 1971

W. J. Folan and Peter J. Priess

MARCH 1972

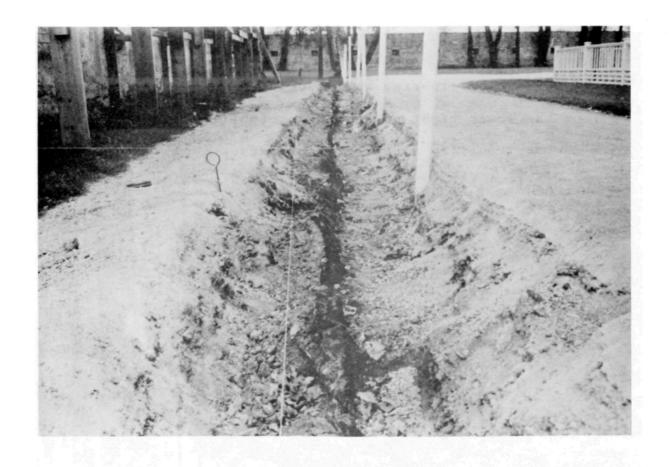
4 A close-up of a section of the palisade remains.

(NHSS 1K-122 M)

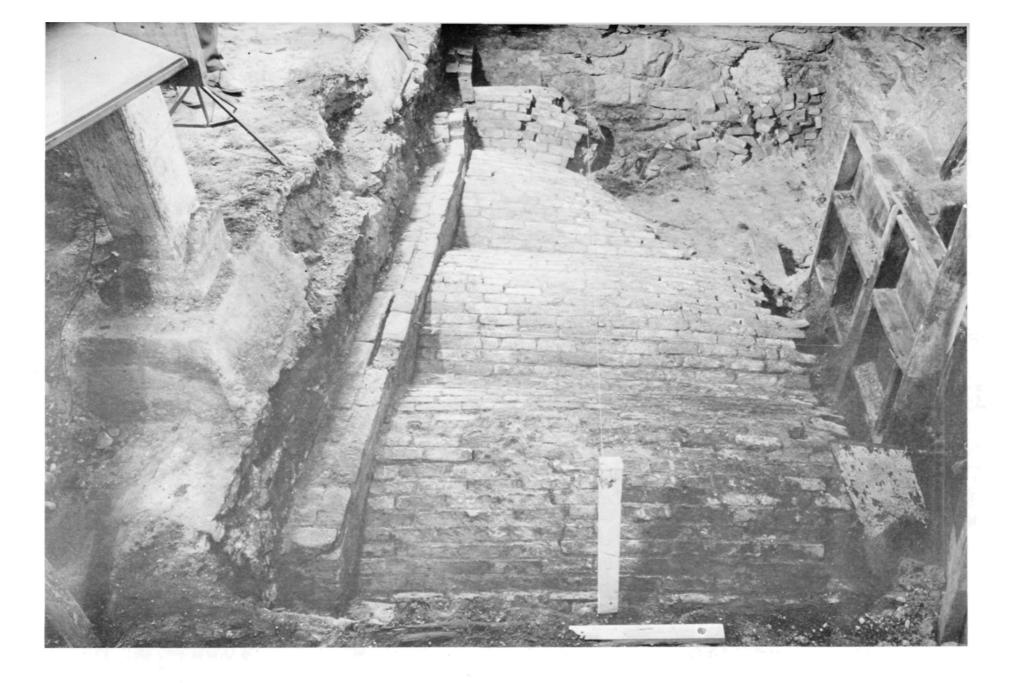
15 The vaults of the subterranean cells were photographed (looking west) in 1971. The wooden forms and braces abutting the front walls of cells 3 and 4 were placed there after the 1968 excavation before the area was backfilled with sand. (NHSS 1K-9 L)

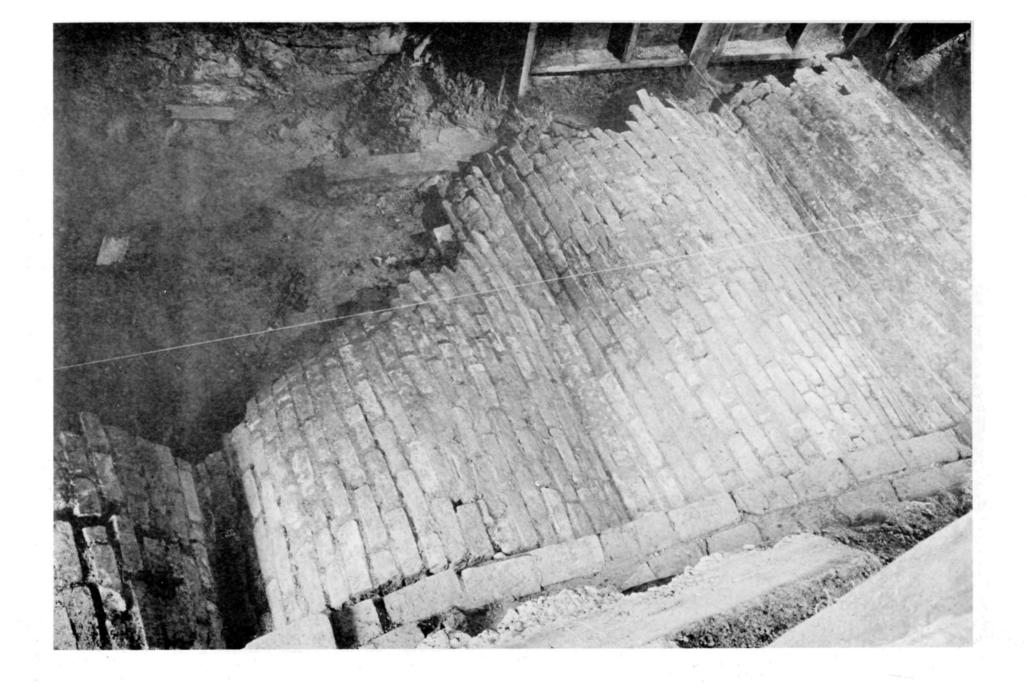
The top of the rear wall of the cell complex is in the foreground of the photograph of the cell vaults (looking northeast) in 1971. From left to right the cells are 1, 2, 3 and 4. (NHSS 1K-10 L)

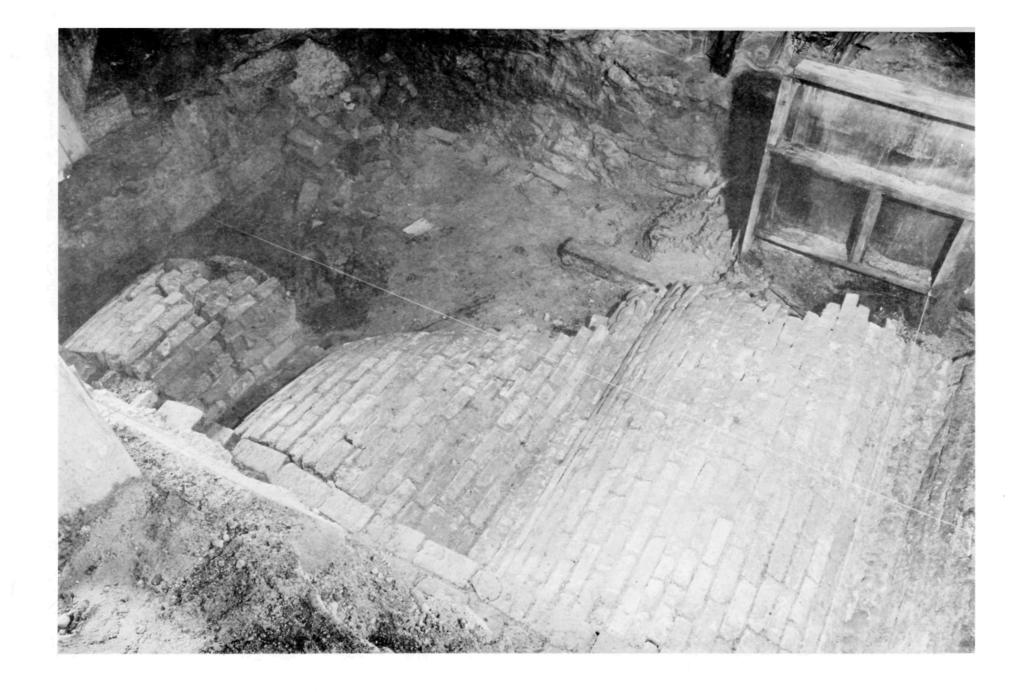
The cell vaults and the top of the rear wall of the cell complex looking northwest. From left to right the cells are 1, 2, 3 and 4. (NHSS 1K-11 L)

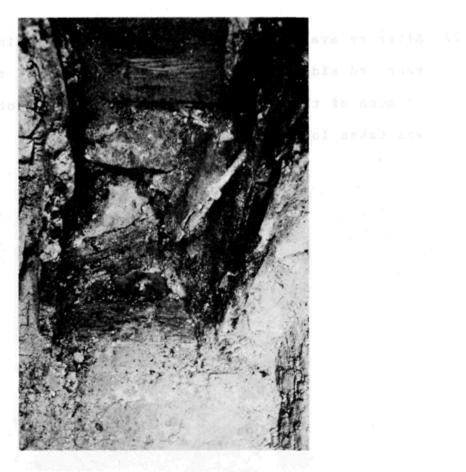
25 The photograph (looking north) of the entrance to cell 2 shows the inside of the jambs, associated hardware and the sill. A plank (upper centre) had no obvious association with the cell. Part of a large stone (see p. 38) is visible between the jambs immediately below the plank. (NHSS 1K-133 M)

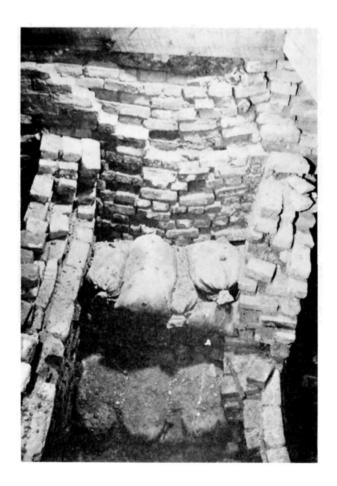
The photograph (looking north) of the interior of cells 2 (left) and 3 (right) was taken during excavation of cell 2 and after the vault of cell 3 collapsed. The bowed western wall and jambs of cell 2 are shown clearly. (NHSS 1K-149 M)

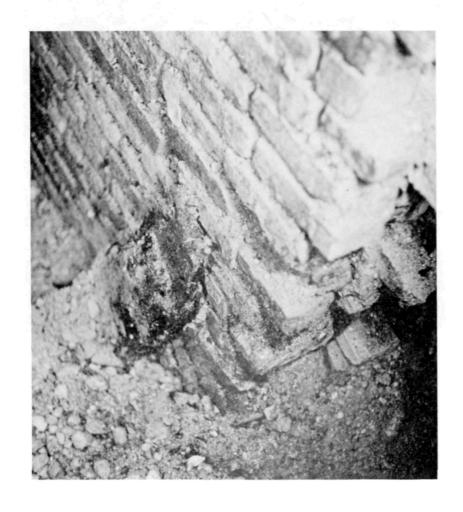
The remains of a door, still attached to its lower hinge, and a double, eastern jamb were located in cell 4. (NHSS 1K-112 M)

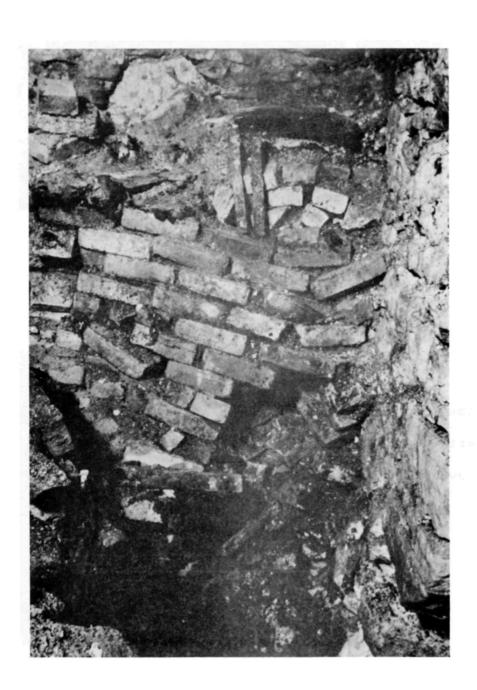
The narrow, brick-floored passageway in front of the cells was originally no less than 2 ft., 5 in. wide, the distance between the front walls of the cells and the northern limit of the brick floor. It may have been wide enough to permit the cell doors to open fully; however, the bulging northern foundation wall increasingly restricted the space in the passageway (Figs. 14, 21, 38, 65, 67).

38 The western end of the passageway in front of the cells as photographed after Priess excavated it in 1968. It was then more complete than when re-excavated in 1971 (see Fig. 14). (NHSS 1K-1 B)

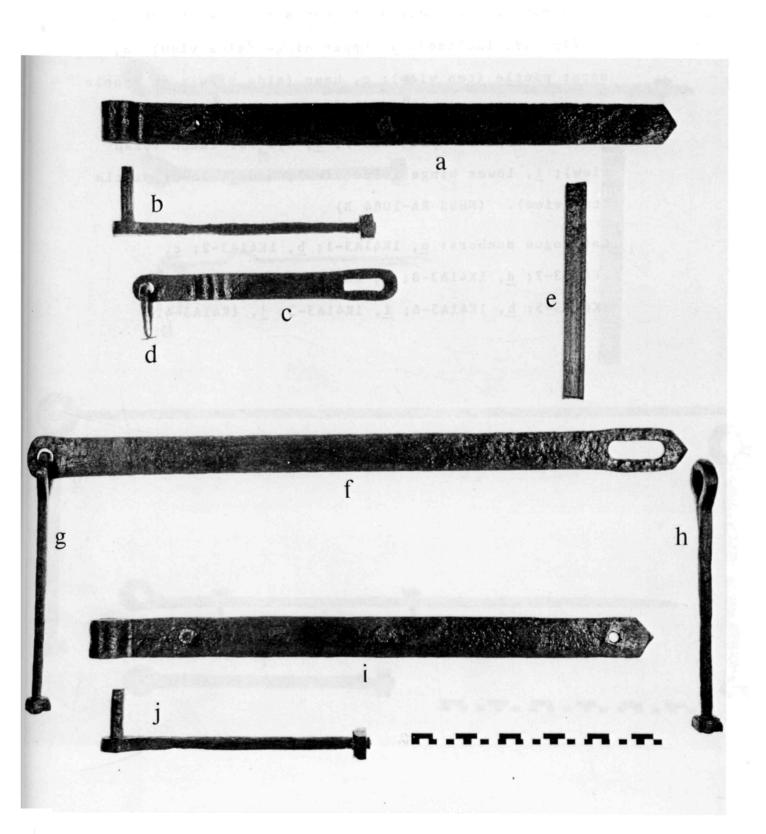
The remaining hardware presents a greater problem. The cast iron hinges have been pitted and chipped by rusting and, furthermore, have not been brought back to a working condition. The pivot staples for the small hasps and the brackets have clenched ends which probably would not stand up to being straightened, driven and clenched again. The peephole bars could probably be used although they also have pitted and striated surfaces.

The hardware from cell 3 included: <u>a</u>, upper hinge (plan view); <u>b</u>, upper pintle (side view); <u>c</u>, hasp (plan view); <u>d</u>, staple for pivot (side view); <u>e</u>, bar; <u>f</u>, hasp (plan view); <u>g</u>, eye for pivot (side view); <u>h</u>, eye for catch (side view); <u>i</u>, lower hinge (plan view); and <u>j</u>, lower pintle (side view). (NHSS RA-1063 B)

The as-found condition of the hardware suggested that much of it could be used in the reconstruction of the cells; however, this impression has been modified with the cleaning of the material. The larger pieces, such as the strap hinges and all the hasps, could be used without difficulty since they were of considerable bulk and lost little of it through rusting. However, they would no longer have their original surface appearance; all the surfaces have some pits and differential rusting has accentuated the laminated nature of the iron, leaving a striated surface. If the appearance of these pieces is not objectionable, they could be re-used on the cell doors.

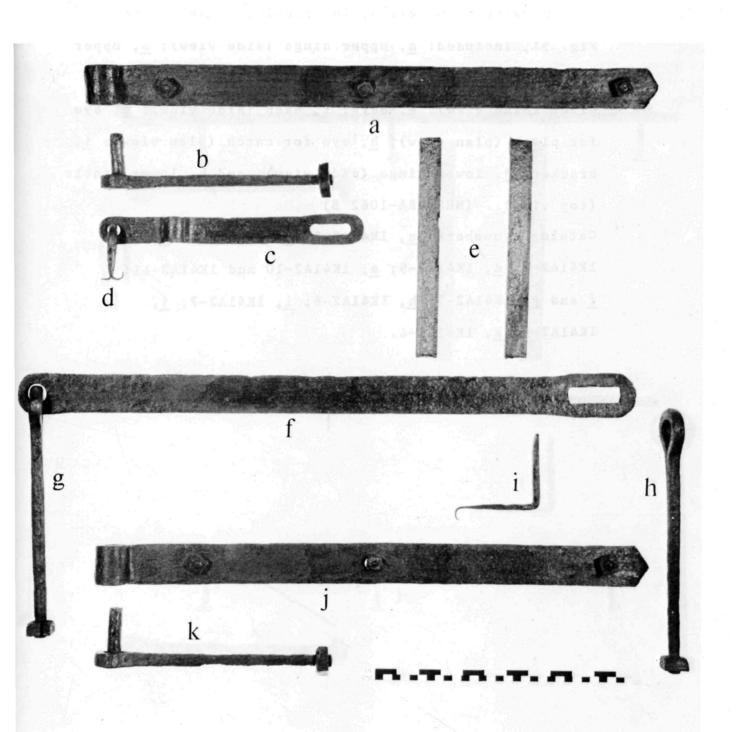
The hardware from cell 4 included: <u>a</u>, upper hinge (plan view); <u>b</u>, upper pintle (side view); <u>c</u>, hasp (plan view); <u>d</u>, staple for pivot (side view); <u>e</u>, bars; <u>f</u>, hasp (plan view); <u>g</u>, eye for pivot (side view); <u>h</u>, eye for catch (side view); <u>i</u>, bracket; <u>j</u>, lower hinge (plan view); and <u>k</u>, lower pintle (side view).

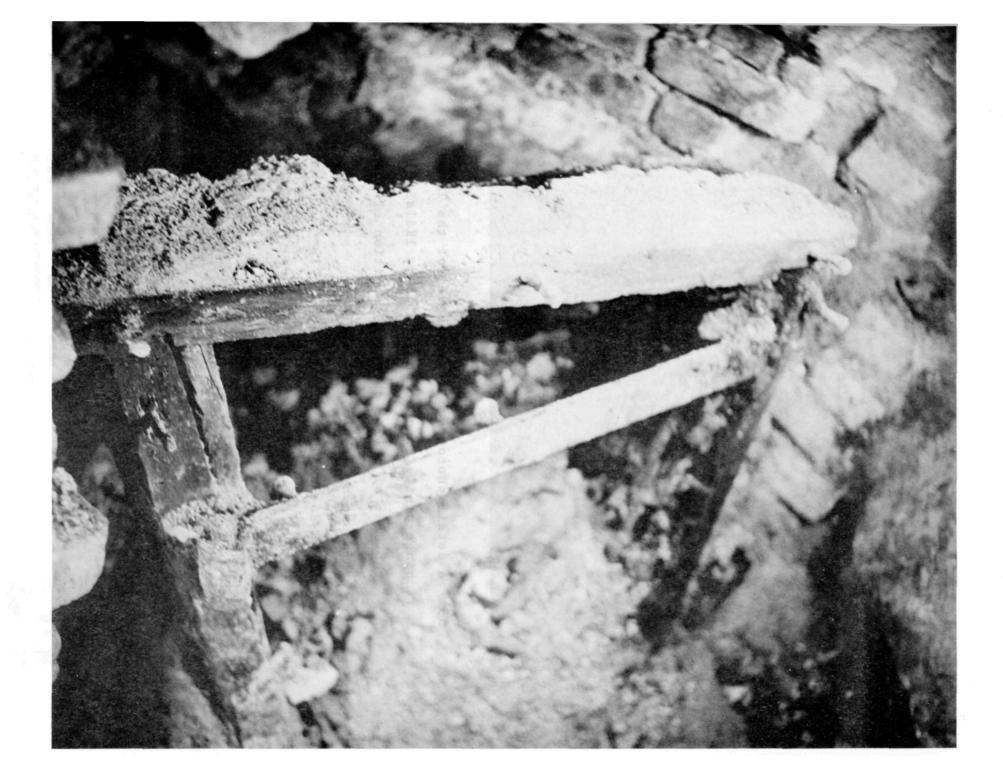
The door jamb, lintel and upper, strap hinge of cell 3 was photographed (looking southwest) before Priess removed them in 1968. (NHSS 1K-87 X)
