DRYWALL STAINING

FINAL REPORT

**PREPARED BY: INSTITUTE FOR RESEARCH AND CONSTRUCTION
NATIONAL RESEARCH COUNCIL**

JANUARY 1992

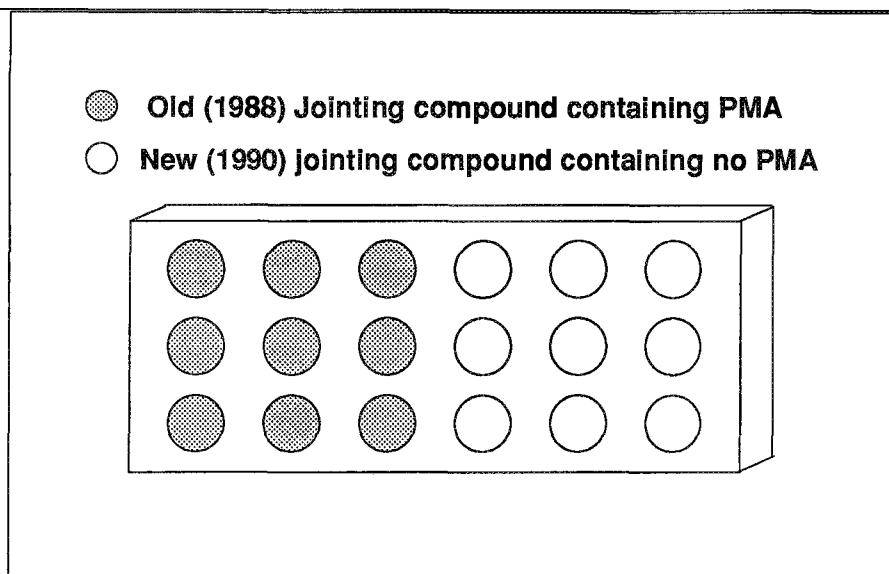
Gypsum boards, on which test specimens were prepared, were cut from a sample of drywall. Eighteen 20 mm diameter holes were drilled halfway through the boards of which nine were filled with old jointing compound (produced in 1988) containing PMA and the remaining holes were filled with new jointing compound (produced in 1990) not containing PMA (Figure 4).

Figure 4. A drywall specimen showing the different jointing compounds used in the lab simulation.

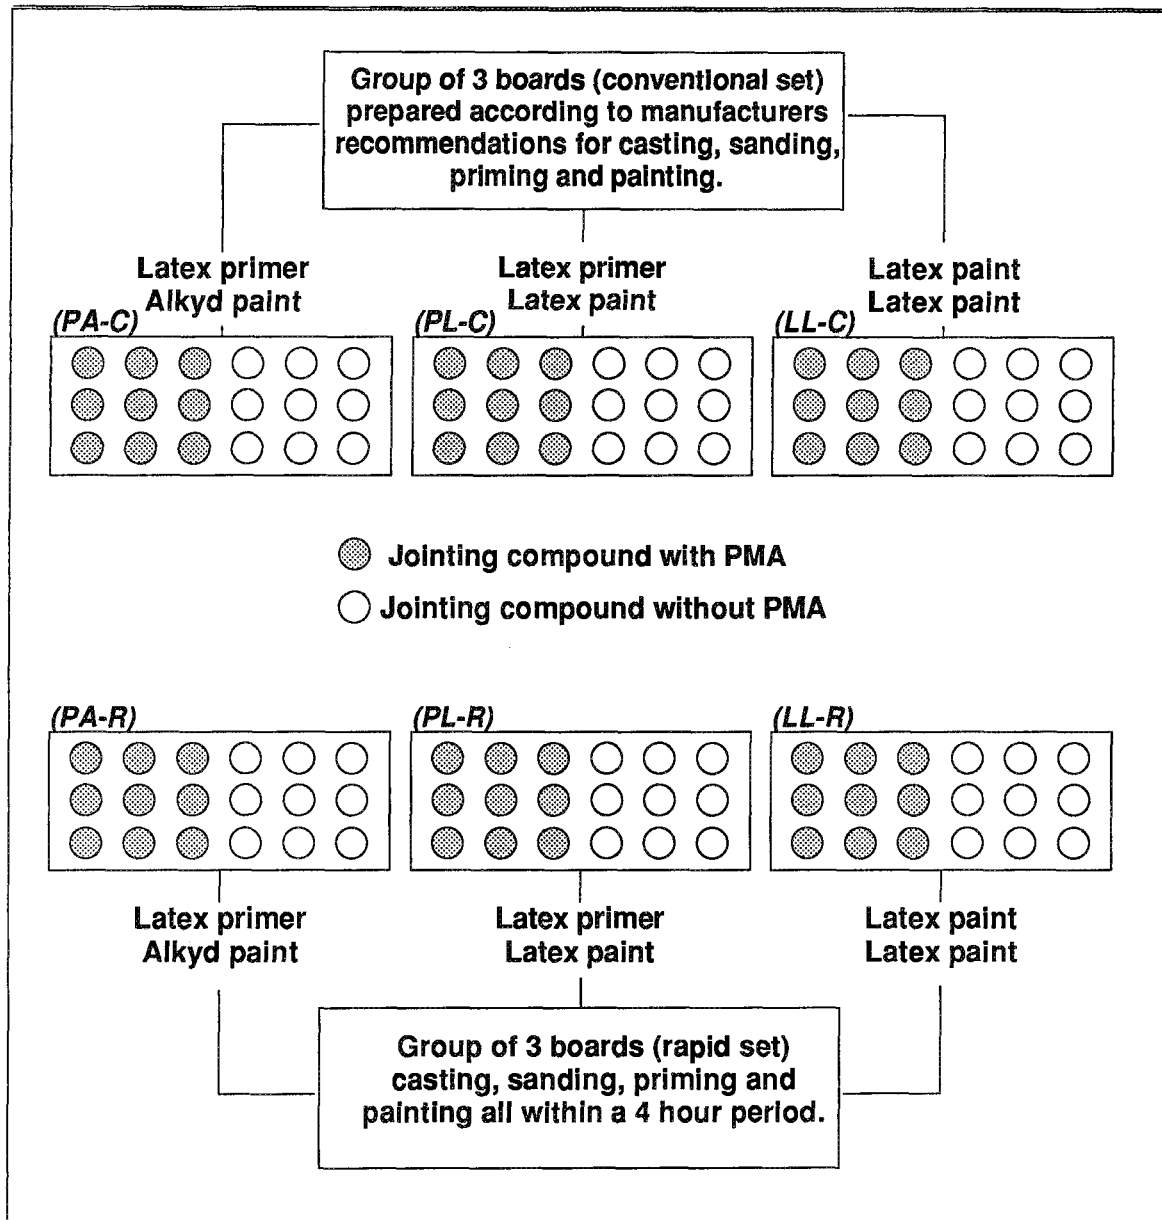
Susceptibility to stain generation, due to the type of primer or finishing coat used, was also examined. From each of the three boards, prepared according to either manufacturer's instructions or the rapid application technique, one board was primed with a latex sealer and finished with flat alkyd paint (PA-R, PA-C). A second board was primed with latex sealer and finished with flat latex paint (PL-R, PL-C) and the third board was primed and finished with flat latex paint (LL-R, LL-C). All of the test permutations are illustrated in Figure 5.

Figure 5. Diagram illustrating the various application and component combinations in the lab simulation.

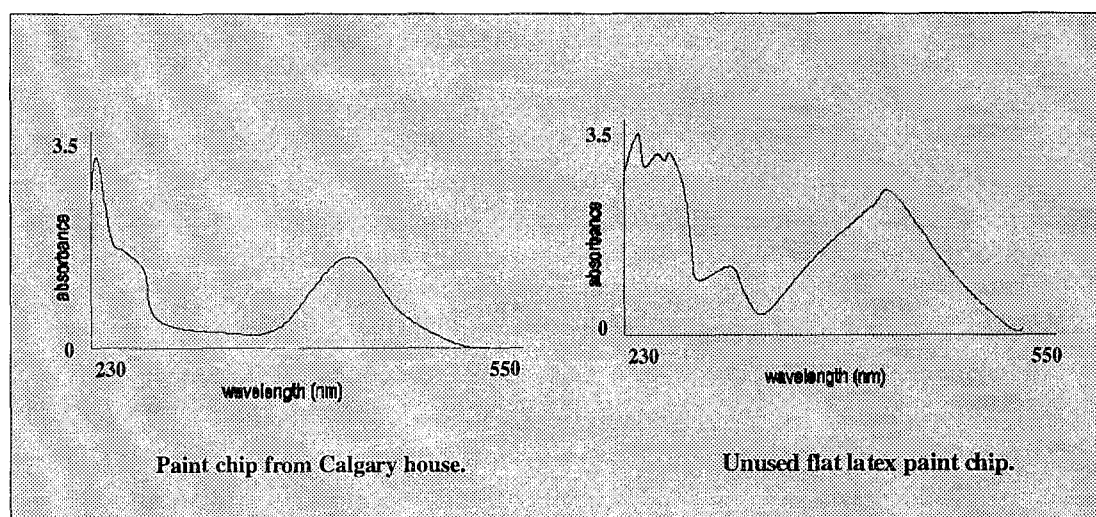
Significant differences were, however, observed between the absorption spectra of extracts of unused finishing materials and samples from the test specimen of drywall. Figure 7 shows the difference in absorption spectra between the methylene chloride extracts of the field sampled paint and the supplied new paint. Differences in the visible absorption portion (230 - 550 nm) of the spectra were observed. A new peak appeared at about 260 nm in samples of the newly supplied sample of paint relative to the paint scraped from the drywall. It can also be noted that the peak appearing around 325 nm is more pronounced in the unused paint sample.

Figure 7. Difference in absorption spectra between the methylene chloride extracts of paint chip from house affected with stain and unused flat latex paint.

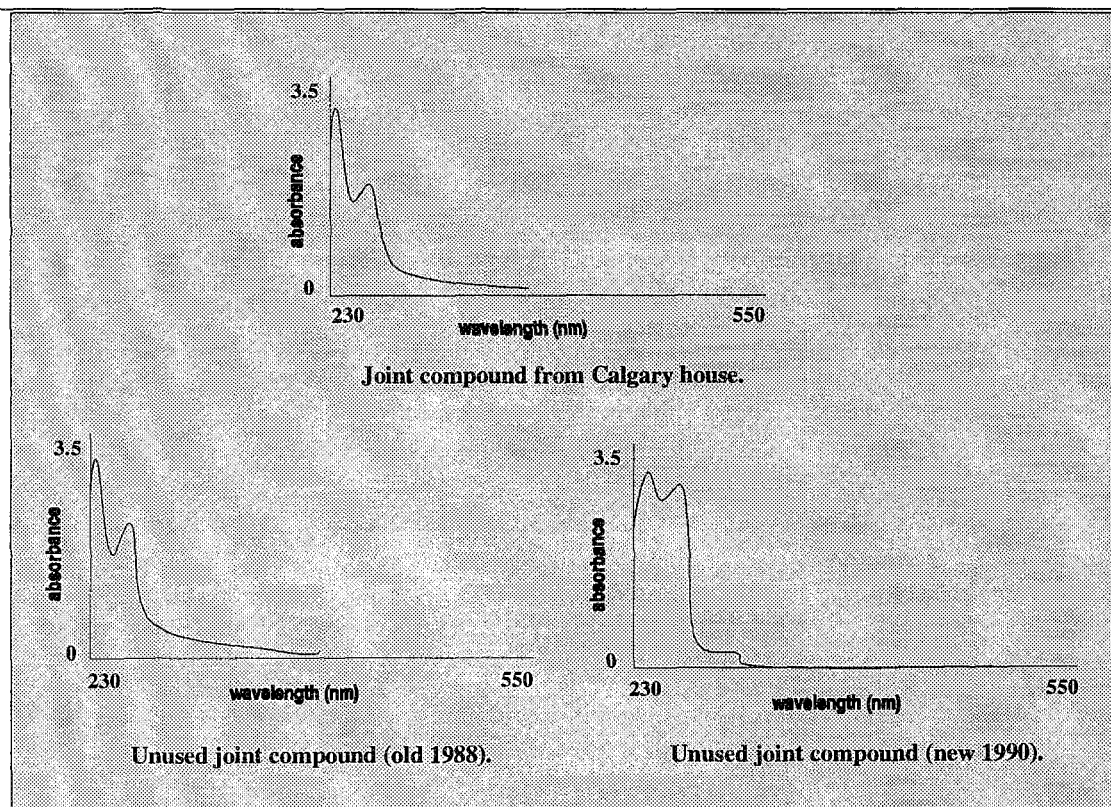
A similar difference was observed when comparing the spectra of the new unused joint compound with either the old unused joint compound or the joint compound from the drywall test specimen. The differential absorption spectra of these extracts are presented in Figure 8. It can be noted that the absorption spectra from the extracts of the old unused joint compound closely matches that of the joint compound sampled from the drywall.

Figure 8. Difference in absorption spectra between the methylene chloride extracts of jointing compound from stain affected house, old (1988) and new (1990) material.

Results of the UV/Visible absorption spectra (Figure 8) and AA mercury analysis (Table 4) show a close resemblance to the old (1988) drywall compound and the compound actually used in the construction of the affected house. The mercury level found by AA in the old (1988) jointing compound specimen (70 ppm) corresponds to a PMA to compound concentration of $117.5 \mu\text{g/g}$. Assuming that the PMA was not decomposed during storage, application of the joint compound to the glass plate in the laboratory or drying, and that it was quantitatively extracted, the concentration of mercury in the final preparation should be $117.5 \mu\text{g/g} \times 3.5 \text{ g/ml} = 411.25 \mu\text{g/ml}$, which corresponds to approximately $410 \mu\text{g/ml}$ of PMA.

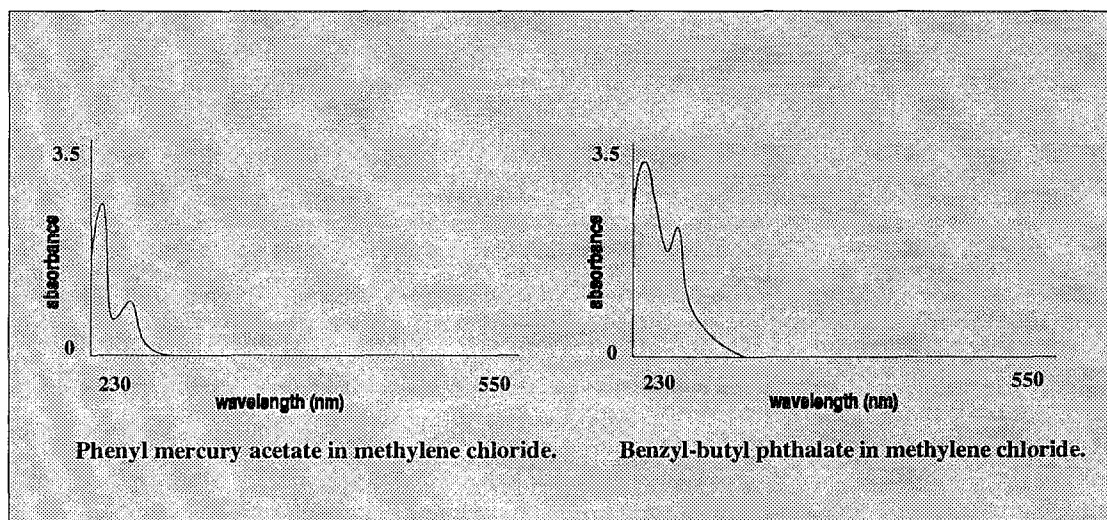
The spectra described above may be compared to the differential absorption spectra of two organic additives, i.e. PMA and phthalates. These additives are commonly found in paints and jointing compound and the absorption spectra are presented in Figure 9. The new peaks that appear in the spectra of the samples of new unused joint compound and paint do not correspond to the absorption of PMA and phthalates. The possible implications of these observations may be that these materials are not incorporated into the new formulation of these products.

Phenol mercuric acetate (PMA) is a fungicidal agent which is commonly added to drywall jointing compound to prevent or retard the growth of fungus. PMA has been used in paint in the same manner and for the same effect. The reason PMA was initially a desirable fungicide was its ability to diffuse freely through wet paint and concentrate on the setting surface of the paint, making it a viable fungicide even when used in low concentrations. This semi-soluble additive is used to protect the new stock of the jointing compound from biological attack. When applied to a drywall surface the PMA migrates to the surface as the jointing compound sets. In this way it protects the jointing compound from mildews and bacteria at the exposed surface. Once the jointing compound is thoroughly dried, the PMA exists as a dry residue on the surface of the joint.

Figure 9. Absorption spectra of methylene chloride extracts of two organic additives, phenyl mercuric acetate and benzyl butyl phthalate, commonly used in jointing compounds.

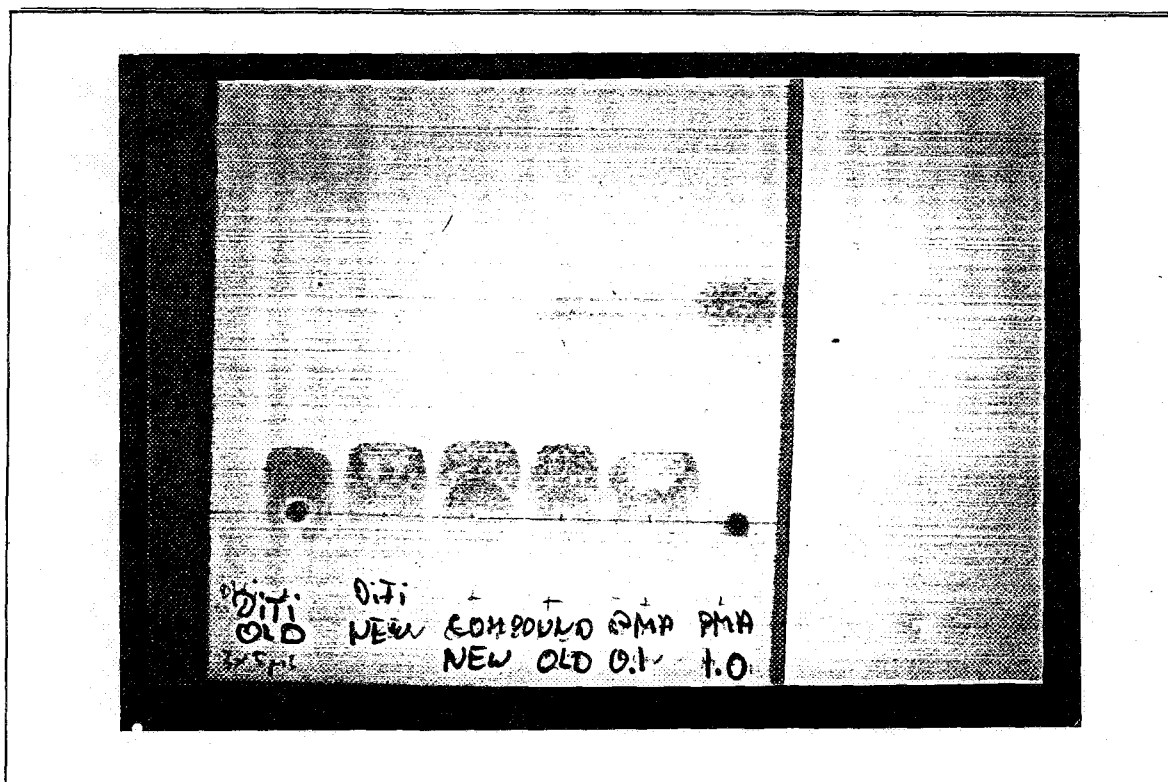
TLC of the organomercury-dithizone complex was used to verify the results determined by ICP screening for metallic ions. Figure 11 shows the results obtained from the extracts of samples of the old and new unused joint compound using the TLC technique. PMA is the standard and dithizone alone is used as the control. Dithizone complexed PMA appears as a reddish spot about mid-way up the slide. Clearly, it can be seen that no PMA is detected in the new sample of unused joint compound, but does appear in the older sample of unused joint compound. This corresponds to the results obtained previously which indicated the presence of mercury in the old compound. The yellow brown spot that appears in the top left corner is a decomposition product of an aged dithizone solution. Since this product had a relatively high value of R_f (i.e. is quite mobile) it did not interfere with the TLC method.

Figure 11. Dithizone complex TLC Plate showing the presence of PMA in the old (1988) but not the new (1990) jointing compounds.

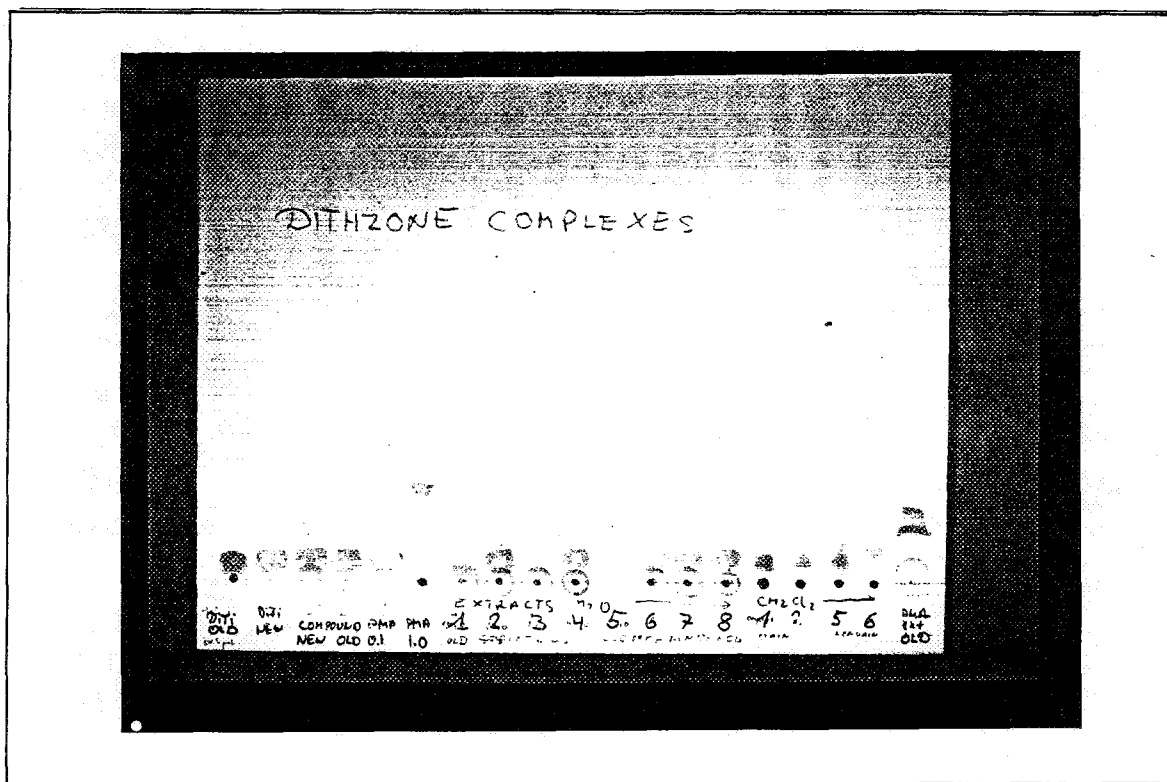
Figure 12 shows an example of the TLC results of the dithizone complexes from various stained and reference extracts. Numbers 1 to 4 are from the stained side of the drywall sample. They are the water extracts of the paint, the compound above the tape, the tape and the compound below tape, respectively. Numbers 5 to 8 are the corresponding water extracts from the reference side. Numbers 1, 2, 5 and 6, on the far right side of the TLC, are dithizone complexed methylene chloride extracts. Numbers 1 and 2 are from the paint and compound above the tape on the stained side. Numbers 5 and 6 are from the paint and compound above the tape, on the reference side. The last spot on the right is representative of a solution having an abnormally high concentration of PMA and should be ignored. This TLC plate is represented schematically in Figure 13 to emphasize the presence of PMA in the various extracts.

Figure 12. Dithizone complex TLC results from various stained and reference extracts.

Based on these results it is shown that no significant qualitative difference between the stained and reference extracts was observed. The result from this TLC plate is representative of all the results obtained using this method.

All extracts from the drywall sample, gave only a very weak spots due to organic mercury (PMA) which does not show up very well in the photograph. Comparison of the total mercury results and complexed mercuries TLC results of the used and unused old joint compound in Figure 12 and 13, shows that the total mercury concentration in these two compounds was similar. However, the results from the TLC indicate that the PMA concentration is much higher in the unused sample of old jointing compound than that in the jointing compound sampled from the drywall (as evidenced by the less intense TLC spot). This suggests that the major form of mercury in the joint compound sampled from the drywall must be inorganic in nature, and it also gives some indication of the instability of PMA.

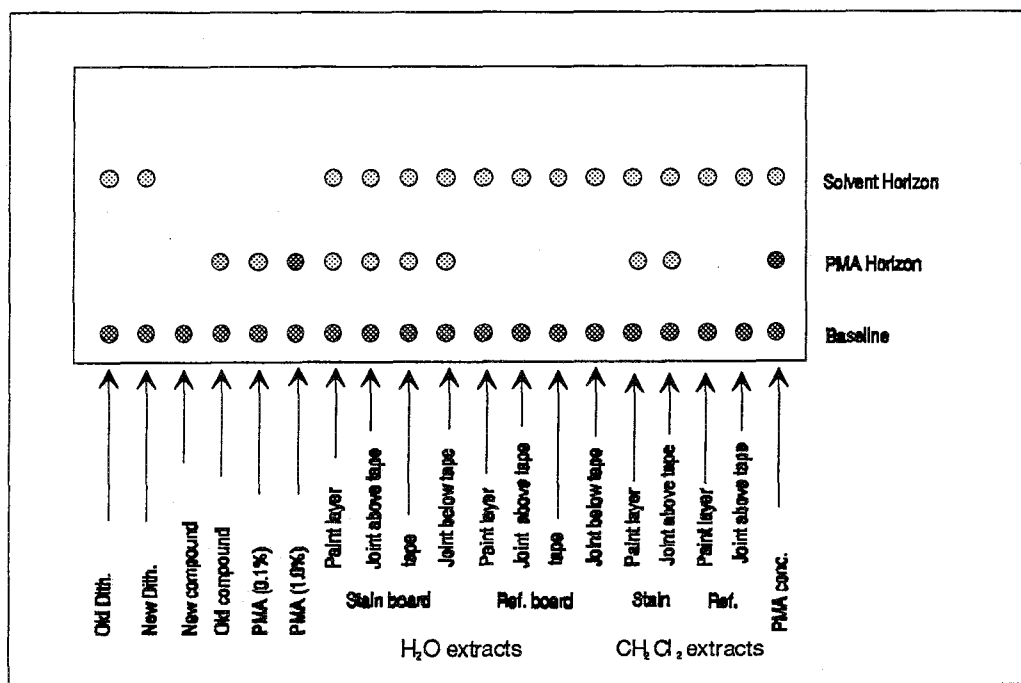
Figure 13. Schematic representation of the dithizone complex Thin Layer Chromatography Gel Plate.
