Air Transportation Safety Investigation Report A1900026

COLLISION WITH TERRAIN

Robinson Helicopter Company R66 (helicopter), C-GAUA
Timmins (Victor M. Power) Airport, Ontario, 18 nm WNW
04 March 2019

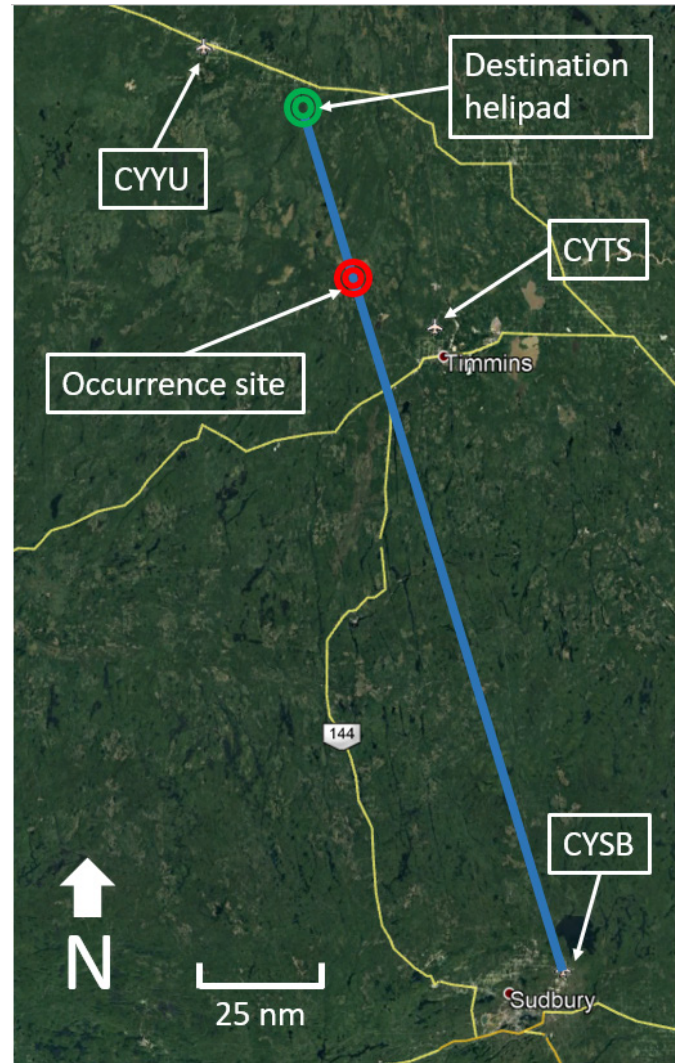
On 04 March 2019, the privately registered Robinson Helicopter Company R66 helicopter (registration C-GAUA, serial number 0142) departed Sudbury Airport (CYSB), Ontario, at 1842¹ on a visual flight rules (VFR) flight to a private helipad near Fauquier-Strickland, Ontario, with the pilot and 1 passenger on board. The helicopter collided with terrain at 2006, 36 nautical miles (nm) south-southeast of its destination (Figure 1).

Figure 1. Route of the occurrence flight, showing the intended destination and the occurrence site (Source: Google Earth, with TSB annotations)
