Marine Transportation Safety Investigation Report M18A0076

CAPSIZING WITH LOSS OF LIFE

Unnamed fishing vessel
Medway Harbour, Nova Scotia
05 May 2018

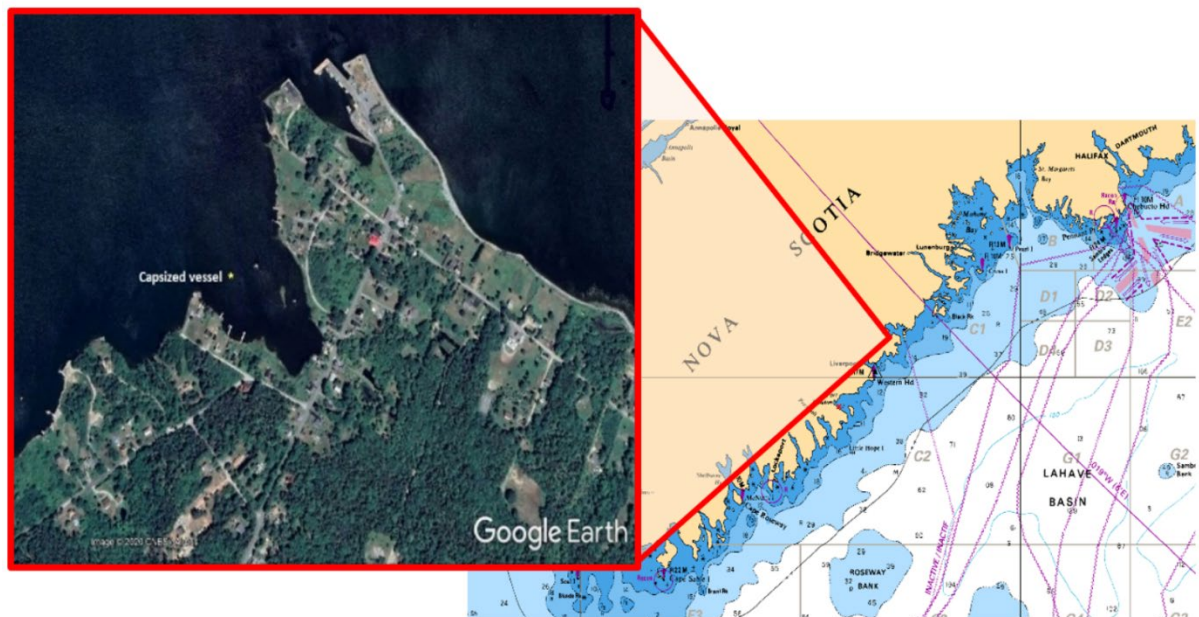
Figure 2. Chart of the occurrence area, with inset image showing the location of the capsizing (Source of main image: Canadian Hydrographic Service, Chart 4003. Source of inset image: Google Earth, with TSB annotations)

Shortly after 1000, the Royal Canadian Mounted Police (RCMP) received a call that a small fishing vessel had overturned 0.04 NM northeast of Beach Cove, Port Medway, Nova Scotia (Figure 2). Locals knew this area was near where the master of the fishing vessel stored his crab crates, leading them to believe it was his vessel. The RCMP called the Joint Rescue Coordination Centre Halifax and a search was launched. The search involved the RCMP, a fast rescue craft from the Liverpool fire department, a Department of Fisheries and Oceans fast rescue craft, a local fishing vessel, a Joint Rescue Coordination Centre helicopter, a fixed-wing aircraft from 14 Wing Greenwood, Nova Scotia, and a local shore-based search and rescue crew that included members of the community.
