Marine Transportation Safety Investigation Report M19C0387

BOTTOM CONTACT

Bulk carrier *Kaministiquia*
Kahnawake, Quebec
27 November 2019

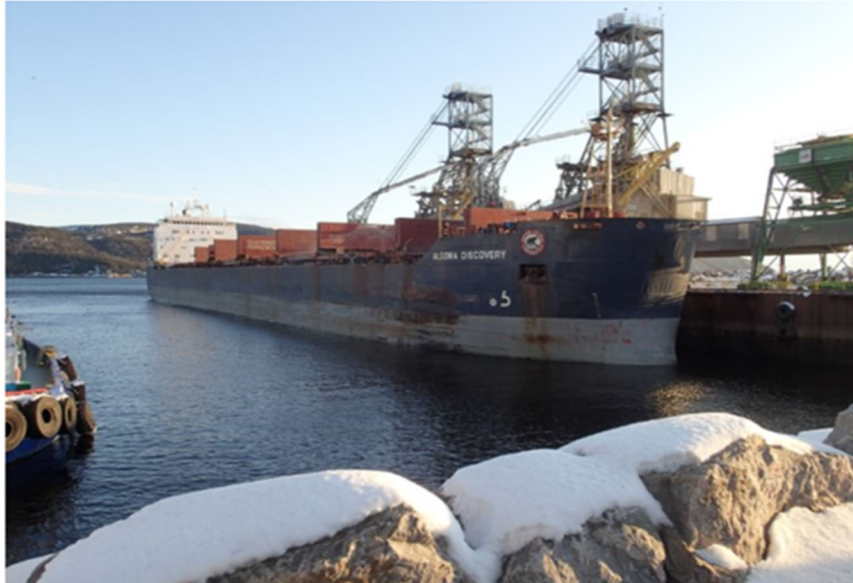
Figure 2. The bulk carrier *Algoma Discovery*, secured alongside the Cargill grain terminal in Baie-Comeau, Quebec (Source: TSB)
