SIDE SCAN SONAR OPERATIONS
1974

BY: R.J.C. ROBITAILLE

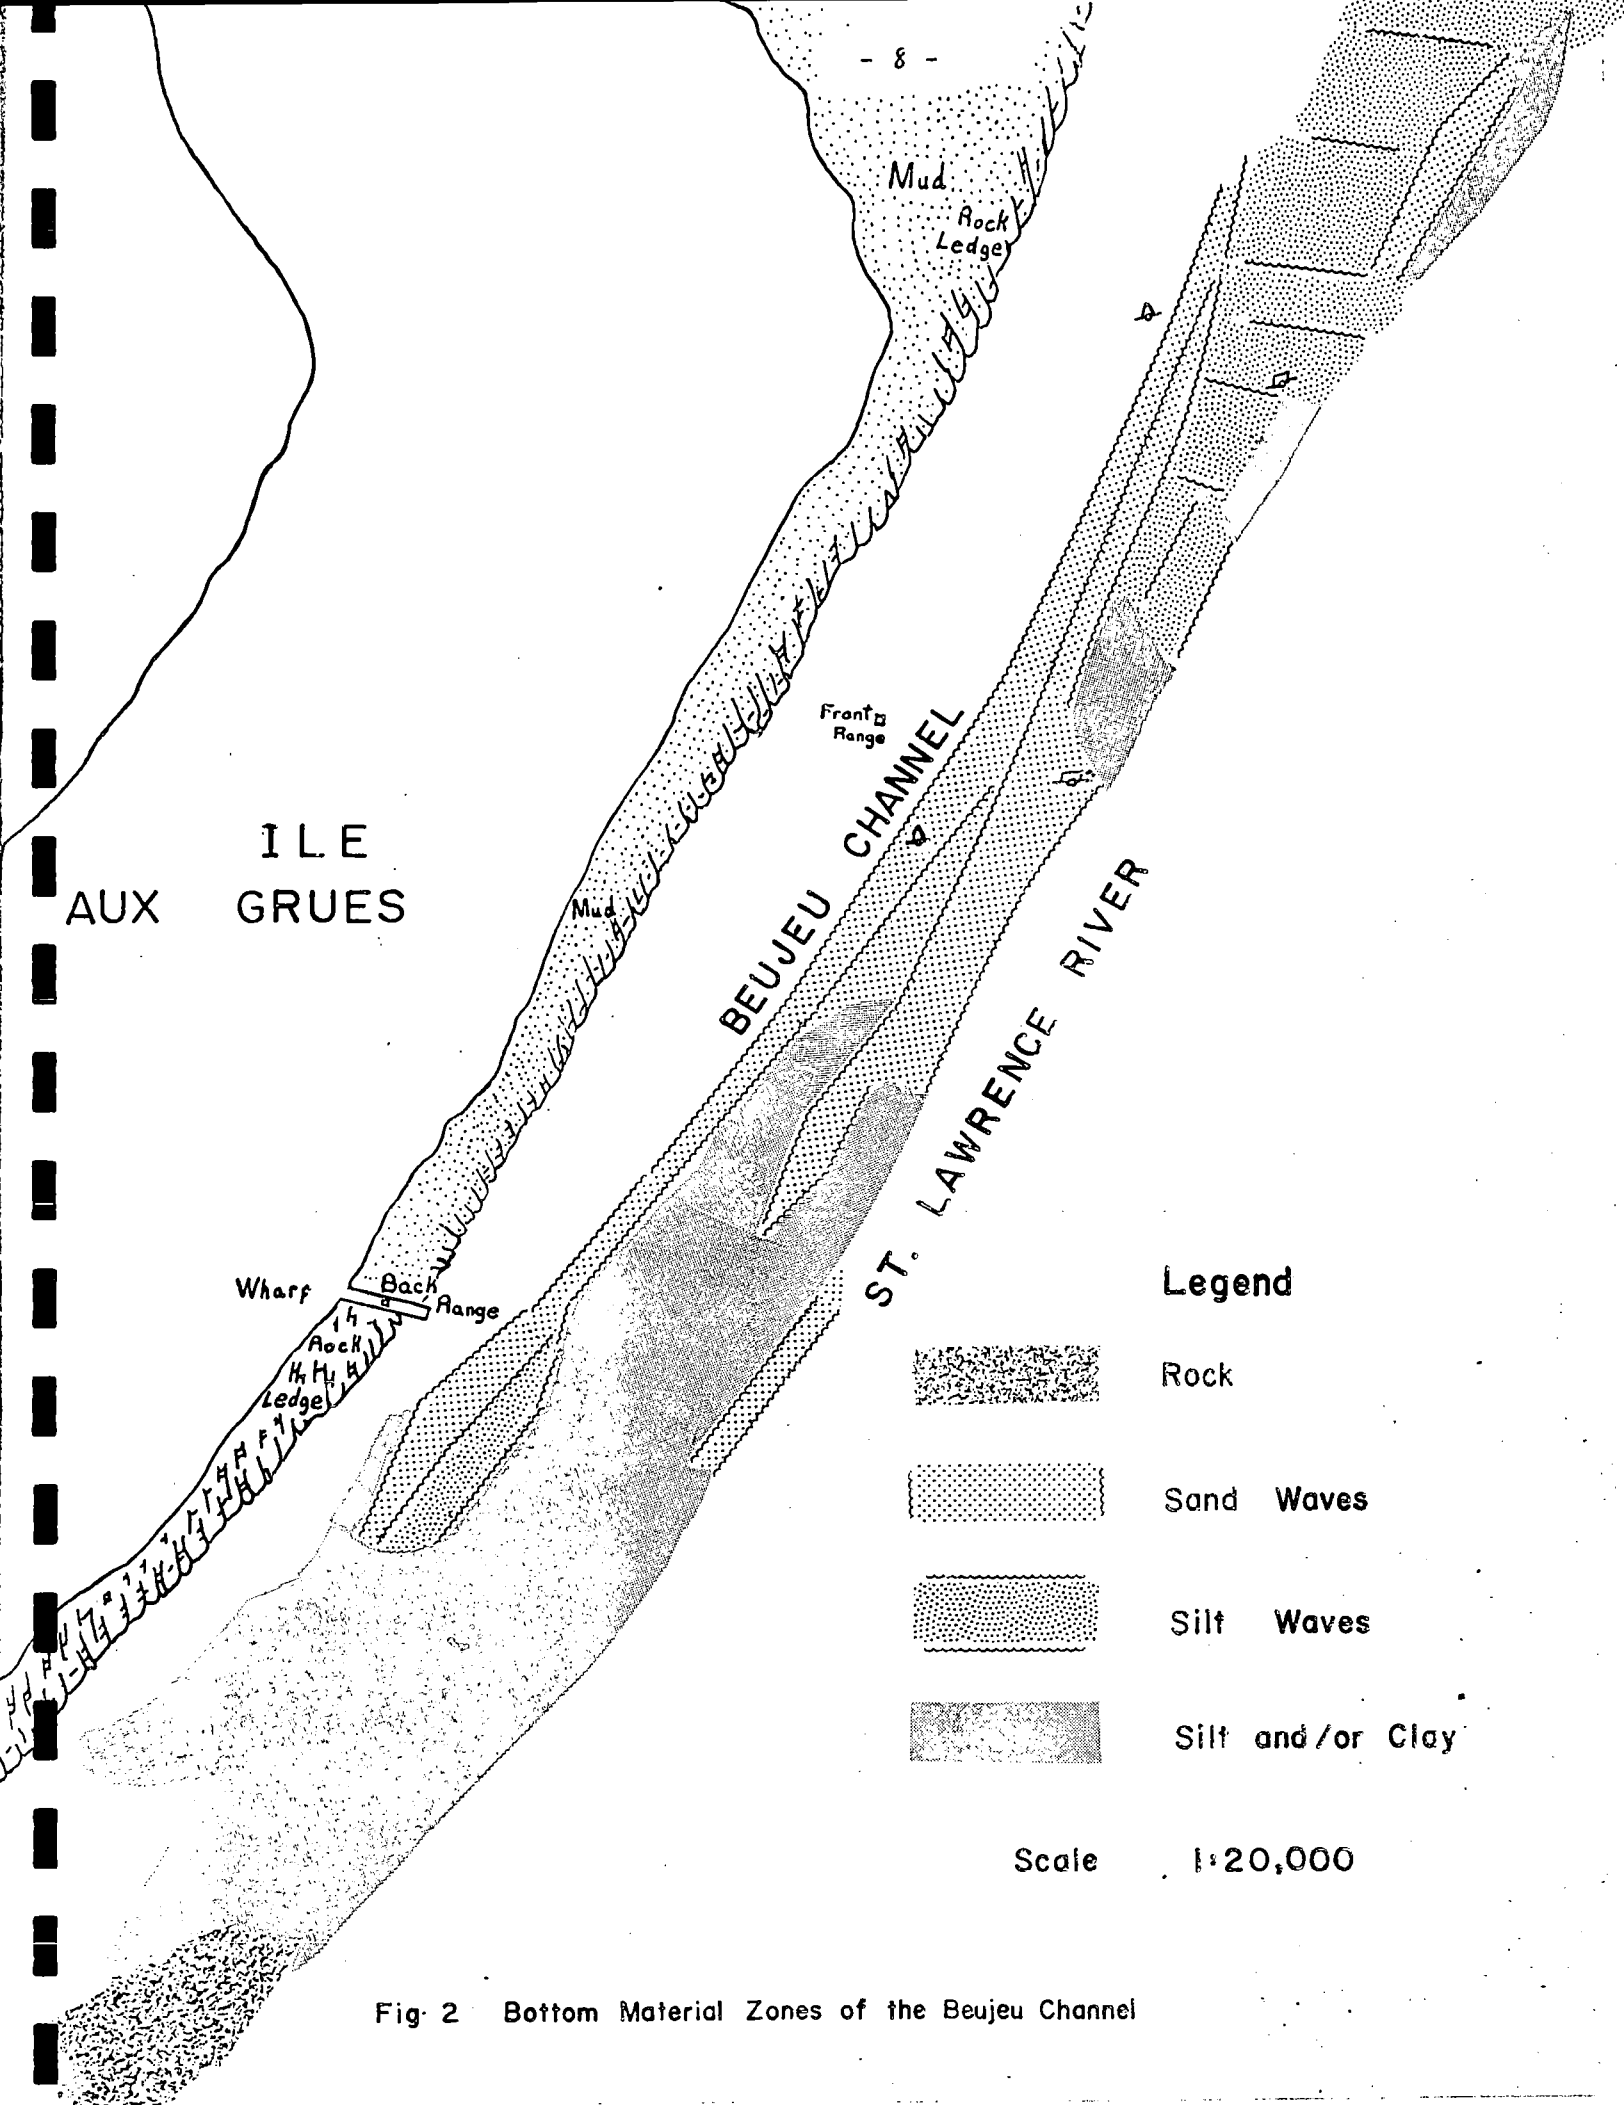
Fig. 2 Bottom Material Zones of the Beujeu Channel

been divided into bottom type zones. Figure 2 illustrates these bottom type zones at the most complex portion of the channel. From this it can be seen that the sonar can improve our bottom sampling technique. The entire area could be mapped into bottom type zones. Conventional bottom samples could then be taken in each of the various zones to confirm and fully describe the material in that zone. Once interpretational expertise has been developed, the need for conventional bottom sampling would be reduced or even eliminated.

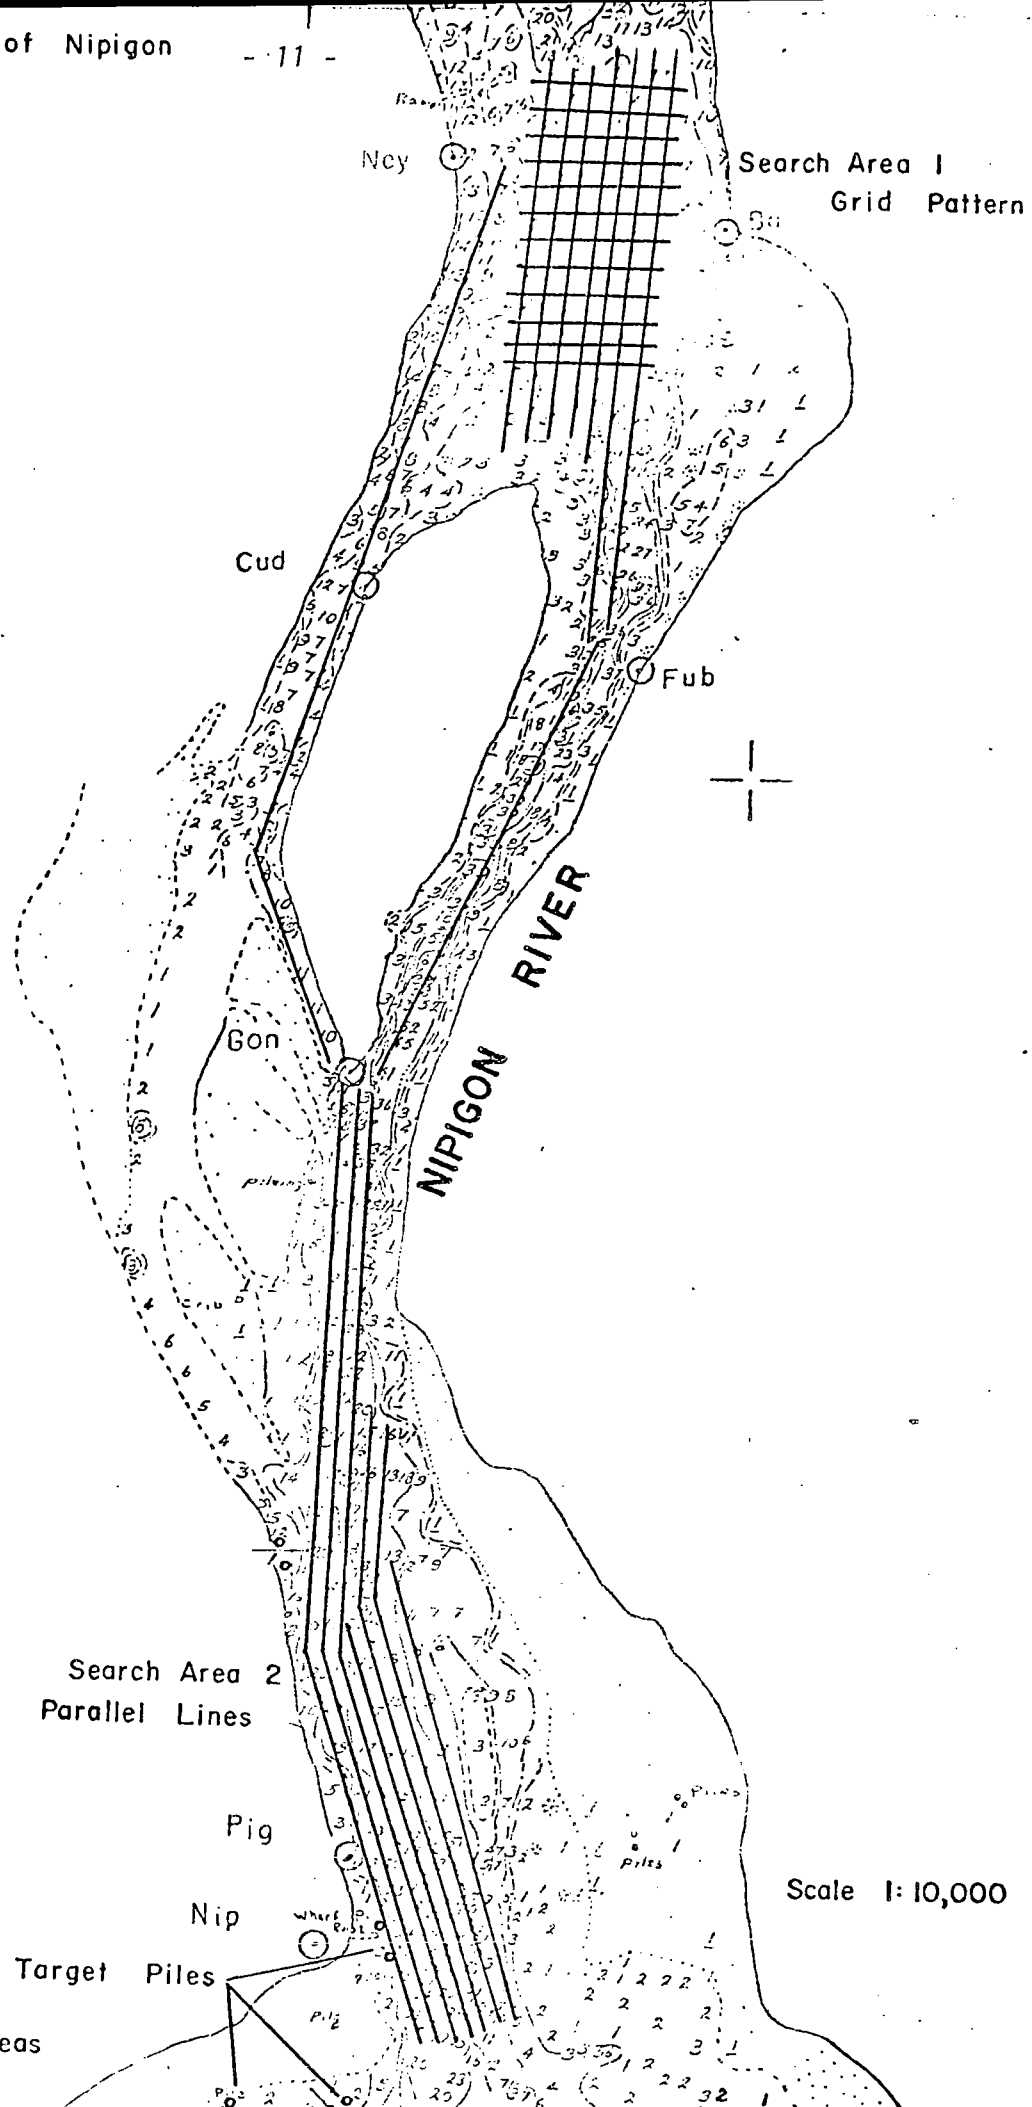
Fig. 3 The Search Areas

near the town of Nipigon was surveyed on a grid, that is, an additional search pattern of parallel lines were run normal to the original search pattern of parallel lines. Figure 3 illustrates the working area, the target piles, and the search patterns used. Finally at the end of each search operation, to ensure that the sonar was still operating properly, the visible piles were again used as targets. On every occasion, the sonar worked equally well after the search operation.
