# AVIATION SAFETY LETTER

ISSUE 1/2020

### **TSB final report A17P0170—Visual flight rules flight into deteriorating weather and collision with terrain**

## **TSB final report A19C0026—Wing lift strut assembly failure and collision with terrain**

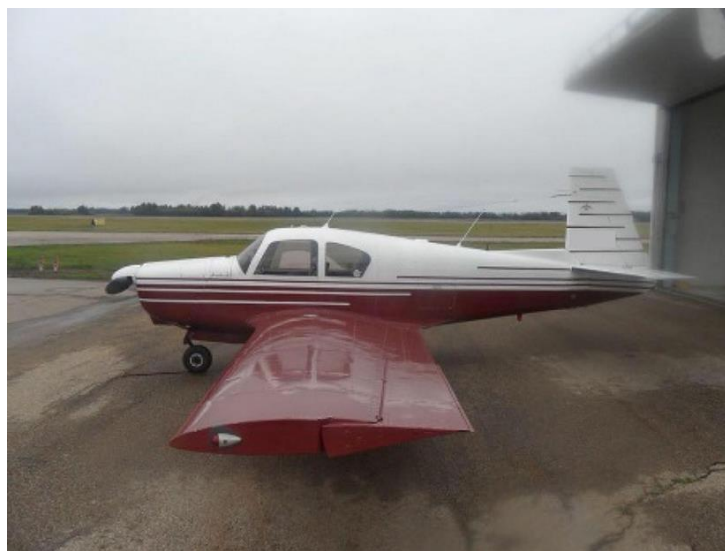
*Figure 1. The occurrence aircraft (Source: R. Friesen)*

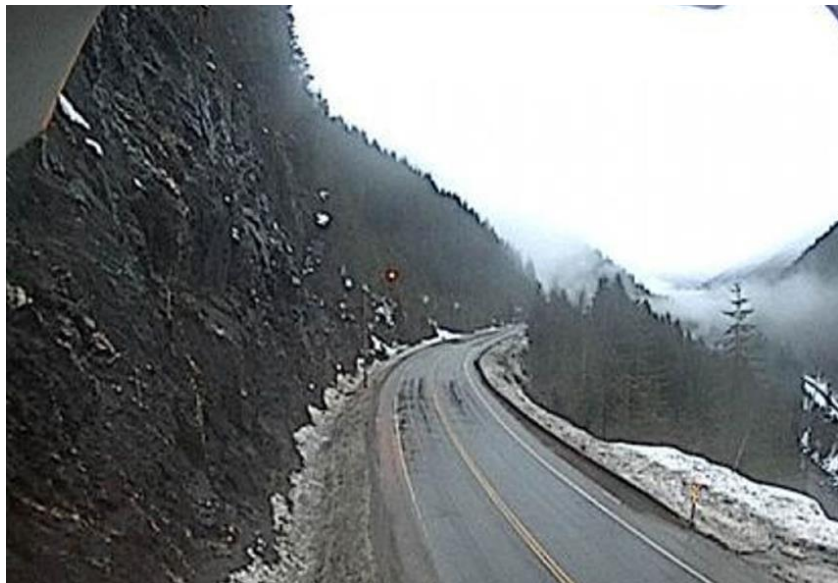
At 15:28 on 25 November 2017, local webcam photos depicted low ceilings, fog, and limited visibility due to snow near the occurrence site (Figure 4 and Figure 5).

*Figure 4. Northeast view taken at Jack McDonald Snowshed (3 050 ft ASL), 22 NM northeast of CYRV at 15:28 on the day of the occurrence (Source: DriveBC.ca)*

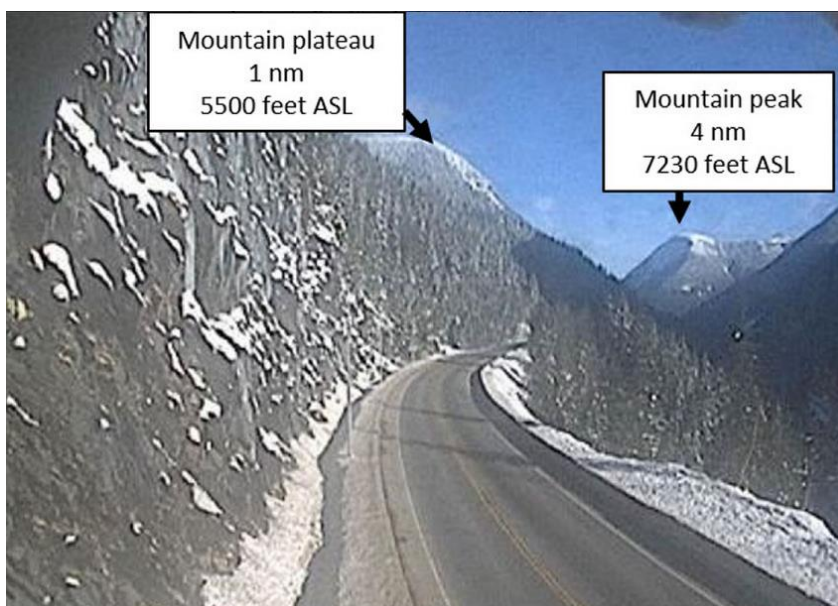
*Figure 5. Northeast view taken at Jack McDonald Snowshed (3 050 ft ASL), 22 NM northeast of CYRV at 10:40 on 19 November 2018 (right) (Source: DriveBC.ca, with TSB annotations)*
