AIR TRANSPORTATION SAFETY INVESTIGATION REPORT A17O0264

COLLISION WITH TERRAIN

Hydro One Networks Inc.
Airbus Helicopters AS 350 B2 (helicopter), C-GOHS
Tweed, Ontario, 8 NM NNE
14 December 2017

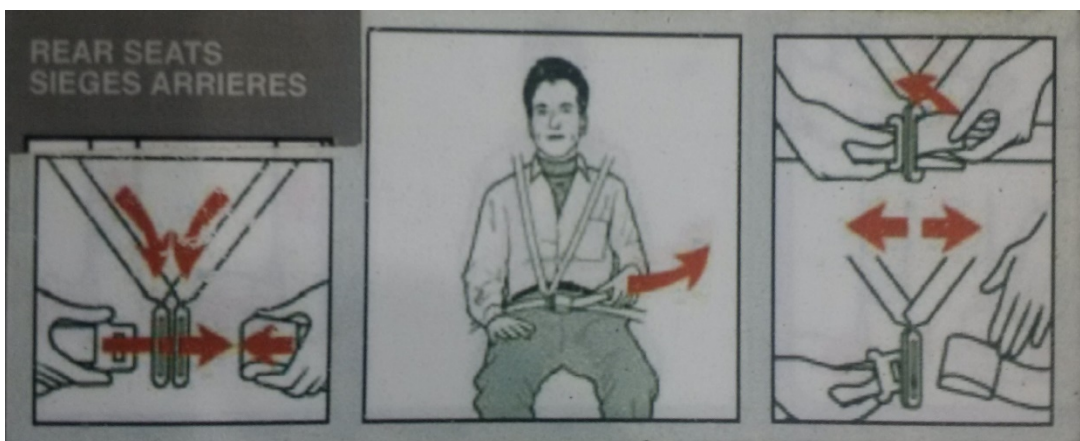
Figure 9. Hydro One's safety briefing card showing how to use the safety belts for the rear seats of the helicopter (Source: Hydro One Networks Inc.)

The helicopter had a 4-seat fixed-position rear bench, which was normally equipped with a 4-point safety belt for each seat. These safety belts were designed so that one half of the lap strap buckle had to be inserted through metal tongues on the shoulder harness before connecting the second half of the lap strap buckle (Figure 9). Lifting the buckle latch simultaneously released the lap strap and both shoulder harness straps. It was possible to wear the lap strap portion only, without the automatic locking shoulder harness attached.
