AIR TRANSPORTATION SAFETY INVESTIGATION REPORT A18Q0030

RUNWAY OVERRUN ON LANDING

Strait Air (2000) Ltd.
Beechcraft King Air A100, C-GJXF
Havre St-Pierre Airport, Quebec
26 February 2018

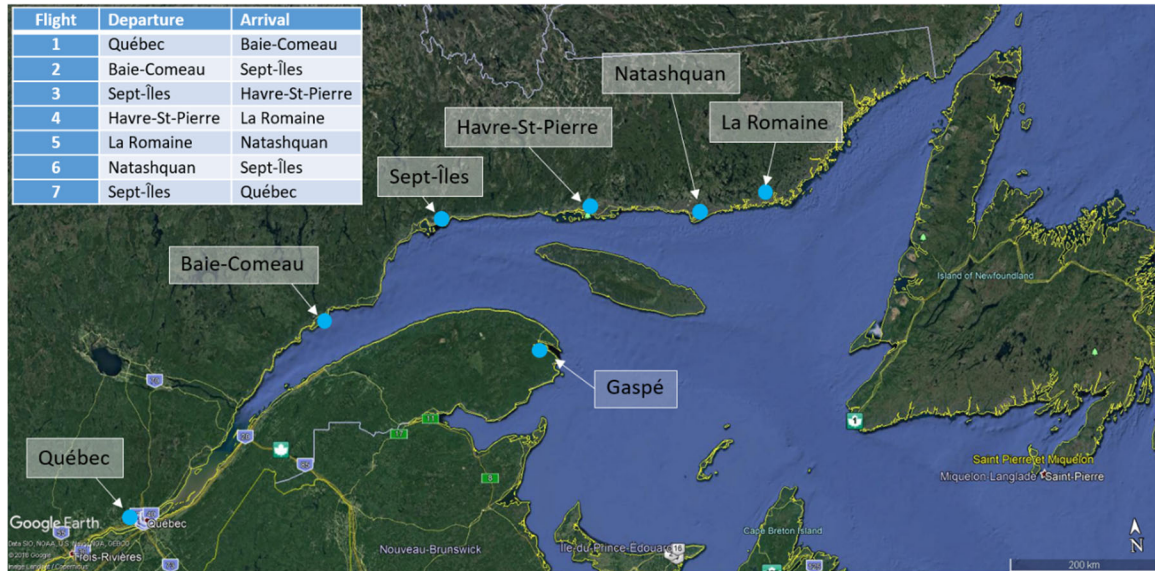
Figure 1. Flights operating as NUK107 on the occurrence date (Source: Google Earth, with TSB annotations)

At 0700, the flight crew began the series of flights operating as NUK107. The first flight, from CYQB to Baie-Comeau (CYBC), Quebec, and the next one, from CYBC to Sept-Îles (CYZV), Quebec, occurred without incident. The aircraft landed at CYZV at 0836.

The 3rd flight of the day, a departure from CYZV scheduled for 1000, was delayed by 46 minutes due to snow accumulation on the aircraft. The snow needed to be swept from the wings and the aircraft brought into a hangar to melt the remaining snow.

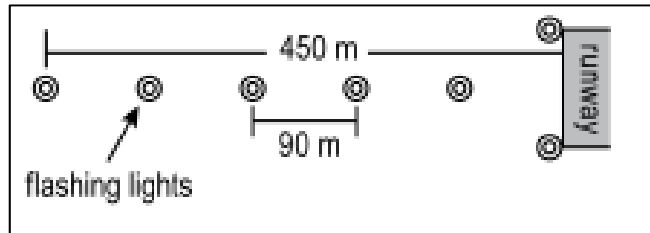
Figure 4. Omnidirectional approach lighting system
(Source: Transport Canada, Transport Canada Aeronautical Information Manual, AGA – Aerodromes [12 October 2017], section 7.5.1)

Runway 08 also has an omnidirectional approach lighting system (ODALS). An ODALS consists of 7 omnidirectional, variable-intensity, sequenced flashing lights. Two lights are positioned 12 m to the left and right of the threshold; they flash in unison. There are also 5 lights on the extended centreline commencing 90 m from the threshold and spaced 90 m apart over a total distance of 450 m. They flash sequentially toward the threshold²⁹ (Figure 4).

Given the presence of a sensitive environmental area, a lake that is home to endangered species, the 5 lights on the extended centreline of the Runway 08 ODALS at CYGV extend over a distance of 419.8 m rather than 450 m, pursuant to an exemption from regulatory requirements issued by TC.³⁰

The ODALS was serviceable at the time of the occurrence, and was turned on automatically when the pilot activated the ARCAL.

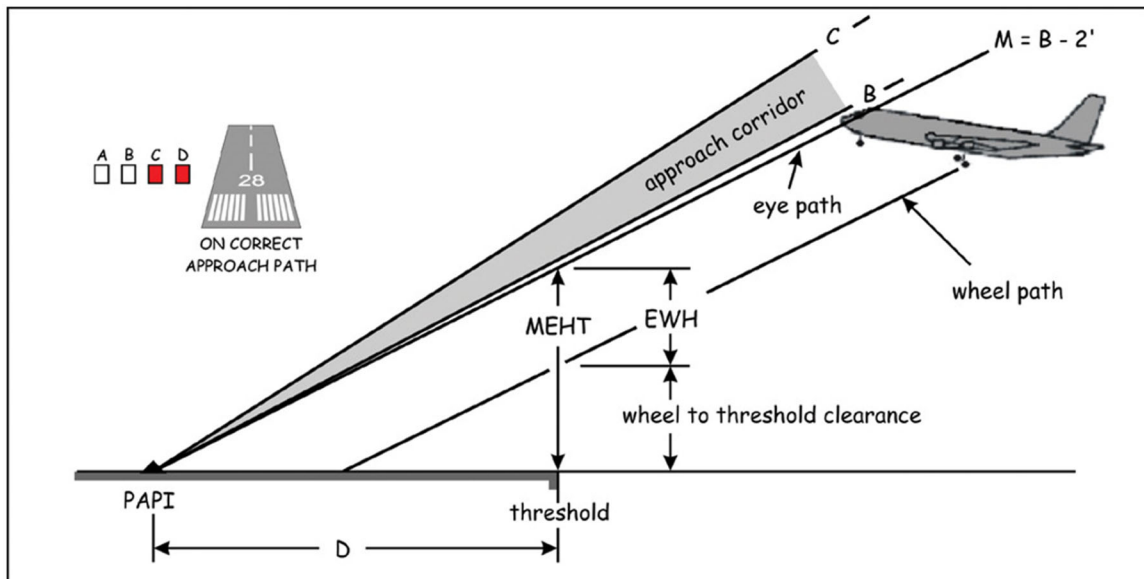
Figure 5. Precision approach path indicator: pilot eye path to wheel path (Source: Transport Canada, Transport Canada Aeronautical Information Manual, AGA – Aerodromes [12 October 2017], section 7.6.4.3)

Runway 08 has a P1 PAPI. A PAPI consists of 4 light units, spaced equally apart, typically situated on the left side of the runway, in the form of a wing bar. When an aircraft is on the approach slope, the 2 units nearest the runway show red and the 2 units farthest away show white.³¹ The P1 PAPI is designed for aircraft with an eye-to-wheel height³² extending up to 10 feet (Figure 5). The PAPI was serviceable at the time of the occurrence; it was turned on automatically when the pilot activated the ARCAL.
