AIR TRANSPORTATION SAFETY INVESTIGATION REPORT A18A0085

RUNWAY OVERRUN

Sky Lease Cargo

Boeing 747-412F, N908AR

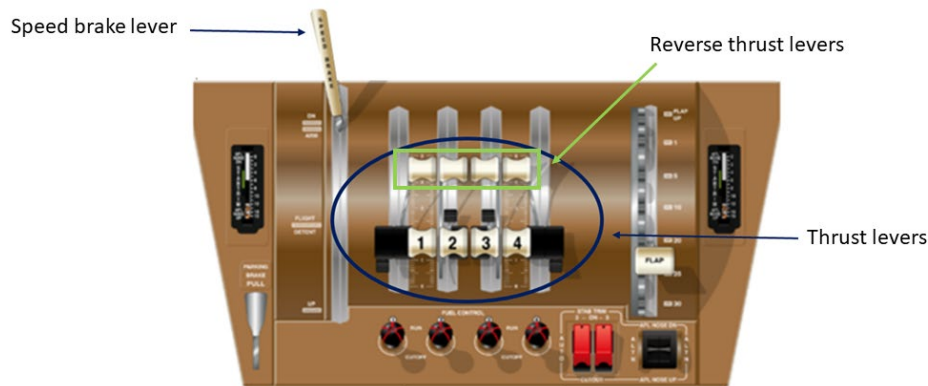
Figure 3. Boeing 747-400 centre pedestal (Source: Copyright © Boeing. Reprinted with permission of The Boeing Company, with TSB annotations)

When the speed brakes are extended automatically, the auto speed brake system moves the speed brake lever aft to the UP position (Figure 3), which, in turn, raises the spoiler panels on the wings. This significantly reduces the lift generated by the wings and transitions the weight of the aircraft onto the wheels. If the auto speed brakes are not deployed properly, the landing distance required on a dry runway may be increased by as much as 870 feet. The FCTM contains 2 specific sentences about the importance of deploying auto speed brakes:
