AIR TRANSPORTATION SAFETY INVESTIGATION REPORT A19Q0091

LOSS OF CONTROL ON TAKEOFF AND COLLISION WITH GROUND

Cargair Ltd.
Piper PA-23-250 Aztec, C-GDUL
Trois-Rivières Airport, Quebec
18 June 2019

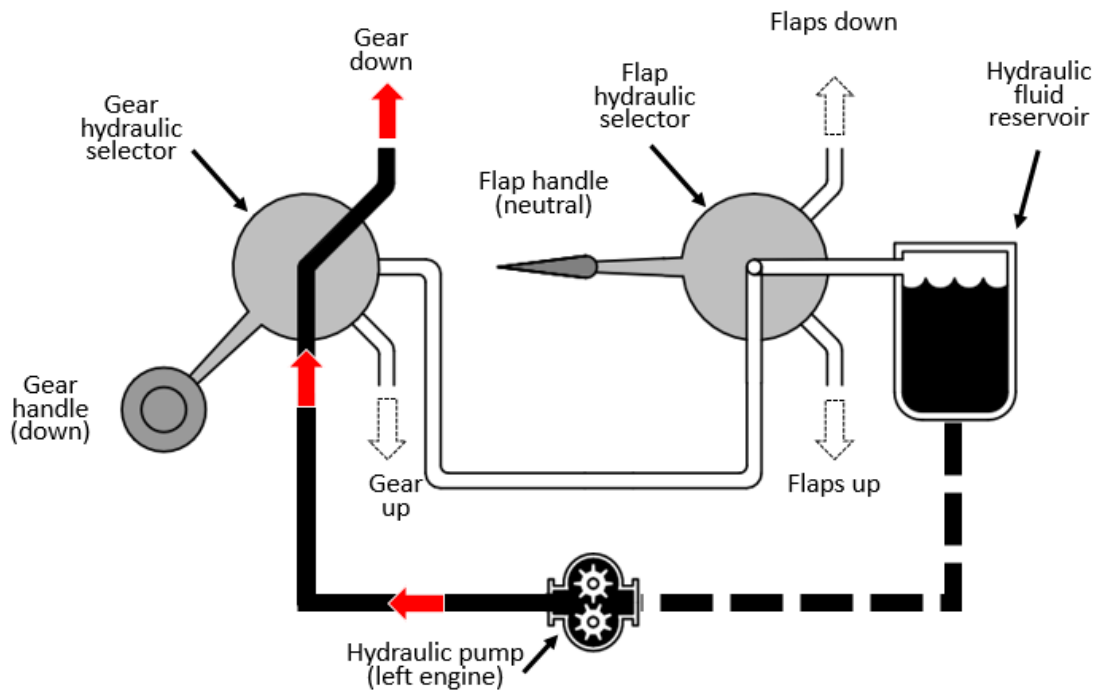
Figure 3. Simplified hydraulic system with the landing gear handle in the UP or DOWN position, preventing hydraulic pressure from reaching the flaps (Source: TSB)

During the occurrence flight, for an undetermined reason, the landing gear handle did not return to the neutral position, blocking retraction of the flaps (Appendix B). On some Cargair Ltd. Piper PA-23-250 aircraft, the landing gear handle would sometimes not return automatically to the neutral position. Generally, the problem was intermittent: the instructor would move the landing gear handle back to the neutral position, then the handle would return to the neutral position during subsequent movements of the landing gear. An examination of the technical records for the occurrence aircraft revealed that a similar problem with the landing gear handle had been recorded in December 2018. No other similar problems were recorded after that.

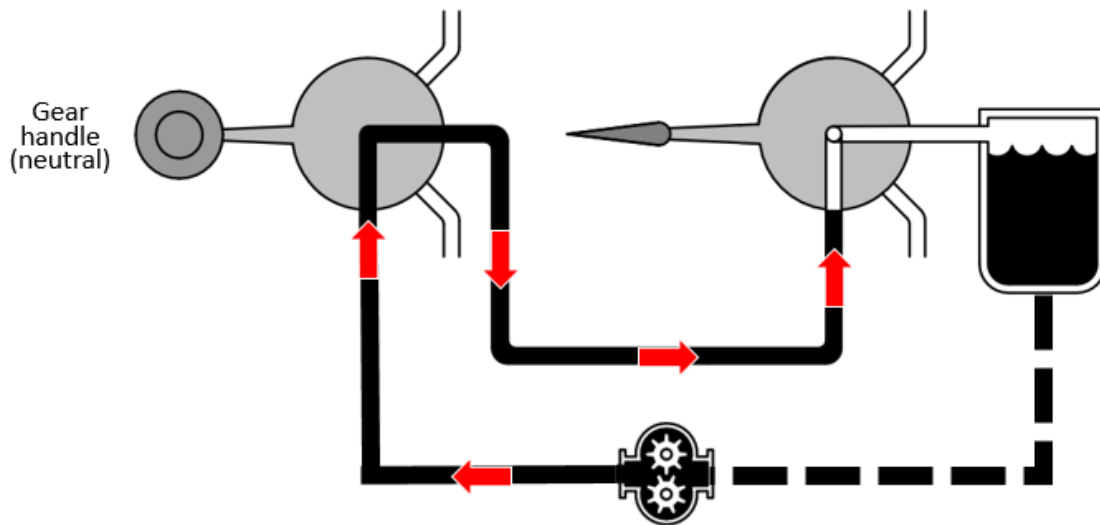
Figure 4. Simplified hydraulic system with the landing gear handle in the neutral position, allowing hydraulic pressure to reach the flaps (Source: TSB)

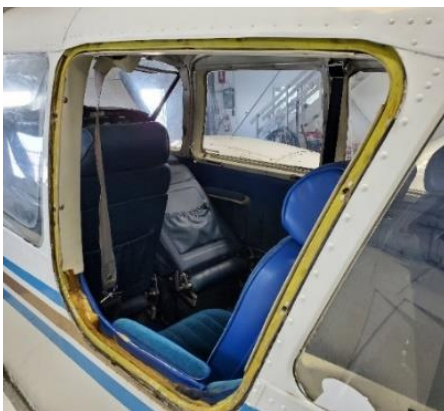
A post-impact fire broke out. Given that the fire was burning near the right wing, on the side where the main door was located, the pilot and the passenger-instructor went to the back of the aircraft with the intention of opening the emergency exit window on the left side, but they could not get it open. They were still able to evacuate the aircraft through this window because the plexiglass had been shattered on impact.

Figure 6. Emergency exit window removed (Source: TSB)

Instructors and pilots receive theory training on how to open the emergency exit window on the Piper PA-23-250. However, this training does not include a practical exercise on how to use the handle to remove the window. Regulations do not require that flight schools provide a practical aspect for this training.

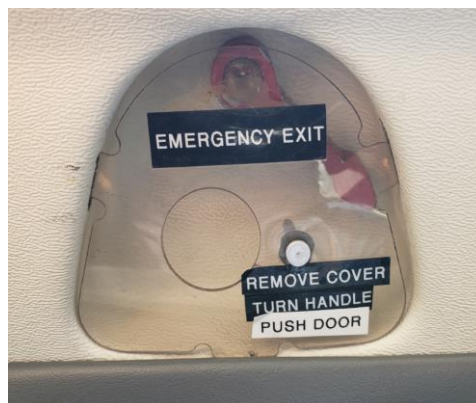
Figure 7. Handle of the emergency exit window with plastic cover (Source: TSB)
