AIR TRANSPORTATION SAFETY INVESTIGATION REPORT A20W0016

LOSS OF PITCH CONTROL ON LANDING

Canadian Pacific Railway Company
Bombardier CL-600-2B16 (Challenger 605), C-GKCP
Calgary International Airport, Alberta
23 February 2020

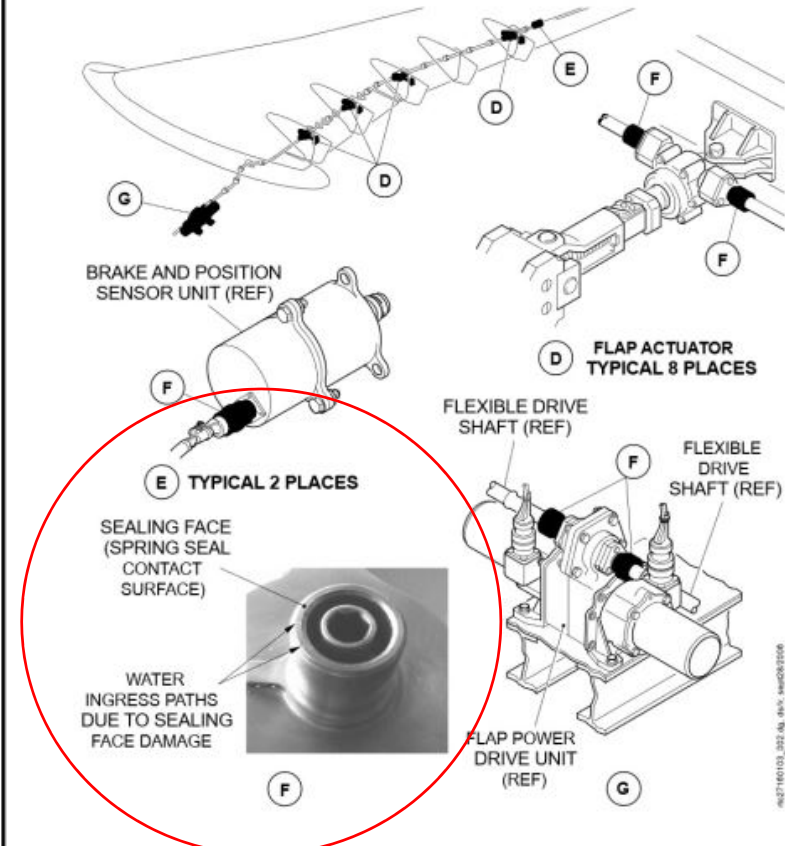
Flexible Drive–Shaft Core – Inspection/Check
Figure 1 (Sheet 2 of 2)

Detailed Inspection of the Left Flap Flexible Drive–Shaft Core (Drive–Shaft No. 2)
