MARINE TRANSPORTATION SAFETY INVESTIGATION REPORT M19P0057

STRIKING OF THE ANCHORED VESSEL *PAN ACACIA*

Bulk carrier *Caravos Harmony*
Vancouver Harbour, British Columbia
17 March 2019

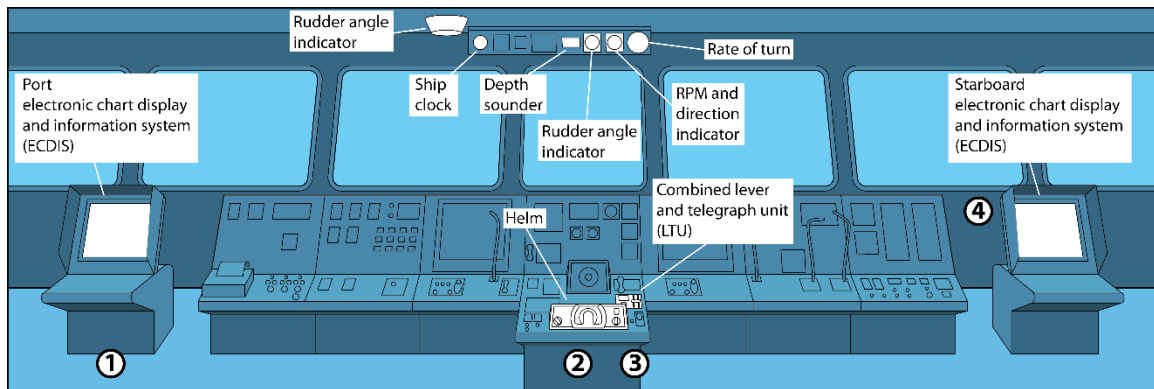
In the same console as the LTU lever, there are digital displays for rpm and the direction of the engine's rotation. There is also a bridge movement recorder which records telegraph movements on a printer. There is one other rpm indicator on the bridge above the bridge midship window in front of the steering console. This indicator provides information about the status and direction of the main engine's revolutions. It is visible from the ECDIS on the port side of the bridge (Figure 8), which is where the pilot was standing throughout the voyage. The pilot's portable pilot unit was also at this location.

Figure 8. Illustration of the layout of the bridge on the *Caravos Harmony* showing the positions of the bridge team (pilot, helmsman, second officer and master) at the time of the occurrence (Source: TSB)

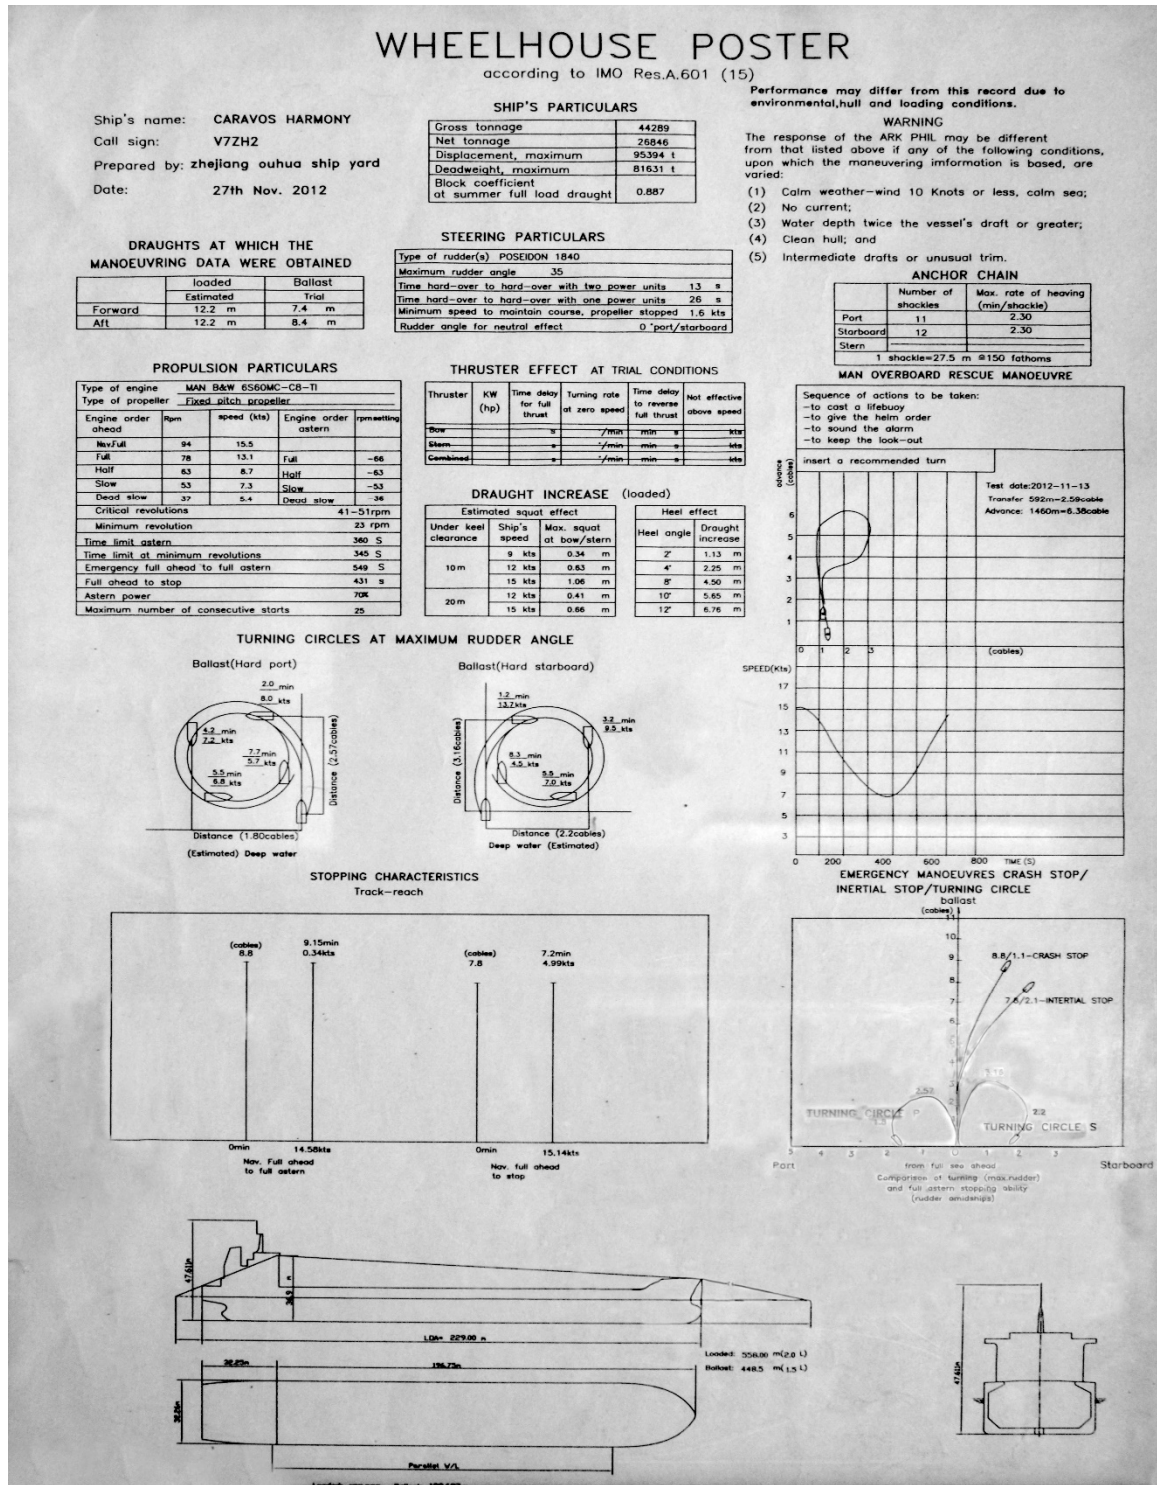
Appendix A – Wheelhouse poster of the *Caravos Harmony*

When a vessel is underway and the main engine is stopped, the vessel will not stop immediately but will continue moving through the water for a certain distance due to inertia. The *Caravos Harmony* wheelhouse poster showed that if the vessel travelling at 15.14 knots (navigation full ahead) in ballast condition has its engine stopped, the vessel will continue 0.78 NM and take 7.2 minutes before the speed reduces to 4.99 knots.^{32,33} Although fuel is no longer going to the engine once it is stopped, the vessel's momentum through the water will drive the propeller and thereby turn the engine.
