Transportation  
Safety Board  
of Canada

# Pipeline Transportation Safety Investigation Report P20H0023

## RELEASE OF CRUDE OIL INCIDENT

Trans Mountain Pipeline ULC  
Sumas Pump Station  
Abbotsford, British Columbia  
12 June 2020

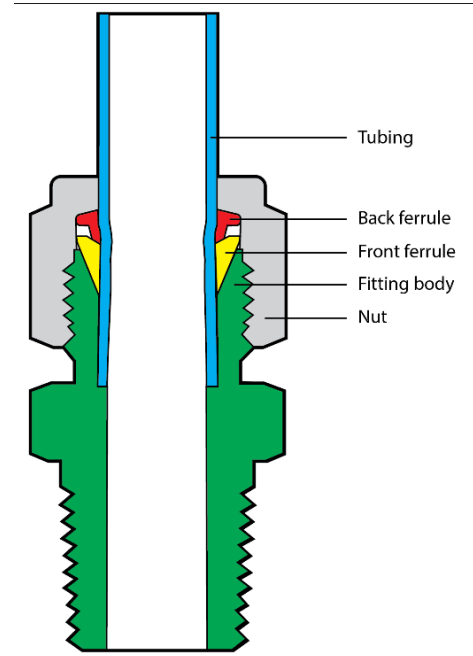
Figure 4. Schematic showing the components of a double-ferrule mechanical grip compression fitting (Source: TSB)

The failed fitting was a 1-inch stainless steel double-ferrule mechanical grip compression fitting manufactured by Swagelok (part number SS-1610-6). This type of fitting consists of an outer nut, a front ferrule, a back ferrule, and a fitting body (Figure 4).

In this occurrence, the tube had pulled free from the compression fitting. A preliminary analysis determined that the occurrence tube had marks of progressive sliding between the two ferrules, which suggested insufficient tightening of the compression fitting at the failure location.

As part of the laboratory analysis, to reproduce the degree of tightening found on the failed occurrence tube, sections of comparison tubes were tightened incrementally from ¼ to ¾ turn. It appeared that no more than ⅝ of a turn would lead to a similar degree of tightening as that found on the failed occurrence tube.

The laboratory analysis concluded that the compression fitting failed because of a loss of ferrule grip due to improper tightening during installation.
